2010/01235:RAB

**MEMORANDUM FOR:** Mosler Rock-Ojai Quarry Recommendations

**SUBJECT:** Effects of Mining Activities on Endangered Steelhead in the North Fork Matilija Creek

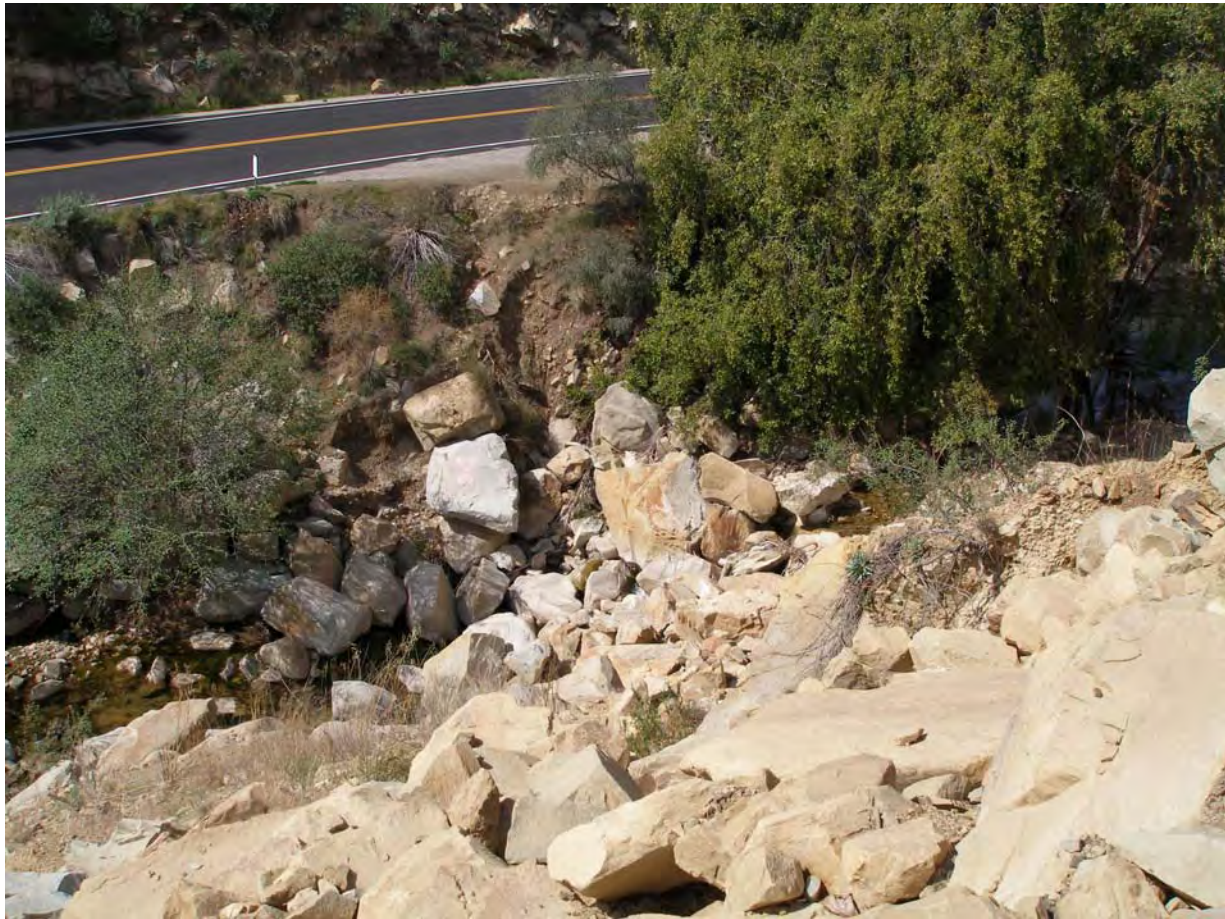
The North Fork provides greater than 5 miles of spawning habitat upstream of the Quarry (Figure 1). The landslide at the north end of the Quarry property in March 2006 created a steelhead passage barrier, and a resulting constriction in the North Fork channel (Figure 2). The U.S. Army Corps of

**Figure 2.** Boulder fish barrier in the North Fork Matilija Creek at site of the 2006 landslide at north end of Ojai Quarry property. Photo taken March 06, 2007, by NOAA Law Enforcement.

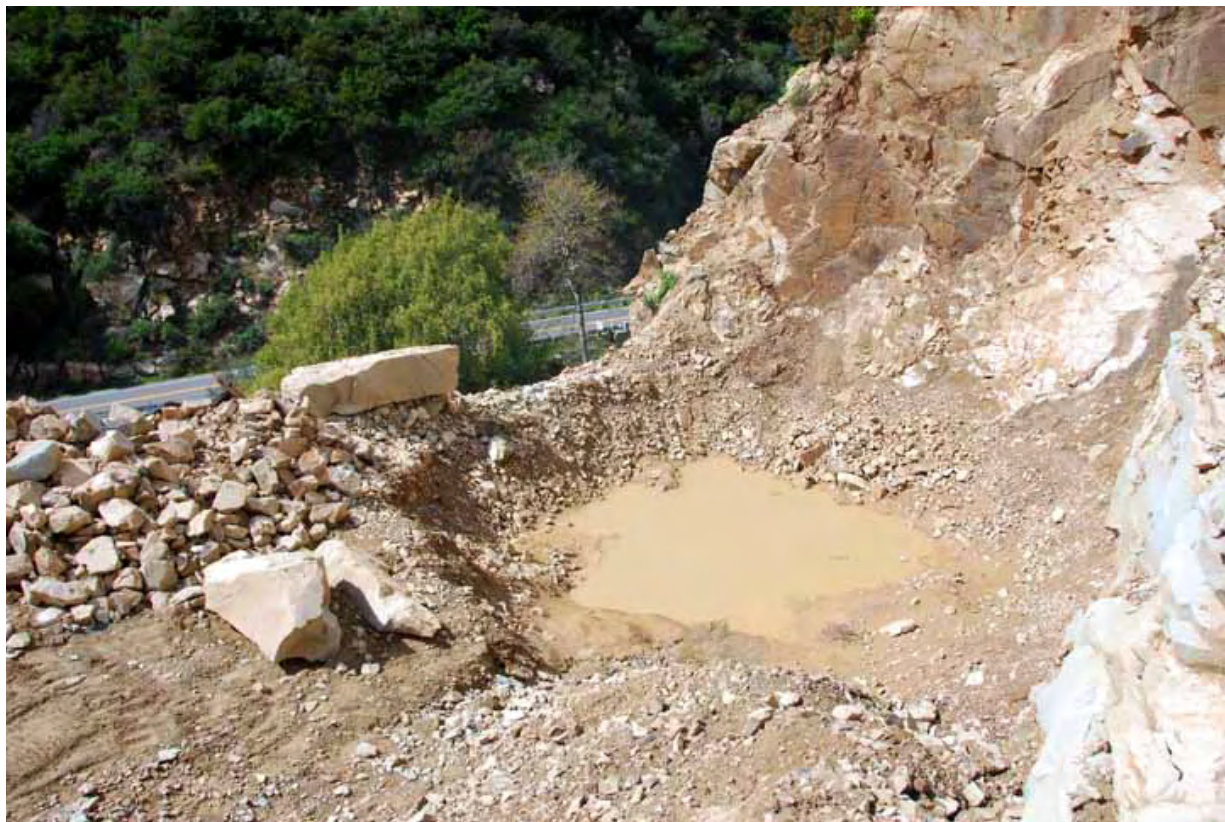
were created by the Quarry with the intent of controlling the runoff of fine sediments that originate from the Quarry property. The upstream basin is an excavation about 10-feet deep surrounded by large boulders on the western perimeter (Figure 3). The detention basin at the downstream end of the property appears to be about 6-feet deep, reinforced with concrete ecology blocks on the stream side and is at the receiving end of two corrugated drainage pipes that drain rainwater and suspended sediment from the property (Figure 4).

**Figure 3.** North sediment detention basin, immediately upslope of the 2006 landslide (figures 3 & 4) and current North Fork fish passage barrier. Photo taken March 7, 2010, by NMFS.

We recommend that the Quarry implement a revegetation plan to NMFS and CDFG in order to rehabilitate the barren landscape and redesign both sediment basins to adequately capture all Quarry property sediment runoff. NMFS believes a crucial step in the control of sediment runoff from the Quarry will rely on the Quarry developing a sediment-maintenance plan that mandates removal of the sediment from both detention basins after each rain event to maintain adequate sediment-capture capacity, as well as requires proper storage of the collected sediment that is removed from the detention basins. In its current configuration, the Quarry does not have an adequate fine sediment storage containment area that prevents sequestered sediment from making its way back into the sediment-detention basin slurry and potentially entering the North Fork (Figure 14). NMFS recommends that the Quarry seek outside assistance from experts in the field of stormwater management (i.e., RWQCB) to redesign the sediment detention basins in order to minimize sedimentation concerns from the Quarry property. The California Stormwater BMP Handbook (2003) provides guidance on recommended designs for this type of sediment detention structures.

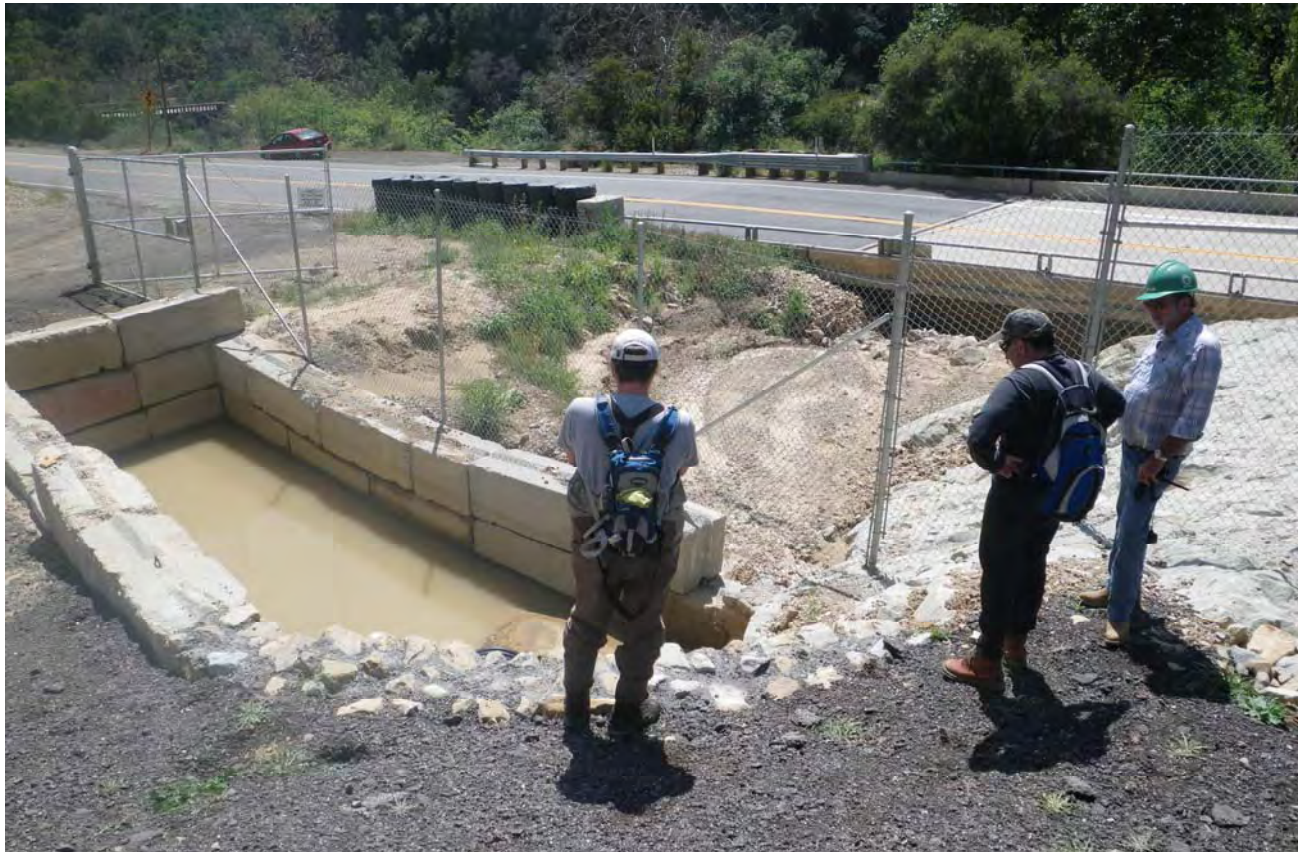
**Figure 4.** South sediment detention basin at Highway 33 and the Quarry driveway. Note fine sediment overflow from basin low point (i.e., spillway). Photo taken April 15, 2010, by NMFS.

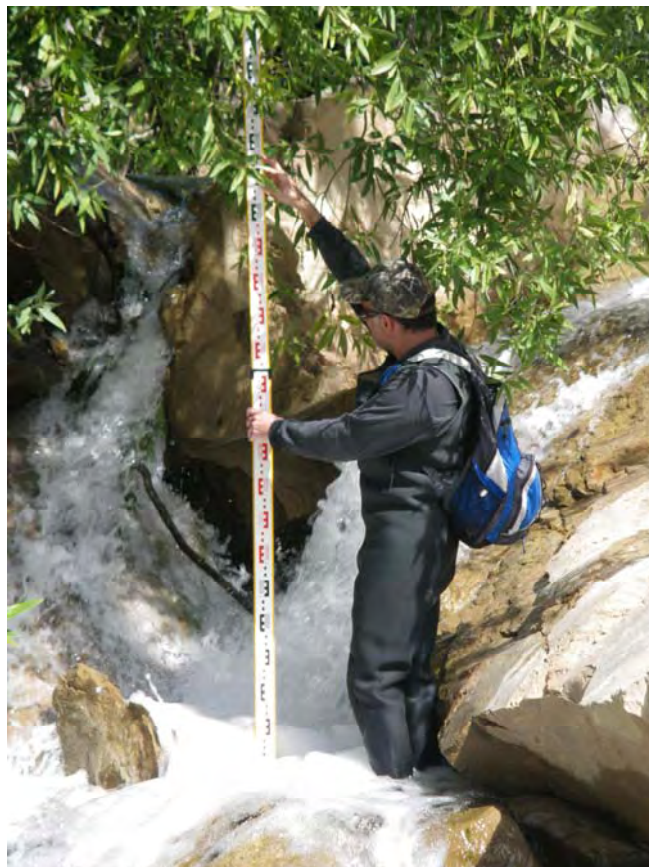
Based on our instream measurements and site observations made on April 15, 2010, angular Quarry boulders located at the base of the 2006 landslide slope in the active channel have created a turbulent cascade barrier with a maximum jump height of 2.15 meters (i.e., measured from jump pool surface to upstream pool crest), a jump pool depth of 0.45 meters and a horizontal distance of 6.0-meters (Figure 5). NMFS (2001) guidelines for salmon and steelhead passage state that a jump pool depth of at least 1.5 times the jump height is required for successful steelhead passage over instream barriers. The measured elevation drop created by the instream boulders was also determined to be in excess of the steelhead jumping ability reported in Powers and Orsborn (1985). Therefore, at the current streamflow of 13.2 cubic feet per second (cfs) in the North Fork and mainstem Ventura River flow of 45 cfs, this turbulent cascade barrier creates a complete stream barrier to upstream migrating adult steelhead. This barrier also impedes the seasonal movements of juvenile steelhead in search of tributary refugia that provide lower water temperatures and seasonal feeding areas. Other boulder impediments observed and measured in the 0.31-mile Quarry reach during the site visit were determined to be partial barriers to juvenile and adult steelhead, but all were evaluated as passable to adults at flows of 13.2 cfs or greater. NMFS spawning ground surveys in the Ventura River and San Antonio Creek this year indicated that steelhead are actively migrating through the Ventura River and spawning at mainstem flows of approximately 30 cfs and above, and that steelhead would likely spawn in the North Fork if passage were possible based on the presence of spawning substrate that exists upstream of the Quarry barrier.

**Figure 5.** Measuring the jump height and jump pool depth of current turbulent boulder cascade barrier in the North Fork at base of 2006 landslide area. Photo taken April 15, 2010, by NMFS.

NMFS recommends the following measures to alleviate the steelhead passage problem in the North Fork, which appear related to the Ojai Quarry operations. Therefore, NMFS recommends the removal of a minimum of five boulders that are the immediate cause of the problem. A cursory description of the boulders recommended for removal are as follows: Boulder # 1) large mid-channel rock creating barrier, 2) angular rock at base of falls minimizing the leaping area, and 3-5) three large rocks at base of the turbulent boulder cascade barrier, which is currently minimizing the holding area for fish attempting to pass upstream of the structure. NMFS is willing to provide more in depth planning guidance and recommends having a NMFS biologist/hydrologist onsite to provide technical assistance during the removal of the barrier.

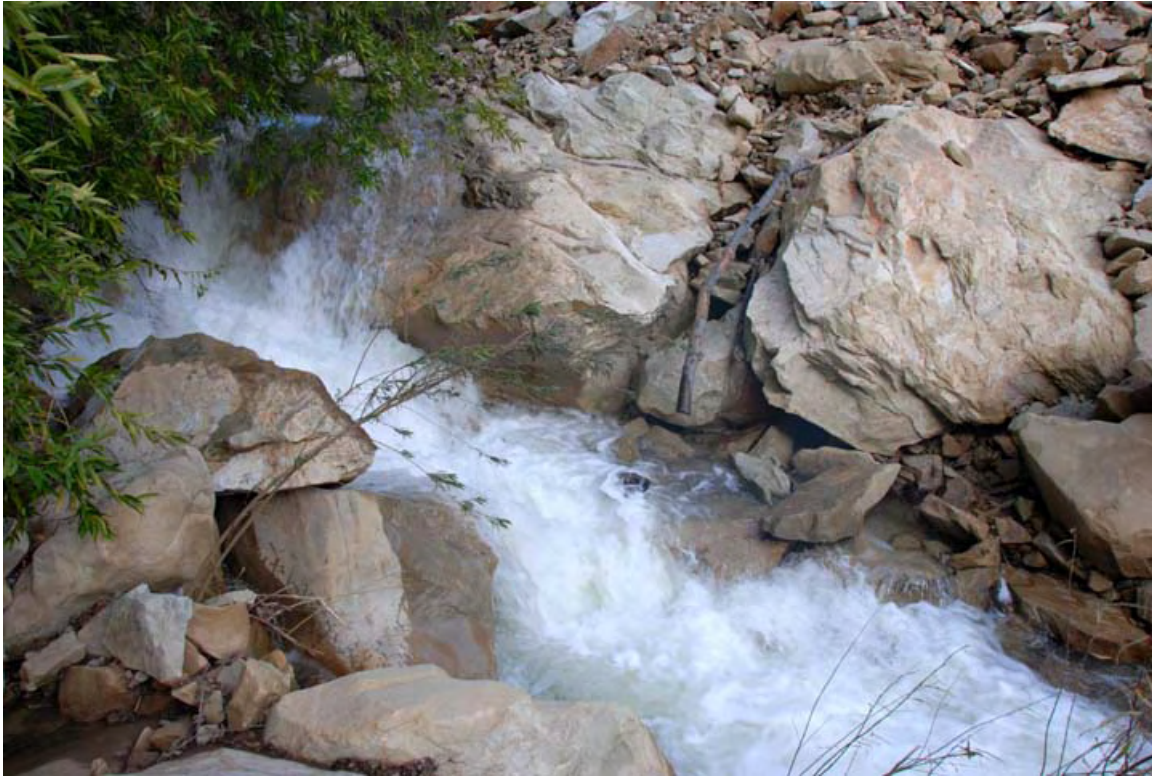
**Figure 6.** Turbulent boulder cascade barrier in the North Fork, located at the north end of the Quarry reach where boulders were once removed. Photo taken January 24, 2010, by NMFS.

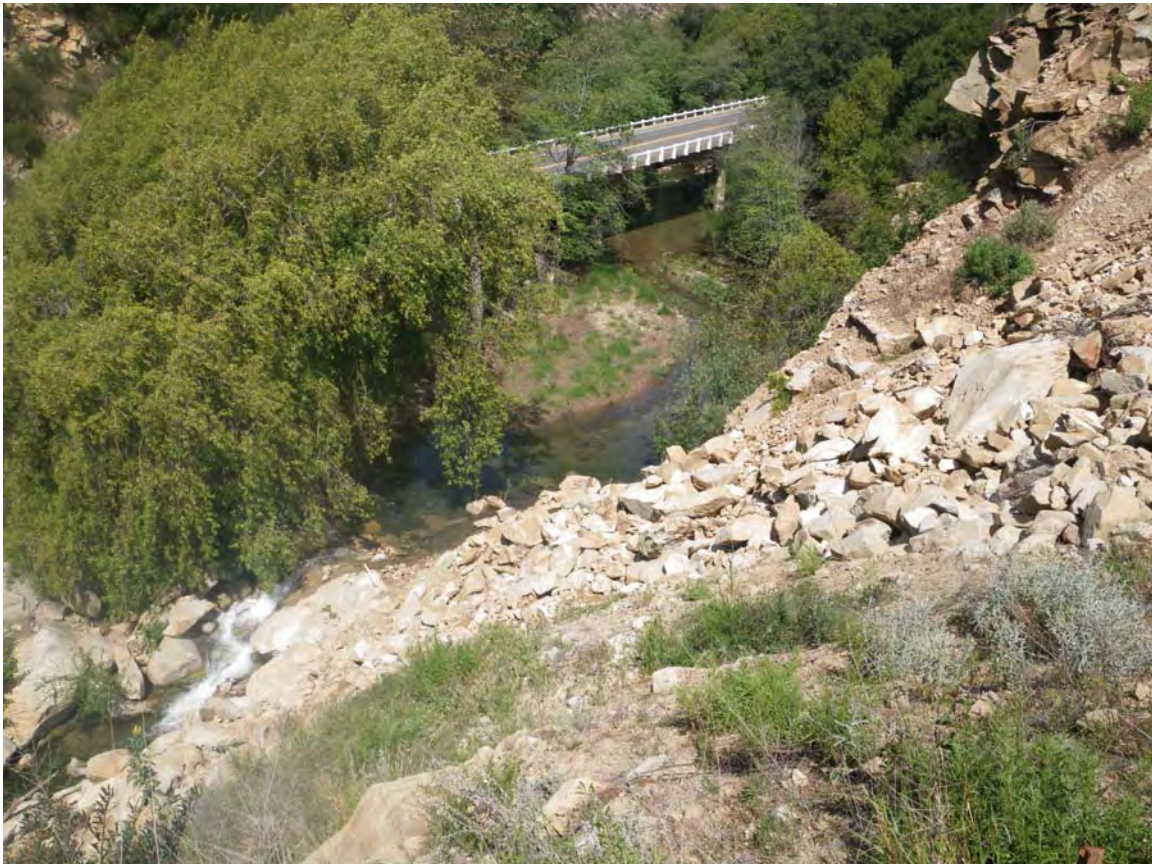
NMFS' inspection of the Quarry reach found that the placement of rock riprap appears to be precluding the establishment of streamside vegetation (Figure 7). Extensive areas of rock riprap placed streamside were observed and such areas lacked streamside vegetation. By contrast, streamside areas immediately upstream and downstream of the rock riprap possessed trees and bushes. Precluding streamside vegetation is of concern owing to the function and value such vegetation provides to streamfish in general and steelhead in particular.

**Figure 7.** Unstable landslide slope at north end of Quarry reach. Current steelhead barrier exists in whitewater area at base of riprap bank stabilization. Photo taken April 15, 2010, by NMFS.

While the boulder removal recommendations provide a temporary solution for the current problem, they do not alone provide a permanent solution to the rockfalls that repeatedly have occurred along the Quarry property. In light of the fact that the rockfalls have been a reoccurring problem at the north end of the Quarry property, NMFS recommends that streambank stabilization methods, incorporating traditional and bioengineering techniques, be applied (Table 1). The current use of cement highway barriers are woefully ineffective at providing the necessary type and level of stabilization, and no measure is in place to prevent the continued slide of boulders and Quarry rock into the North Fork at the site of the current fish passage barrier. Because all streambank-stabilization activities and placement of fill within the banks of the stream need to be permitted by the Corps of Engineers and CDFG, and there is no record of a state or federal permit on file with these agencies that authorizes the installation of riprap bank stabilization, it appears these quarry boulders were cast down the unstable slope without the proper regulatory guidance or authorization. As illustrated in the background section of this memorandum, this letter marks the fifth time in the past five years that boulder removal has been recommended at this site to restore endangered steelhead passage. Previous recommendations to remove quarry rock from the North Fork were made by NMFS, CDFG and the Corps on April 19, 2006, August 2, 2006, March 6, 2007, February 20, 2008, and December 10, 2008. NMFS recommends that the loose boulder material be removed from this unstable slope and that Quarry hire a licensed contractor to properly stabilize this erodible slope.

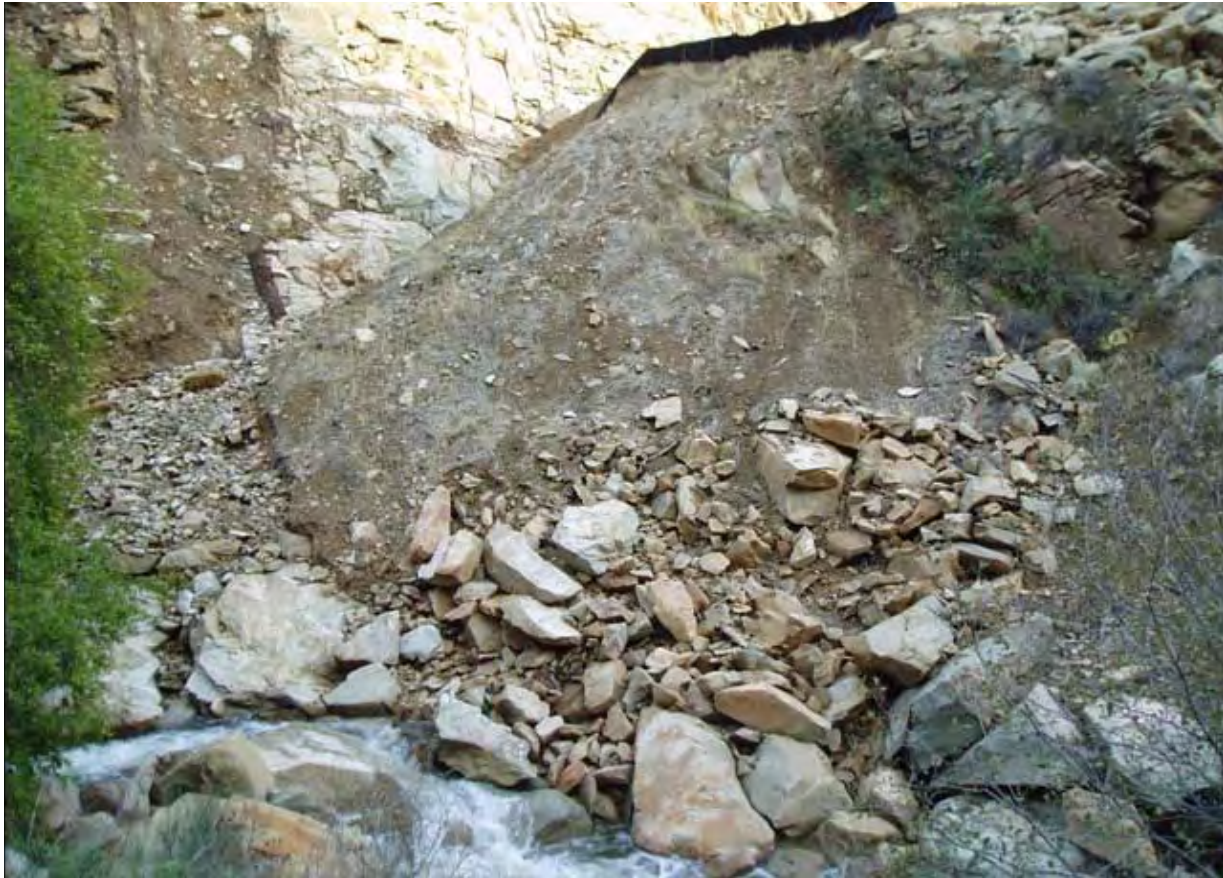
Evidence obtained from inspection of the North Fork adjacent to the Quarry indicate that the characteristics and condition of the constricted river channel within the Quarry reach are the result of improper land-use activities, namely the artificial importation of inorganic debris. The placement of fill material on the Quarry slopes has occurred at two discrete portions of the 0.30-mile long Quarry reach. Specifically, the channel width at the northern border of the Quarry reach has been reduced by the placement of inorganic material on the east bank that appears to be sloughing into the channel. Riprap fill (i.e., 2-3 ton boulder) has been haphazardly placed on the steep slope at the location of the 2006 landslide. Although the slope has been armored by rock, it remains unstable due to the manner in which the rock was placed on the steep slope and the lack of proper bank stabilization (i.e., creation of a foundation) prior to the bank armoring. NMFS biologists documented the angular Quarry boulders placed on the landslide slope at the edge of the Quarry road upslope of the North Fork channel, which extended the entire way down the embankment to the edge of the North Fork and into the channel (Figure 7). Evidence suggests that the angular boulders creating the turbulent boulder cascade barrier were stray boulders that potentially originated from this unauthorized bank armoring. Photographs clearly show that unauthorized riprap fill has been placed on the east bank of the North Fork sometime between January 2008 and January 2010 (Figures 8 & 9).

**Figure 8.** Quarry landslide area on January 7, 2008, note the lack of boulder riprap fill on left half of slope (Source: Santa Barbara Channelkeeper letter dated March 24, 2008).

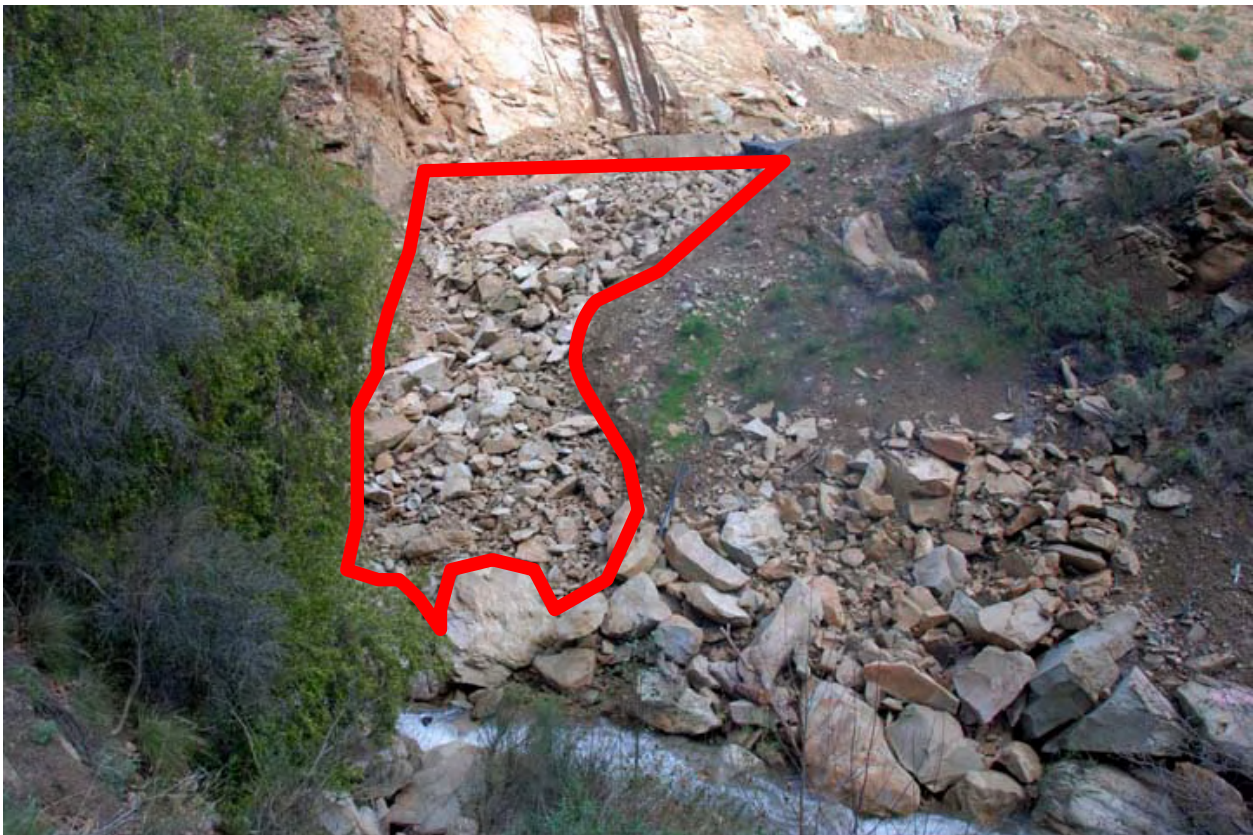
**Figure 9.** Same Quarry landslide area as above, except red polygon shows boulder riprap fill placement in the floodplain and up the Quarry slope. Photo taken January 24, 2010, by NMFS.

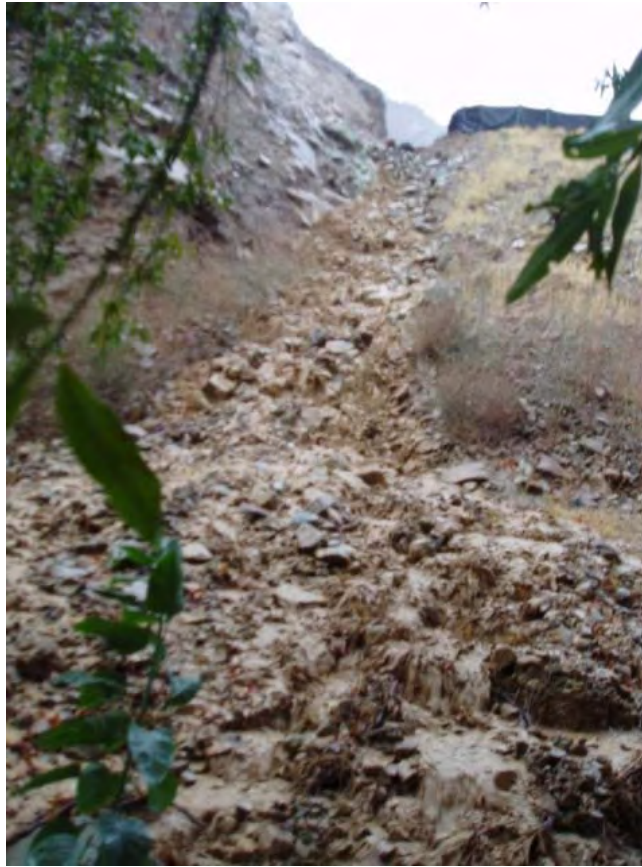
**Figure 10.** Landslide area below north sediment detention basin during rain event on December 18, 2007 (Source: Santa Barbara Channelkeeper letter dated March 24, 2008).

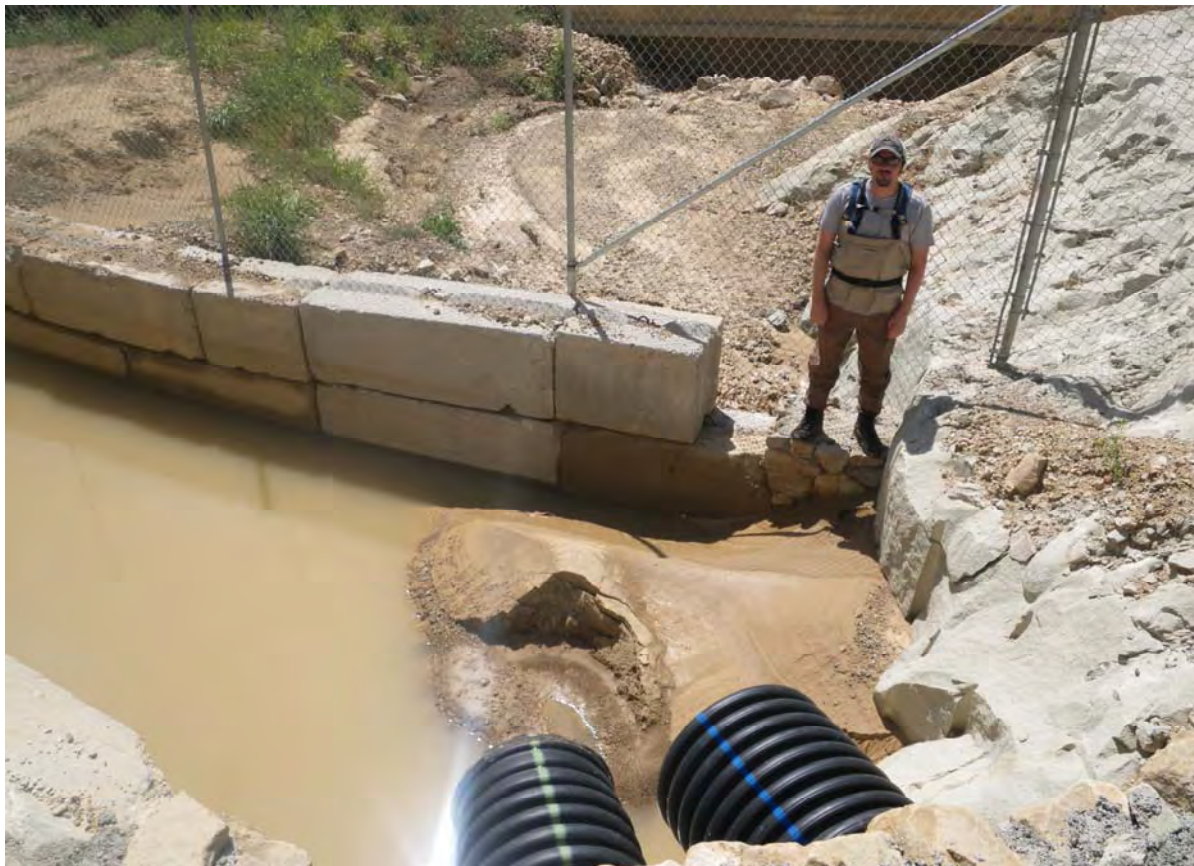
**Figure 11.** Zoom view of the south sediment detention basin. Note high sediment load in basin that accumulated after April 12, 2010, 1.76" rain event. Photo taken April 15, 2010, by NMFS.

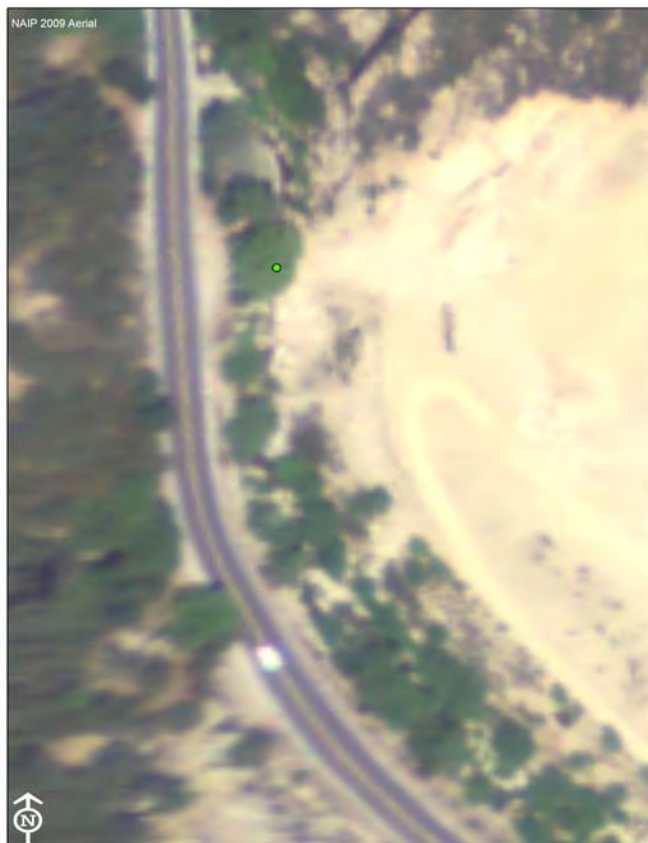
was installed as a measure to prevent Quarry sediment that washes off bare slopes and quarry roads during rain events from entering the North Fork. Based on NMFS' site visit observations, the frequency that the fine sediment is removed from the basin is not clear. Due to the 1) small size of this basin, 2) lack of drainage features, 3) large amount of loose upslope Quarry material, and 4) close proximity to the adjacent unstable landslide slope, it is reasonable to expect that this basin can fill, frequently, with Quarry material and be rendered ineffective, and the narrow earthen dam on the unstable slope face can fail and cause another landslide at this site (Figure 10). In response to NMFS' questions regarding the frequency that sediment needs to be removed from the south sediment detention basin, the quarry operator stated that the fines need to be removed from that basin on a regular basis. At the time of NMFS' April 15, 2010, site visit, the south sediment-detention basin had accumulated a high level of fine sediment in response to a moderate 1.76-inch rain event on April 12, 2010 (Matilija Dam Station #304). It does not appear that the south sediment basin, as constructed, can effectively capture and retain a sufficient amount of the quarry sediment runoff, particularly during moderate to large storm events (Figure 11). Furthermore, the basin spillway does not appear to function effectively. Evidence suggests that water-sediment slurry flows freely from the basin to the creek during storm events as suggested by the swath of unvegetated gravel and fine sediment that is visible leading away from the basin spillway to an erosion channel beneath the SR-33 bridge (Figure 11). Aerial photographs of the Quarry property demonstrate the loss of vegetative land cover and the extensive areas of exposed soil that are burdening the two small sediment detention basins during storm runoff (Figures 12 & 13).

**Figure 13.** Aerial photograph (2009) of the north end of the Quarry reach. Green dot references the site of the current steelhead boulder barrier.

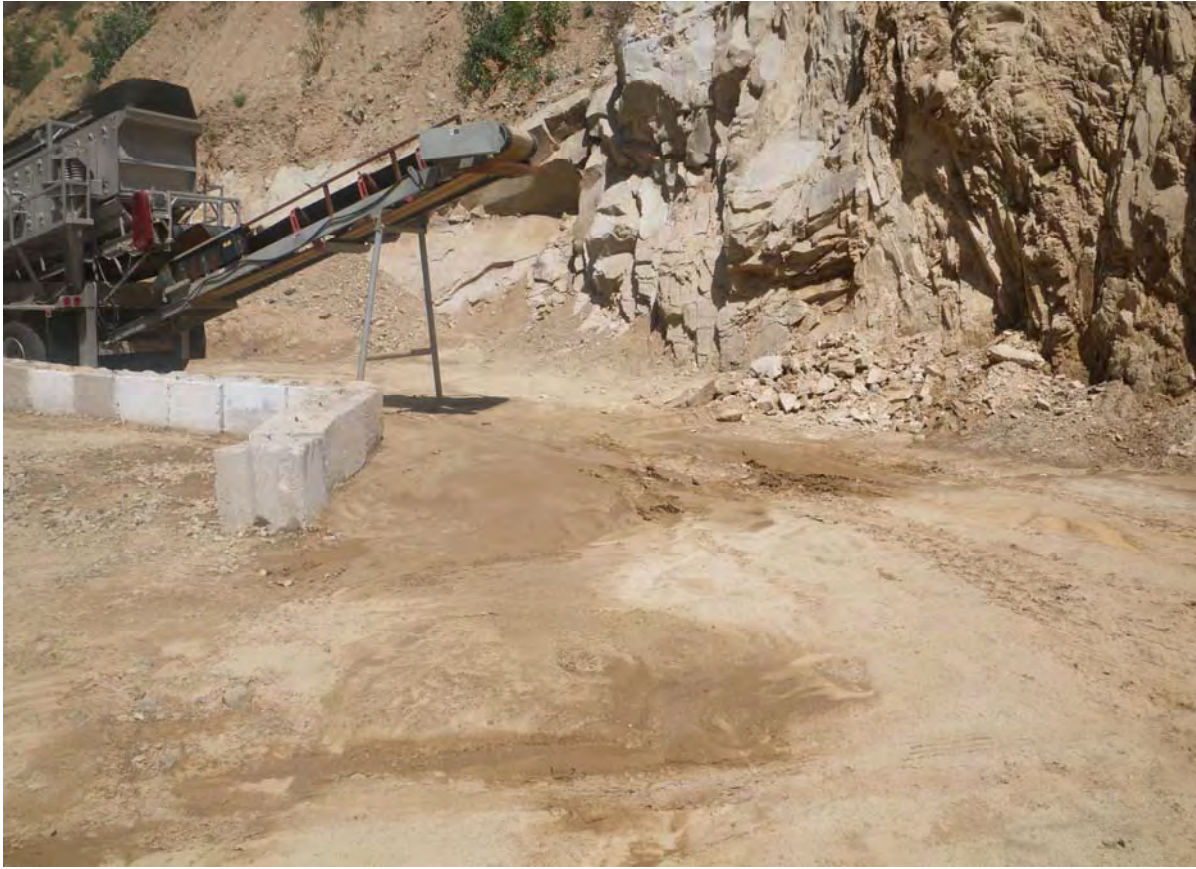
**Figure 14.** Location where detention basin sediment is deposited and allowed to air-dry. Note lack of adequate retaining structures to prevent runoff. Photo taken April 15, 2010, by NMFS.
