Habitat Restoration Opportunities for the Lower Ventura River

December 2010

**SANTA BARBARA
CHANNELKEEPER®**

Ben Pitterle

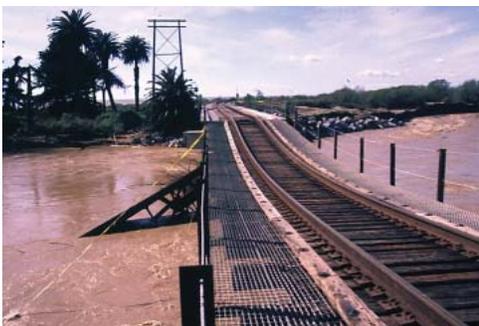
Figure 6: In 1993 the Southern Pacific Railroad bridge was severely damaged by flood waters. Photo credit: Mark Capelli.

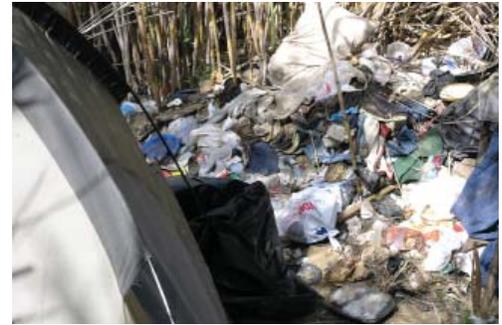
Figure 9: A camp site in the Ventura River Estuary surrounded by garbage.

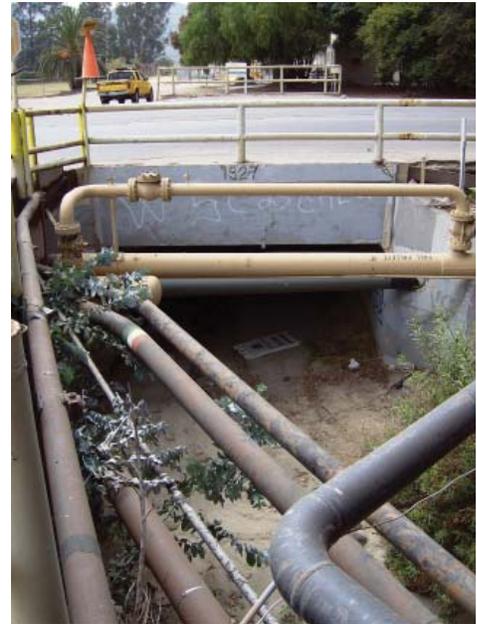
Figure 13: Canada de San Joaquin Creek as it heads underground at Ventura Avenue

The impacts of adjacent land uses can be visually observed in CSJ Creek. Numerous pipelines located in the creek channel extend the length of the creek (Figure 13). Severe stream bank erosion is threatening adjacent homes along Dakota Drive. Based on stream bank conditions, the dominant presence of fine particles in stream bed substrate, and adjacent agricultural and oil development, it is likely that CSJ Creek is a significant source of sediment to the Ventura River during storms. A bank stabilization project for CSJ Creek is slated for implementation in the VCWPD Integrated Watershed Protection Plan.

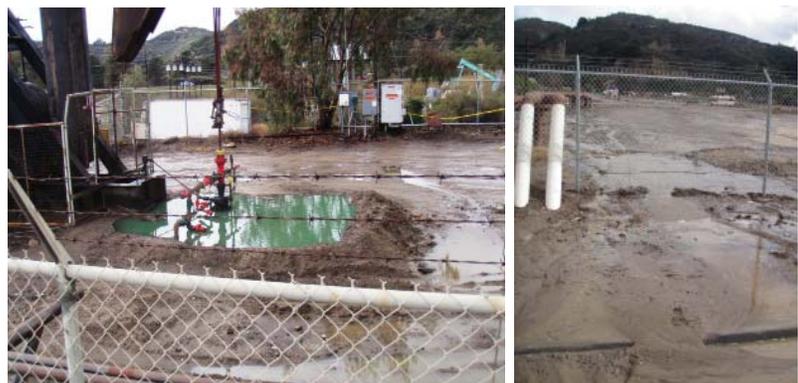
Figure 16: Chemical and sediment contaminated runoff from oil development facilities during a storm.

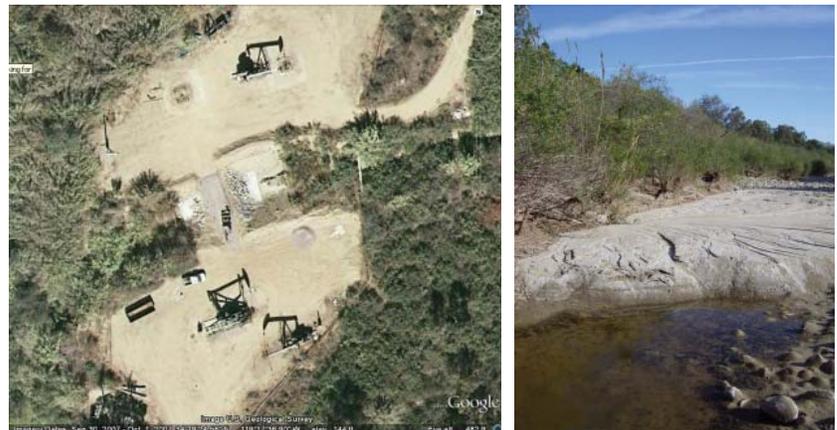
Figure 19: Recent construction activities (left) activities have resulted in the deposit of sediment and fill in the Ventura River (right).

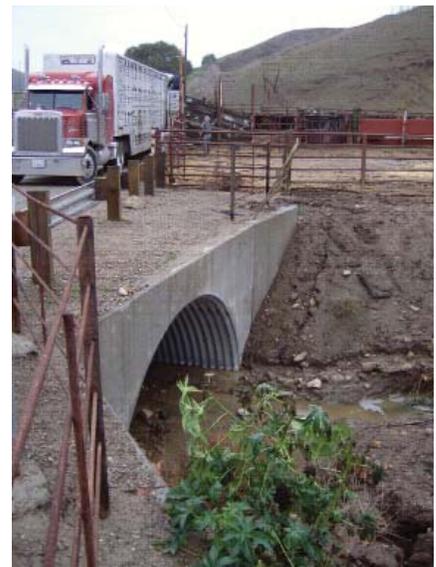
Figure 25: Large numbers of cattle being loaded into a cattle enclosure overlying a tributary to Canada Larga Creek.

This livestock enclosure should be modified or relocated so that animals do not have direct access to Cañada de Aliso Creek. Physical barriers should be constructed to exclude all physical contact with livestock. Manure management BMPs for proper collection, storage and disposal of animal waste should be implemented throughout the facility to prevent contamination of the creek with animal waste during storms. Treatment BMPs such as filter strips and buffer areas should also be implemented on site. Once these measures are in place, vegetative restoration using native riparian plants could restore habitat value and provide further water quality benefits to the tributary.

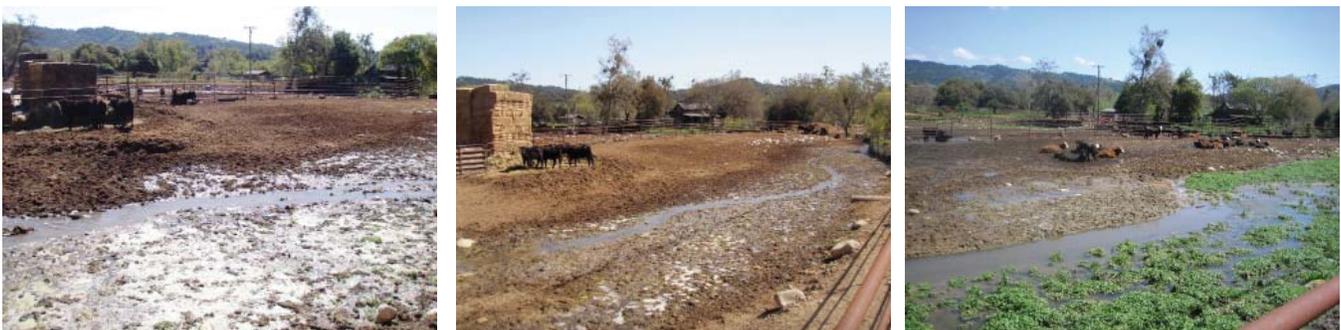
Livestock and equestrian enclosures have been constructed directly on top of the small tributary that flows for much of the year to the Ventura River. Animals such as cattle, buffalo and horses have direct access to this small drainage throughout most of the year, including during periods when the tributary is flowing. Animal waste is directly deposited into the drainage, and contaminated water from this site flows directly to the Ventura River. This site is a source of microbial, nutrient, and sediment pollution.

Figure 27: Photos taken on February 8 2010, March 24 2009 and April 7 2006 (left to right) demonstrate the presence of livestock and animal waste in a Live Oak Creek tributary.

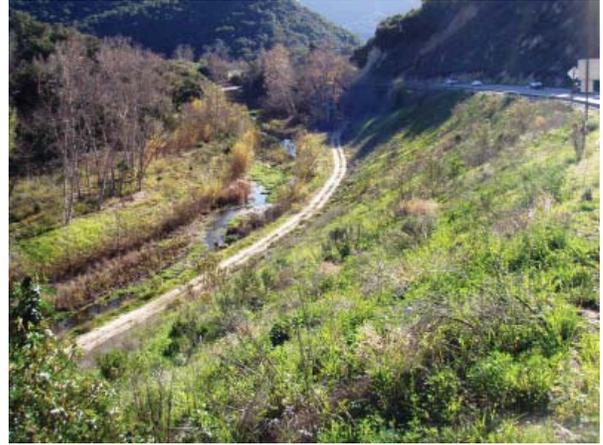
Unfortunately, revegetating the stream bank itself may not provide the benefits of shade and temperature control to San Antonio Creek. An unpaved access road was installed between the base of the stream bank and the creek when the highway was repaired, and a compacted access road prevents vegetation from growing between the creek and toe of the slope. In-stream root wad habitat features were installed in the creek when the highway repairs were completed, but these features cannot provide the full benefit they were intended to provide without adequate shade from riparian vegetation. Willow plantings and other riparian vegetation should be installed between the road and stream to provide shade and other benefits to the creek.

Figure 30: (August 2010) failure to maintain restored riparian trees.

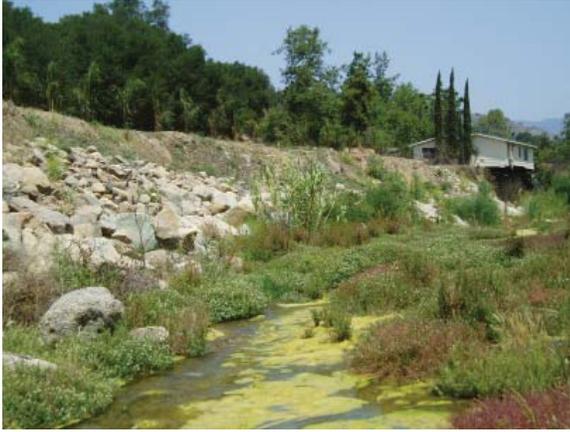
Figure 33: Deposition of rocks and boulders to protect an unvegetated and severely eroding stream bank where property damage has occurred.

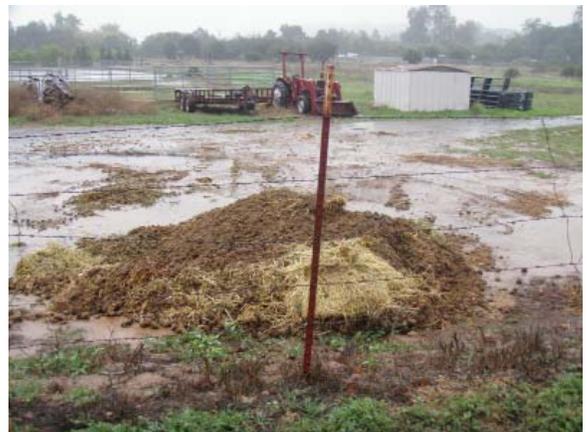
Figure 34: A manure pile left uncovered at an equestrian boarding facility near the Ventura River during a storm in December 2010.

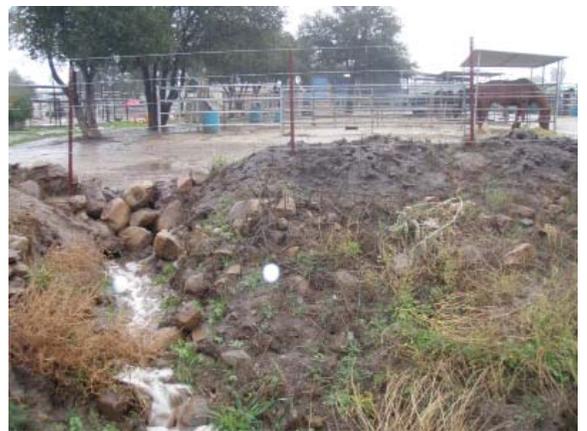
Figure 35: A pipe discharging contaminated storm water from an equestrian boarding facility. When analyzed, this discharge exceeded maximum detection limits for fecal indicator bacteria tests.

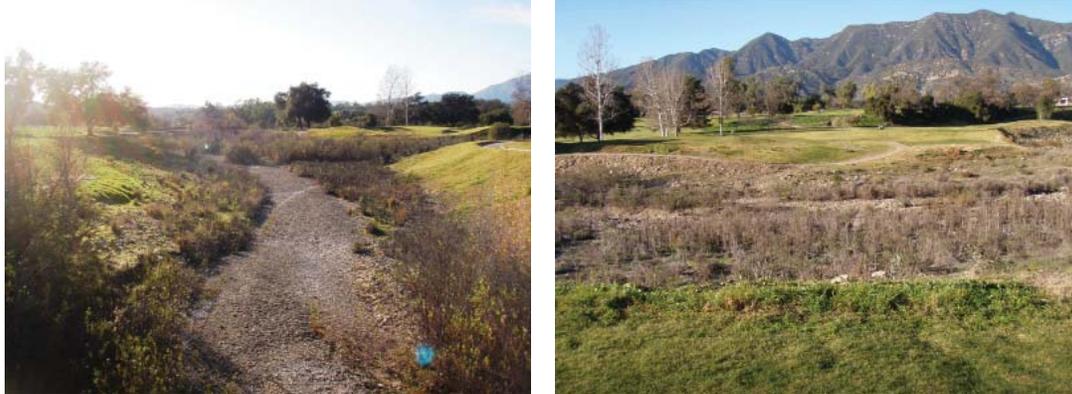
Figure 43: Lack of riparian vegetation along Thatcher Creek due to encroachment of the golf course.

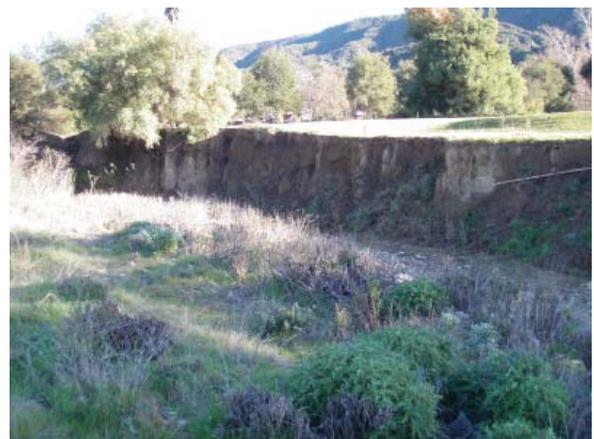
Figure 44: Stream bank erosion at Soule Park Golf Course.

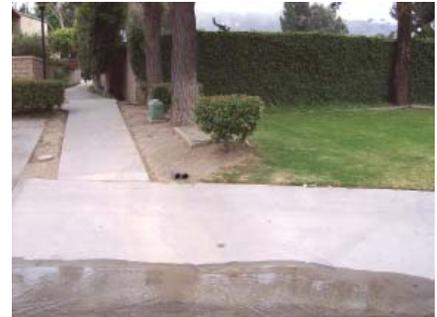
Figure 63: Existing drainage features bypass natural infiltration and bioretention areas at Venwood Condominium Complex.

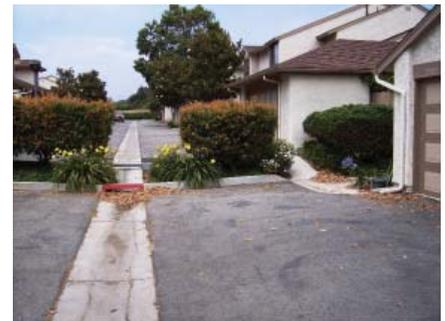
Figure 64: Existing drainage features bypass natural infiltration and bioretention areas at Paseo del Mar Condominium complex.

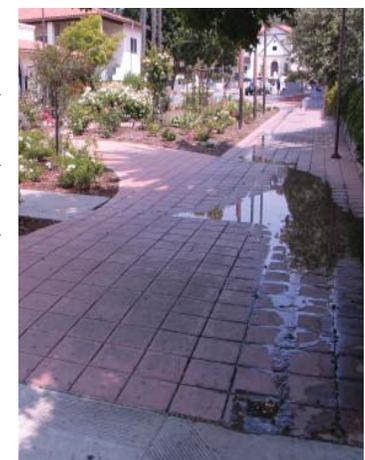
Figure 71. Runoff from Figueroa Plaza entering the municipal storm sewer

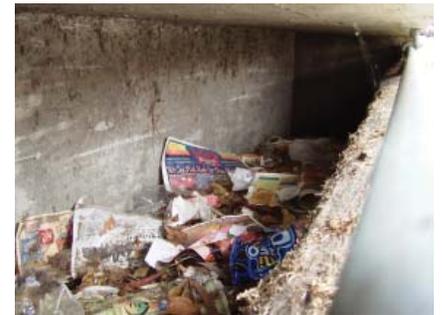
Figure 73. Trash and debris in a Ramona Street storm drain inlet
