HISTORICAL ECOLOGY **of the lower Santa Clara River, Ventura River, and Oxnard Plain:** an analysis of terrestrial, riverine, and coastal habitats

HISTORICAL ECOLOGY PROGRAM
CONTRIBUTION NO. 641 • AUGUST 2011

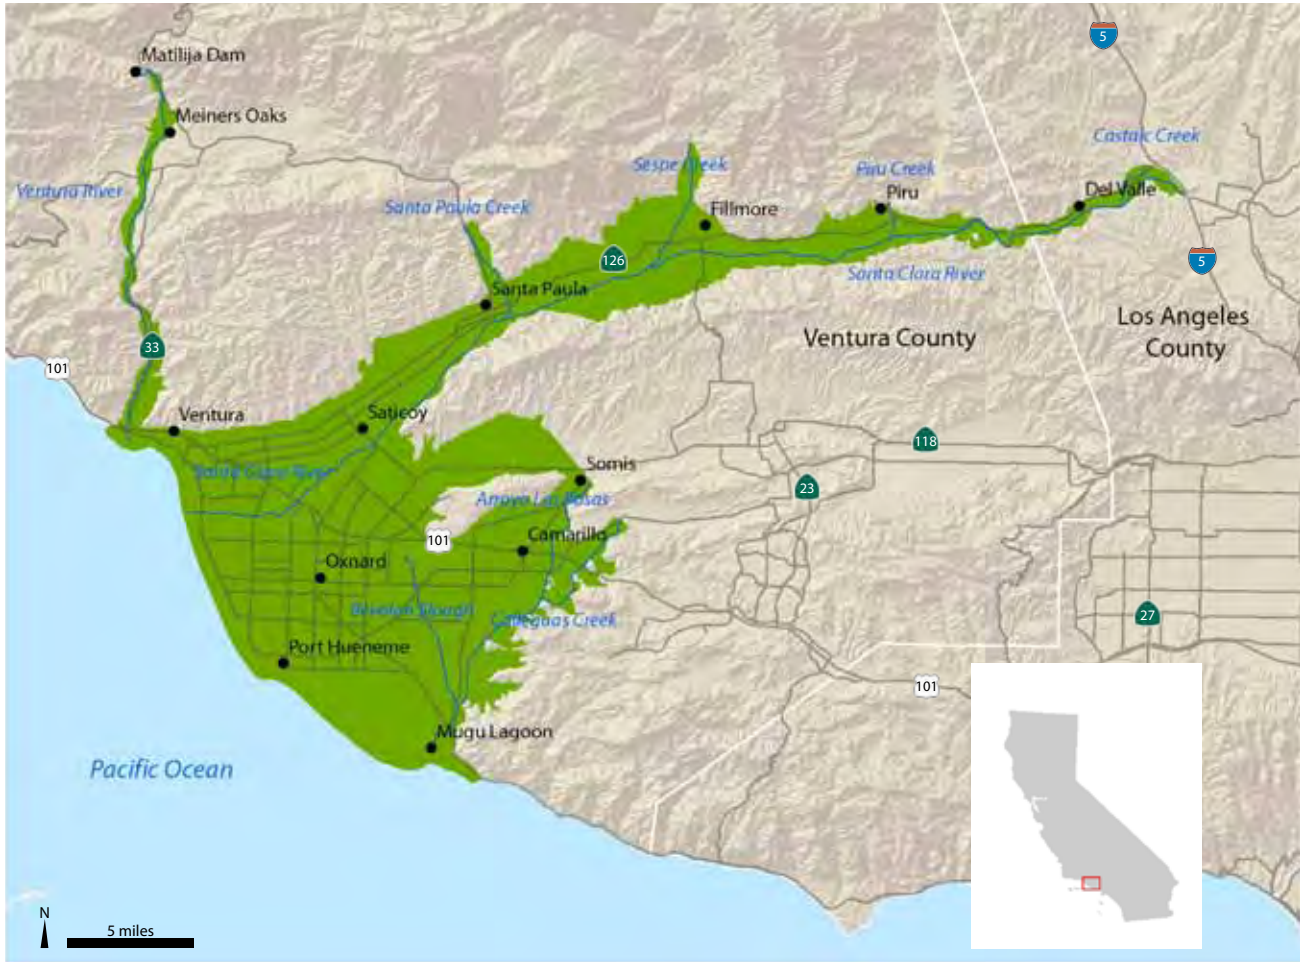
Fig. 1.2. Study area and regional geographic context. The project area included the Ventura River to Matilija Dam, the Santa Clara River to Interstate 5 in Los Angeles County, and the Oxnard Plain.

This study focuses on the habitat and drainage patterns of the region’s lowlands, where change has been most pronounced. The study area encompasses three major contiguous areas: the Ventura River, the lower Santa Clara River, and the Oxnard Plain (fig. 1.2). Specifically, the geographic scope is the Ventura River and valley from its mouth to the Matilija Dam (exclusive of the Ojai Valley), and the Santa Clara River and adjacent valley floor from its mouth to its intersection with Interstate 5 in Los Angeles County (including only the lowest reaches of major tributaries, and focused on the Ventura County portion of the valley). It also includes the lowlands and coastal margins south of the lower Santa Clara River, including the Oxnard Plain and lower Calleguas Creek watershed west of Somis and the edge of the Santa Monica Mountains and south of South Mountain.

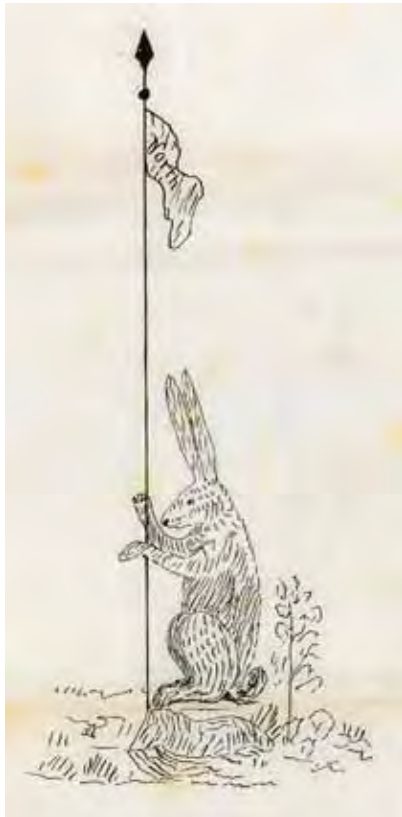
Fig. 1.3. Detail from a map of Rancho San Miguelito and the lower Ventura River, 1897. A jackrabbit serves as the compass, pointing north. (Barry 1897, courtesy of the Museum of Ventura County)

To acquire these sources, we visited local historical archives, public libraries, county offices, and regional archives. In total, we visited twenty-seven source institutions across California to collect data (table 1.1). We also reviewed material available online and conducted searches of over twenty electronic sites and databases. We acquired scans, copies, or photographs of a diverse array of primary and secondary sources pertaining to the historical landscape of Ventura County (fig. 1.3; also see “Historical data for Ventura County” spread, pages 6-7).

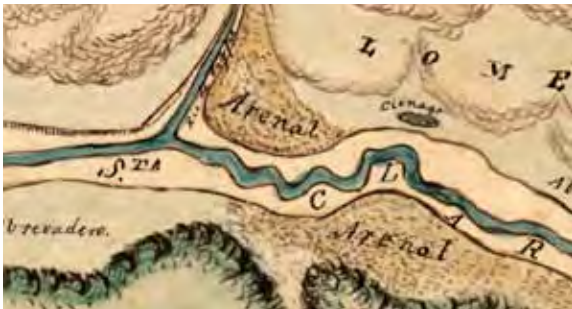
Mexican land grant sketches (1840s-1850s). As the Mission system disintegrated, influential Mexican citizens submitted claims to the government for land grants. A *diseño*, or rough sketch of the solicited property, was included with each claim. *Diseños* often show notable physical landmarks which would have served as boundaries or natural resources, such as creeks, wetlands, springs, and forests. While *diseños* are not as spatially accurate as subsequent surveys, they provide extremely early glimpses of former landscape features and patterns. (U.S. District Court ca. 1840d, courtesy of The Bancroft Library, UC Berkeley)

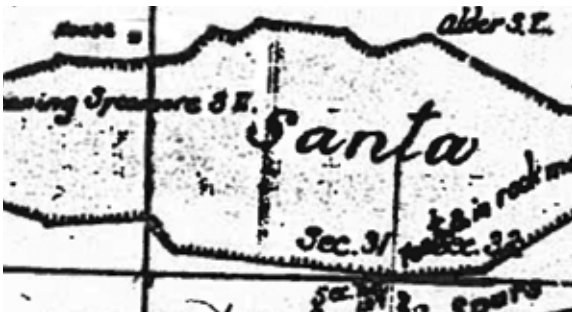
General Land Office Public Land Surveys (1853-1900). In areas not claimed through the land grant system, the U.S. Public Land Survey imposed a grid of straight lines on the landscape, dividing property into six-mile square townships. Each township was further subdivided into 36 one-mile sections, each section containing 640 acres. Surveyors methodically surveyed section lines along these transects, noting cultural and natural features they encountered along the way. Survey notes and plat maps from these surveys are useful for their ecological information. (Hoffman 1868d, courtesy of the Bureau of Land Management)

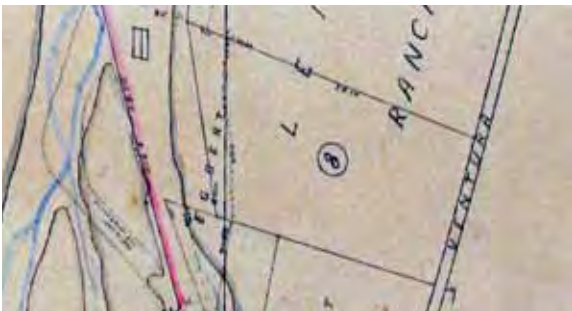
City and county surveys (1860-1930). Local surveyors produced abundant maps, including many surveys of individual parcels. These maps, often surveyed at a large scale, contain details not included in other regional mapping efforts such as sloughs and side channels, smaller ponds and wetlands, or clusters of trees. Though coverage is inconsistent, these maps are invaluable in constructing an understanding of local ecosystem dynamics. (Barry 1894, courtesy of the Ventura County Surveyor’s Office)

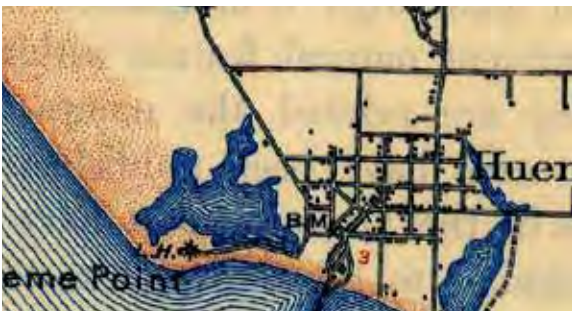
U.S. Geological Survey topographic maps (1903-1943). Shortly after 1900, the USGS (established in 1879) began producing topographic quadrangles at 1:62,500 for the Ventura County region. Though the maps are relatively coarse, they provide some of the earliest consisent, comprehensive coverage for the entire region. (USGS 1904, courtesy of the CSU Northridge Geography Map Library)

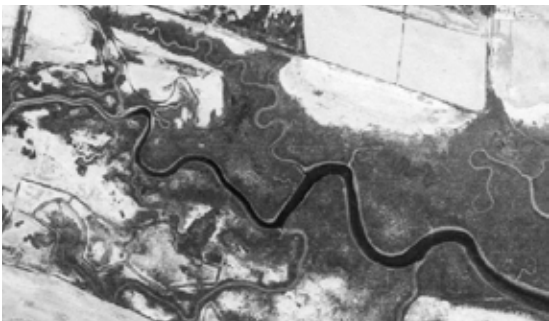
Historical aerial photography (1927-1959). A Depression-era program to ensure crop stability and soil conservation practices resulted in extensive aerial photographic coverage for much of the county. The bulk of historical aerial imagery used in this study is from 1927 and 1938. While the photographs were taken after substantial modification, the photos nevertheless reveal relict ecological features, traces of which are often still present in the landscape. (Fairchild Aerial Surveys 1927, courtesy of Whittier College)

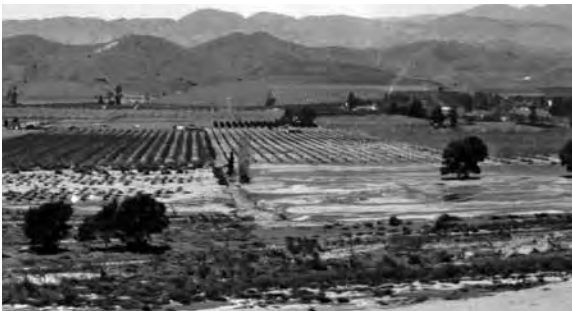
Landscape photography (1860s-1950s). Historical photographs represent a category of diverse historical data that can provide extremely localized, accurate information. Photographs can capture the conditions of a given place and time in a manner that provides substantial detail about specific species presence and landscape structure. (Isensee 1928b, courtesy of Museum of Ventura County)

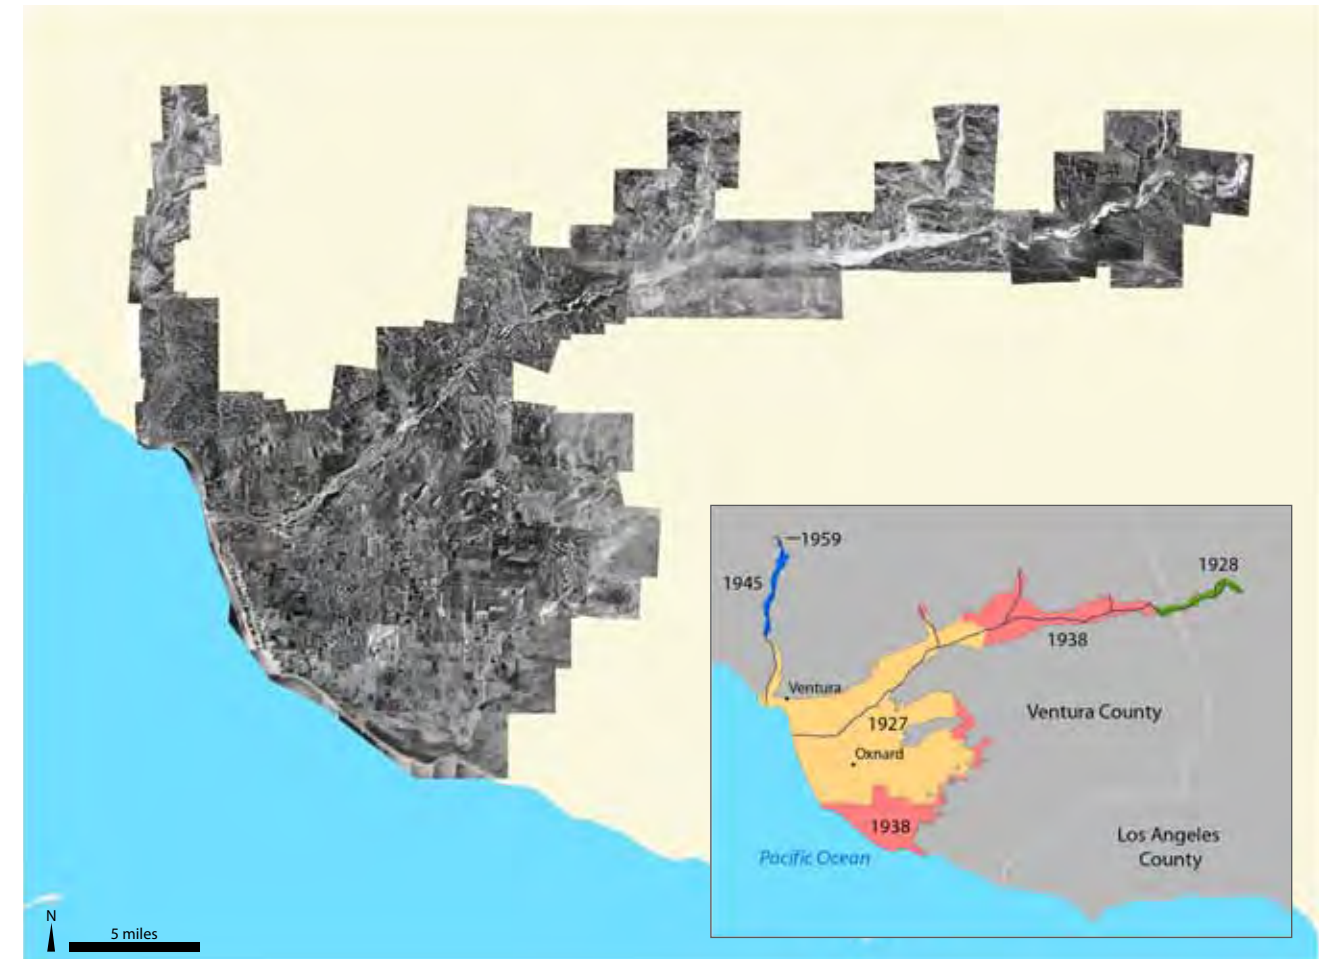
Fig. 1.4. Earliest date of aerial photo coverage. Two hundred and thirty-eight historical aerial photographs were orthorectified and mosaicked to provide continuous coverage of the study area. Aerials spanned from 1927-1959, with the bulk of photos from 1927 and 1938.

One heavily used source was historical aerial photography, which required orthorectification and mosaicking of 238 aerial photographs into a comprehensive, continuous coverage of the entire study area (fig. 1.4). Aerials were acquired from a number of source institutions and spanned a number of different years. The earliest imagery (1927), used where available, makes up about one half of the entire photomosaic. Later imagery (from 1938, 1945, and 1959) was substituted where 1927 imagery was not available. The spatial consistency, accuracy, and high level of detail available made these an invaluable source for the project.

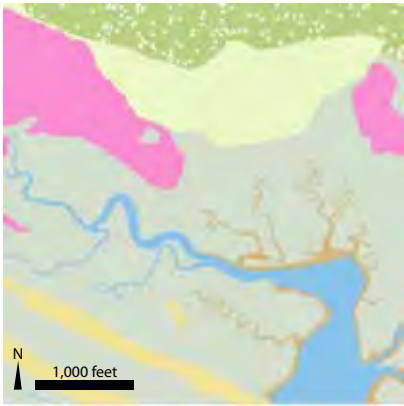
Fig. 1.8. Detail of wetland mapping, northwestern edge of Mugu Lagoon wetland complex. We mapped seasonal wetlands (such as alkali meadows, shown here in green with white stipple) in addition to perennial wetlands (such as the tidal marsh shown in grey-blue).

WETLAND HABITATS We documented the extent and distribution of wetland types prior to significant Euro-American modification based on available historical evidence (fig. 1.8). Wetland types mapped include palustrine habitats (alkali meadow, alkali meadow/flat, wet meadow, valley freshwater marsh, perennial freshwater pond, willow thicket, and willow-cottonwood forested wetland) and also a number of coastal habitat types (see habitat crosswalk, table 1.3).

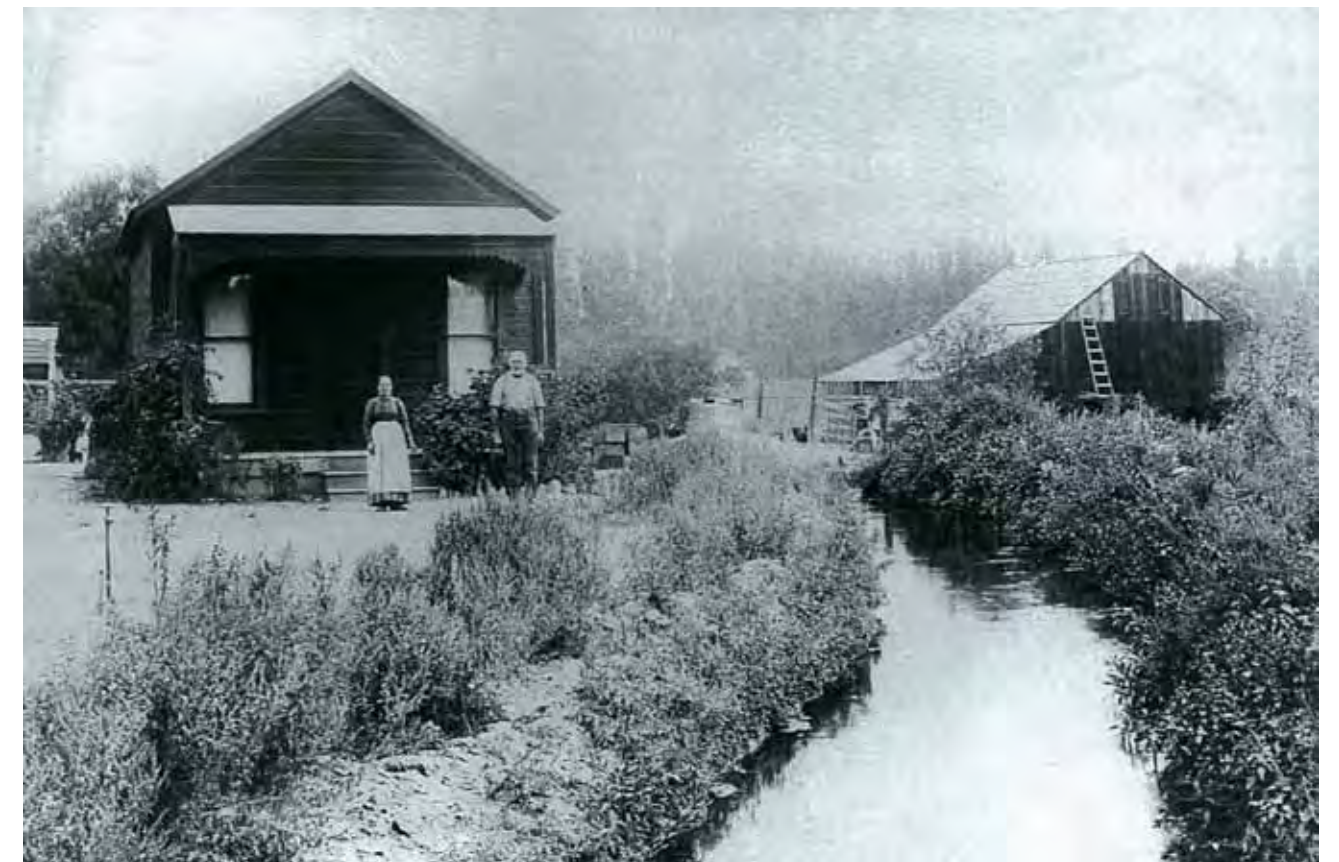
Fig. 2.8. Diversion ditch from Santa Paula Creek, ca. 1900. Surface diversions, such as this ditch taking water from Santa Paula Creek downvalley, brought water from areas with abundant surface flow to drier portions of the valley. (Unknown ca. 1900a, courtesy of the Santa Paula Historical Society)

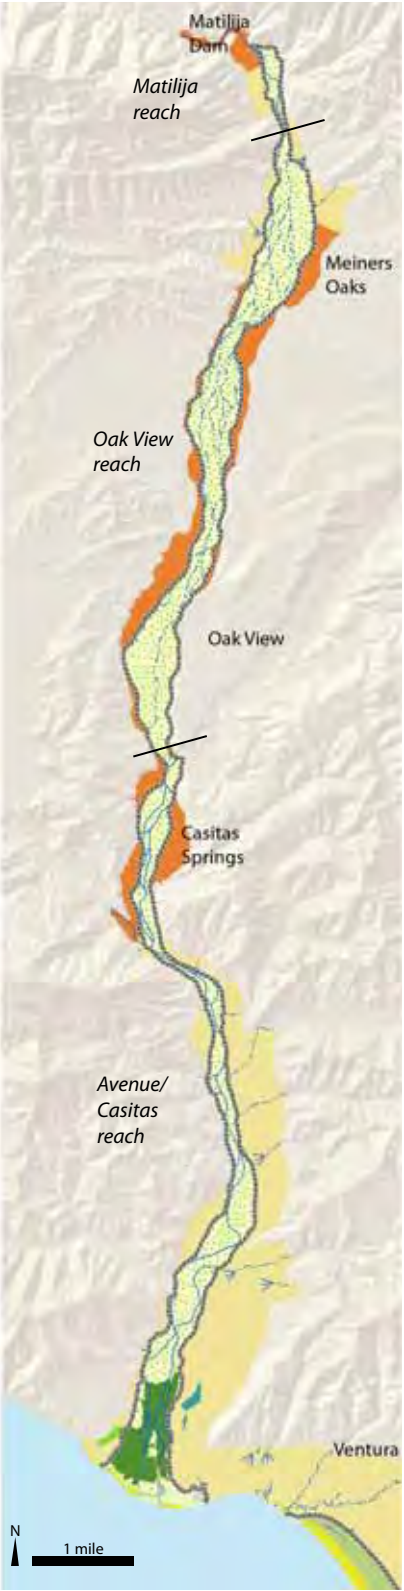
Fig. 4.2. Ventura River reach divisions. We divided the river into three reaches, based on hydrological and ecological characteristics: the uppermost Matilija Reach, the middle Oak View reach, and the lower Avenue/Casitas reach.

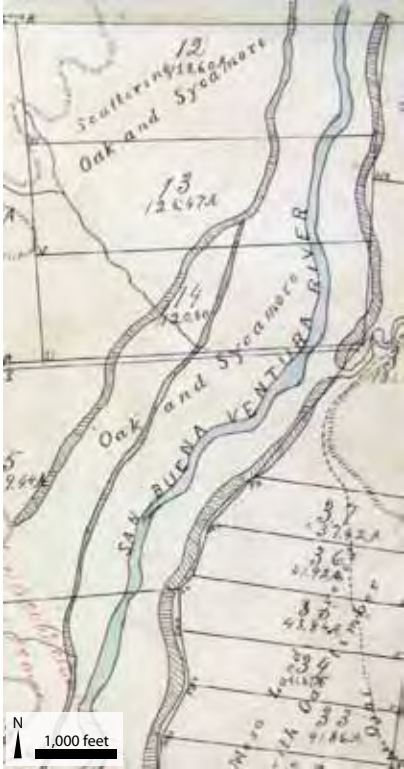
Fig. 4.4. Ventura River in the vicinity of present day Oak View, 1876. This late-1800s map depicts sycamores and oaks occupying the river corridor, as well as “scattering oak and sycamore” on the valley floor between the high bank and the scrub-covered mountains to the west. (Hare 1876, courtesy of the Ventura County Surveyor’s Office)

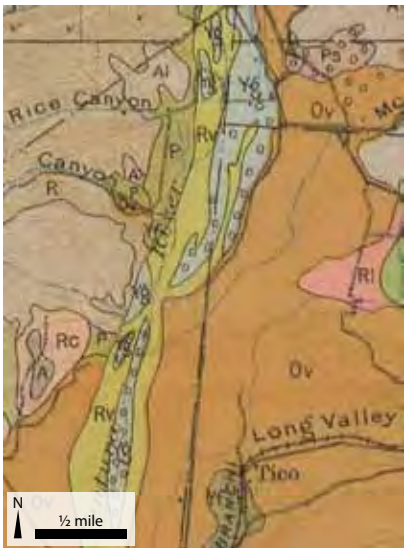
Fig. 4.7. Islands in the Ventura River, 1917. The 1917 soil map shows islands surrounded by riverwash (Rv) over a three mile stretch west of the Ojai Valley. The islands are composed of coarse Yolo gravelly and bouldery fine sandy loam (Yg), a soil type documented to support live oaks and sycamores on alluvial fans in the Santa Clara River valley. (Nelson 1917)

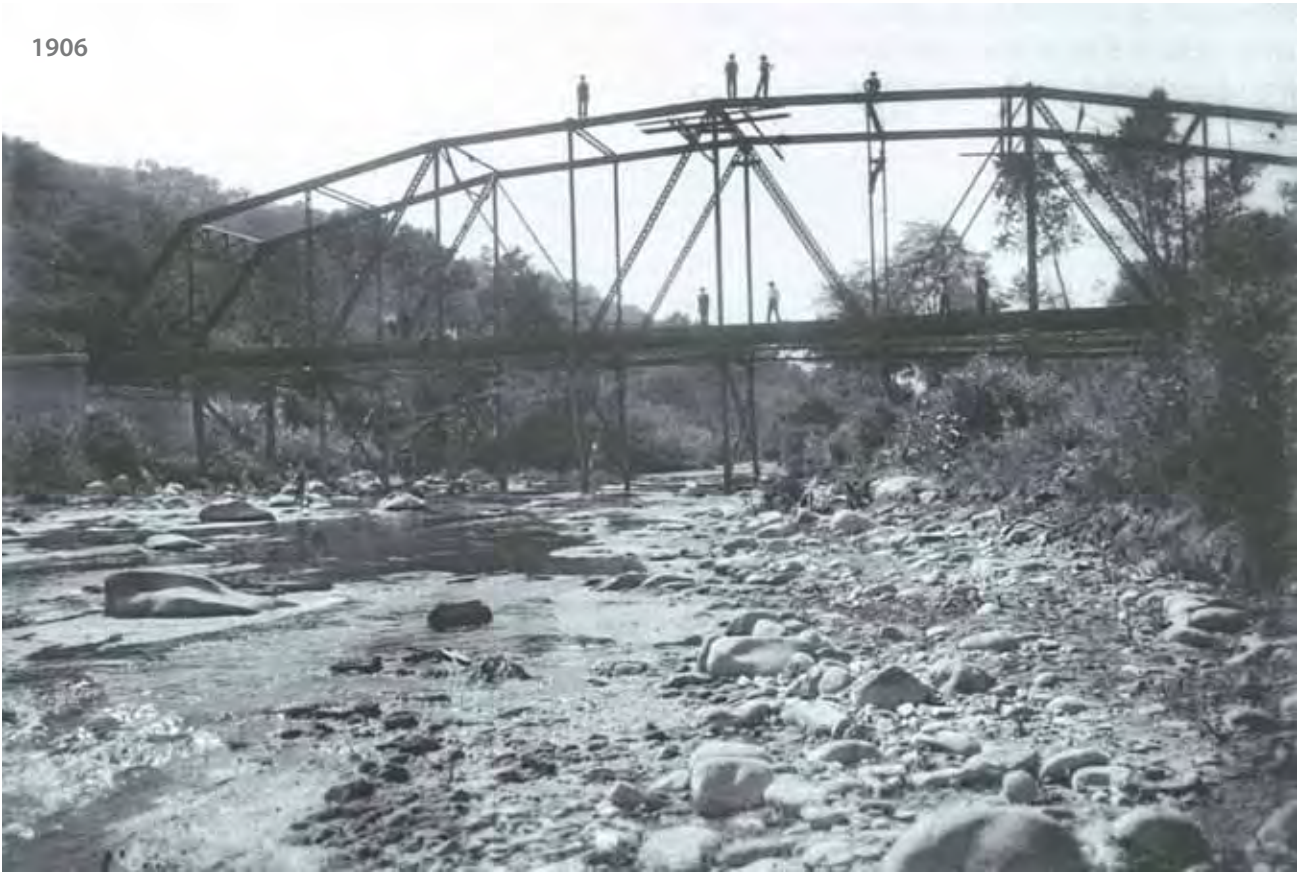
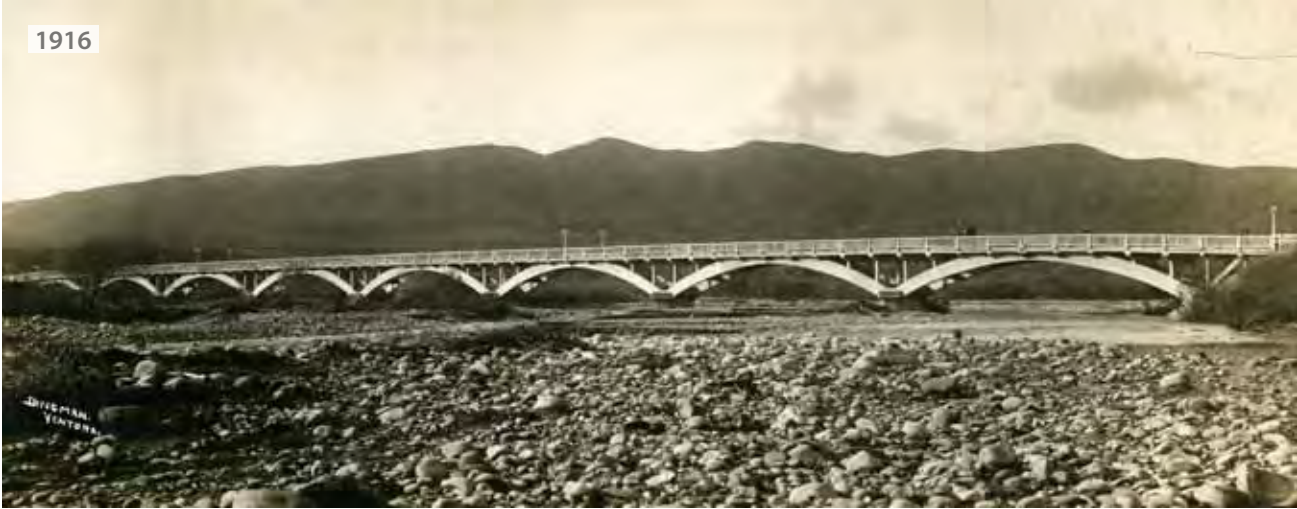
Fig. 4.8. These images of the Ventura River at Foster Park (top, ca. 1906) and at Main Street in Ventura (bottom, 1916) show the abundant cobbles and boulders characteristic of the river bed even nearly at the estuary. (Unknown ca. 1906, courtesy of Craig Held; Unknown 1916, courtesy of the Museum of Ventura County)

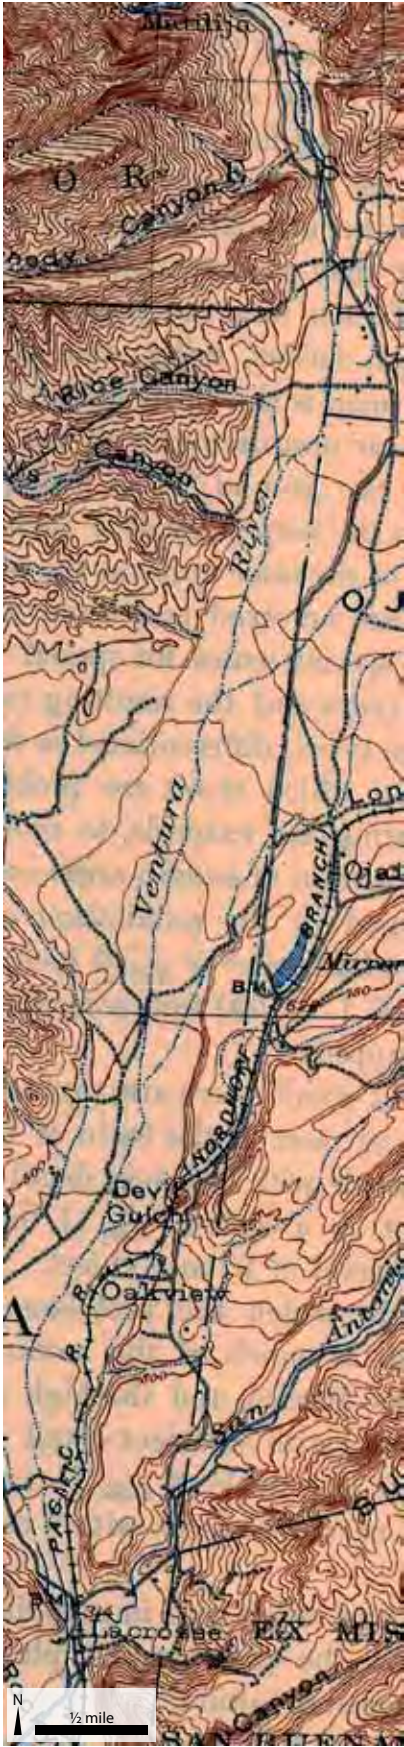
Fig. 4.9. Intermittent and perennial reaches on the Ventura River, 1903. The early USGS topographic quadrangle depicts summer flow conditions on the Ventura River. A solid line indicates perennial flow, while a dashed line signals an intermittent reach. The quad shows the river as about half perennial and half intermittent. (USGS 1903c, courtesy of the Los Angeles Central Library)

Both descriptions of the Ventura River—as an abundant source of water, and as an arid stream—have some element of truth. Documentation of flow conditions on the Ventura River consistently depicts three reaches with distinct summer flow regimes within the study area. These reaches are depicted on the historical topographic quad for the river (USGS 1903c; fig. 4.9). The first perennial reach extends from beyond the northern edge of the study area (Matilija Hot Springs) downstream to around the Cozy Dell Canyon (Matilija reach). Below this, the Ventura River valley begins to open up into the head of the Ojai Valley, and the river is intermittent until below

Oak View and the river’s confluence with San Antonio Creek (Oak View reach). Last, perennial flow is shown from just above the San Antonio Creek confluence downstream to the ocean (Avenue/Casitas reach). However, the precise extent and location of summer water would have fluctuated in response to annual variations in rainfall and runoff. During wet years or series of wet years, reaches with perennial flow would have extended both spatially and temporally, while during dry years intermittent reaches may have been more extensive and would have lost surface flow earlier in the season.

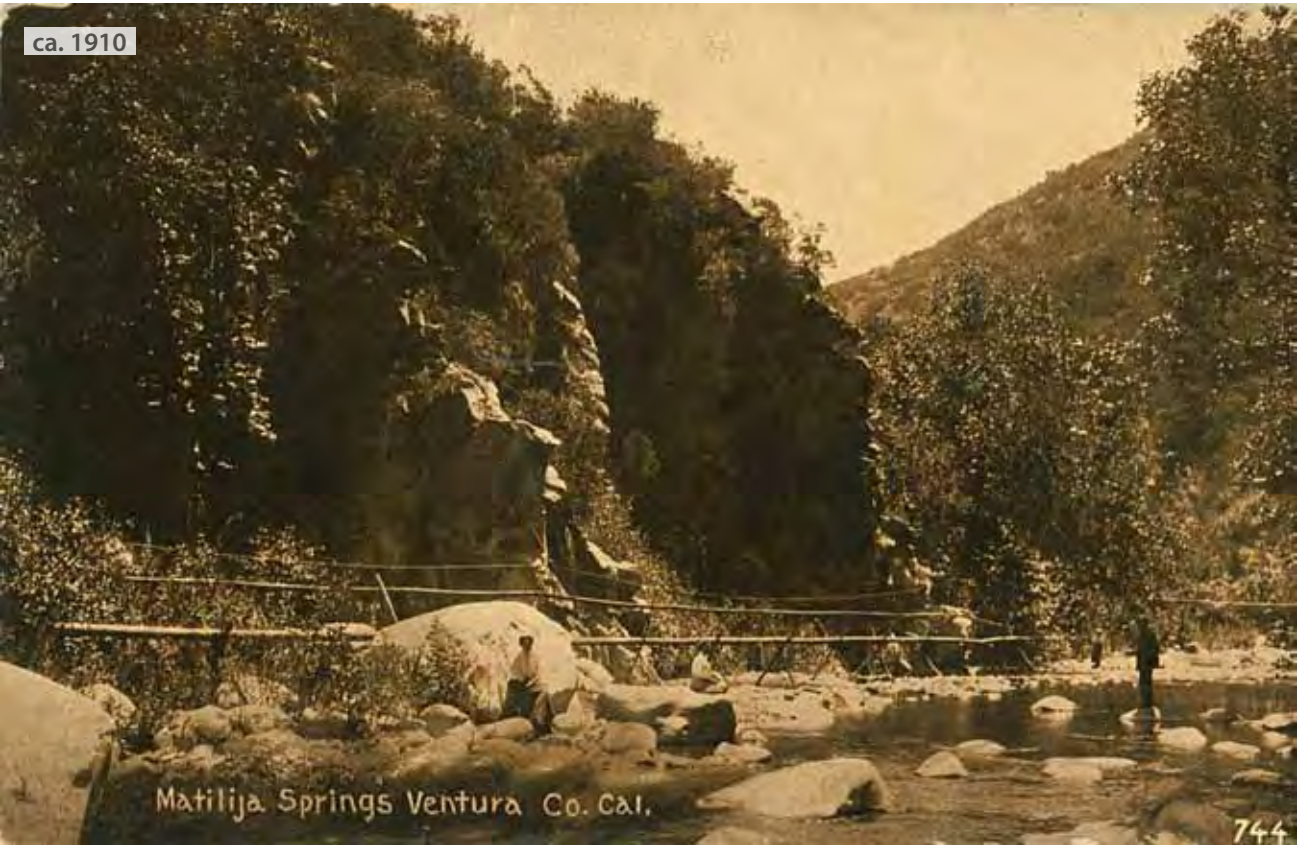
Fig. 4.10. Two views of the upper Ventura River, ca. 1910. These two postcards, both dating from the first years of the 20th century, show the boulder-filled channel of the river in lower Matilija Canyon. The photograph at top was taken at Matilija Hot Springs, just below Matilija dam. The photograph at right was taken less than a half mile downstream. Note the narrow fringe of mulefat, willow scrub, and trees (likely alder, cottonwood, and sycamore). (Unknown ca. 1910b, d)

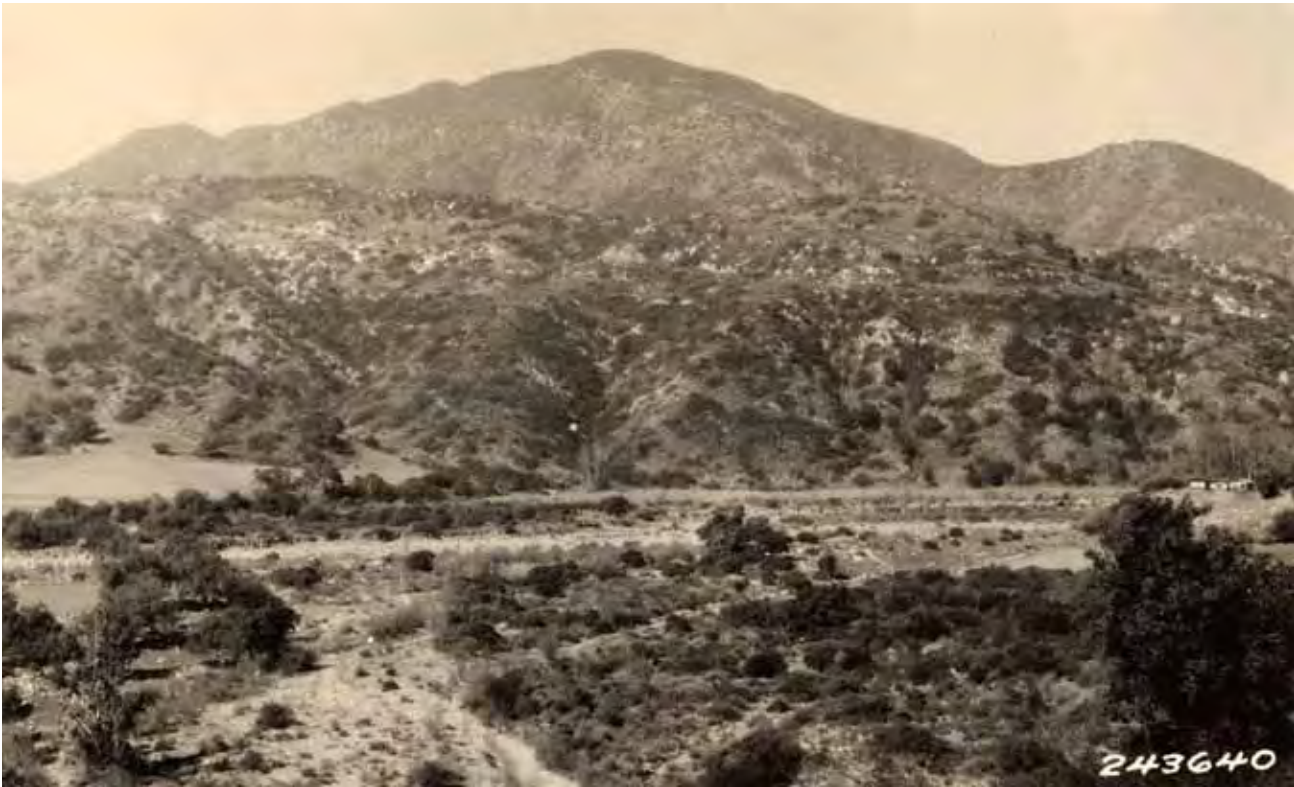
Fig. 4.11. “Looking west across Ventura River, mouth of Matilija Canyon,” February 1930. This photograph, part of the Wieslander Vegetation Type Mapping Project of the late 1920s and early 1930s, shows low scrub flanking riverwash along a shallow, broad channel in the intermittent reach of the river. It was taken approximately one mile below the mouth of Matilija canyon, looking west toward the site of the current Robles Diversion Dam (Capelli pers. comm.). (Clar 1930, courtesy of the Marian Koshland Bioscience and Natural Resources Library, UC Berkeley)

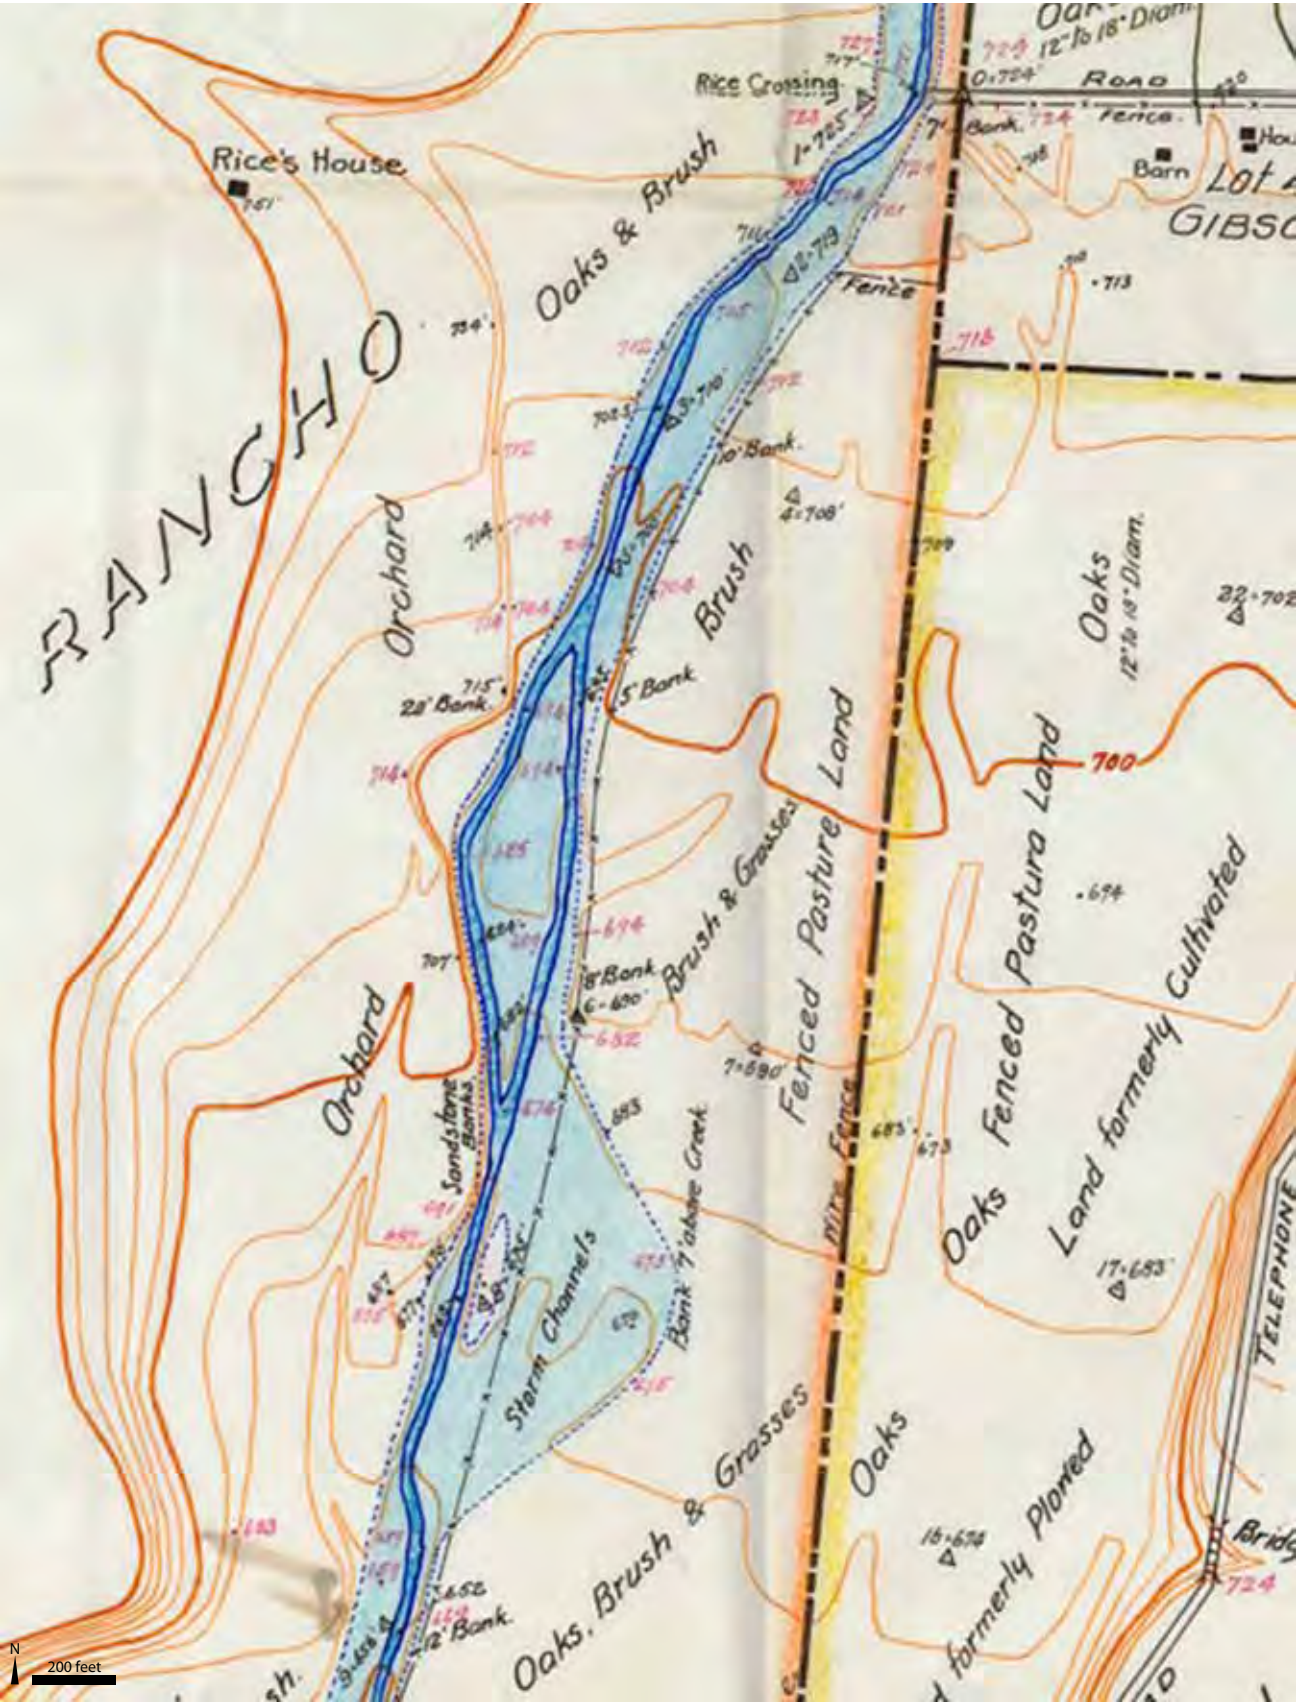
Figure 4.12. Vegetation in the Ventura River, 1903. This map of the river in the intermittent reach near Meiners Oaks shows local-scale variation of riparian vegetation, including oaks, sycamore, and brush, within its outer banks. It is evident from this map that many portions of the bottomland had already been cleared or fenced for pasture. (Lippincott 1903, courtesy of the Museum of Ventura County)

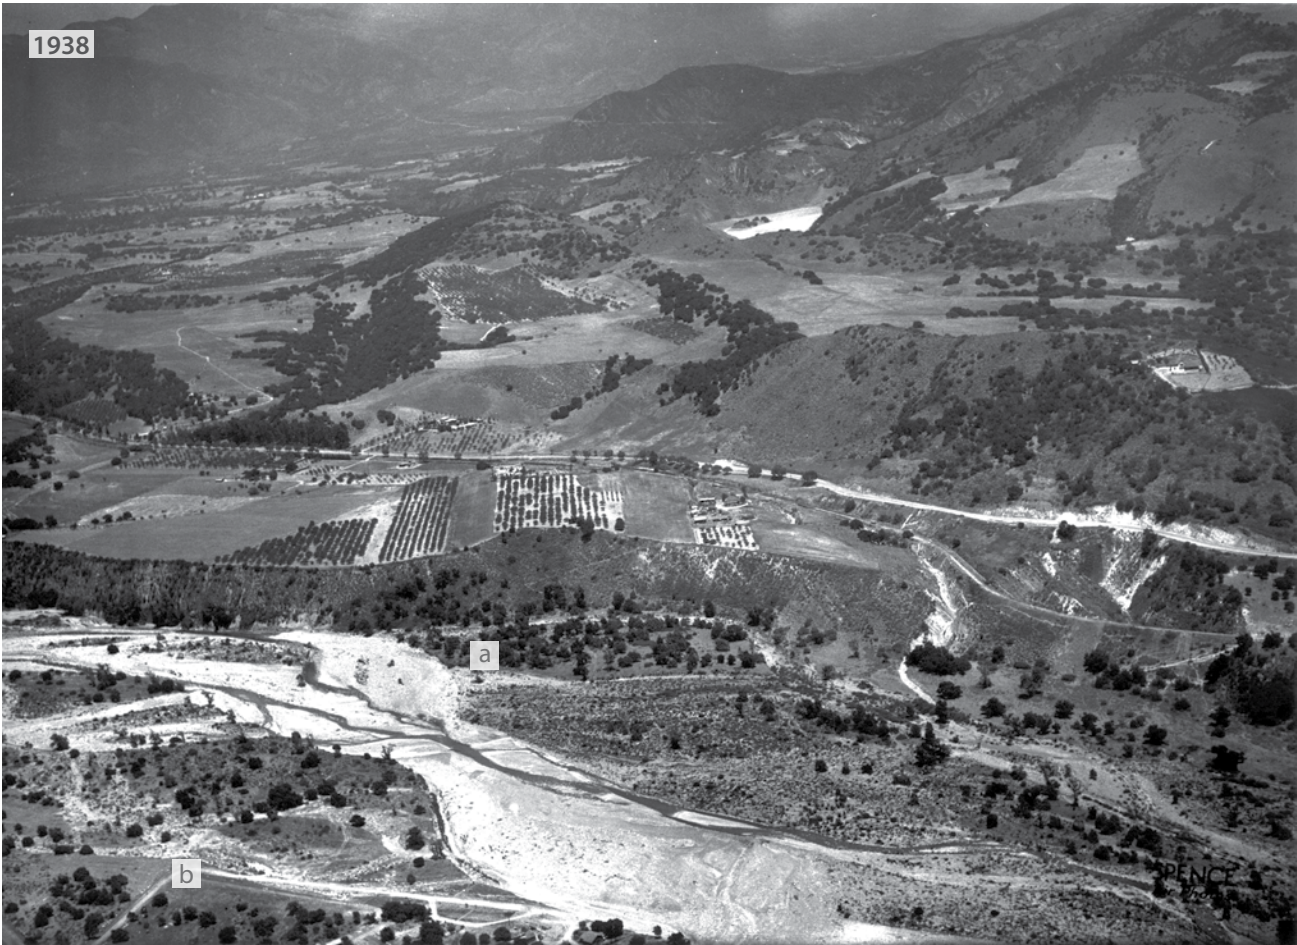
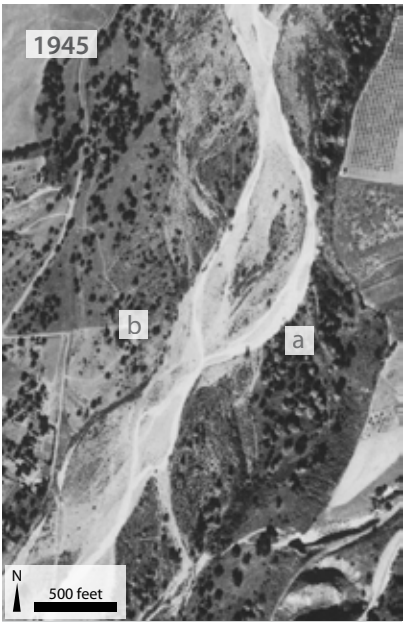
Fig. 4.13. Ventura River at Live Oak Acres. The oblique aerial photograph (top), taken in June 1938, shows characteristic riparian patterns in the Oak View reach. Sparsely vegetated riverwash composes the active channel, flanked by dense scrub on bottomlands. Further away from the active channel, more mature live oaks colonized higher river surfaces. Seven years later, the aerial photograph of the same place in 1945 (left) shows similar patterns of riverwash, scrub, and trees. (Spence Air Photos 1938, courtesy of the Benjamin and Gladys Thomas Air Photo Archives, UCLA Department of Geography; Ventura County 1945, courtesy of UCSB Map and Imagery Library)

Oaks (Hoffmann 1932b), and slender woolly buckwheat (*Eriogonum gracile*) and chaparral yucca (*Hesperoyucca whipplei*) were collected in the river near Oak View (Pollard 1963a, 1969). Mulefat was also documented (*Baccharis salicifolia*; Pollard 1944). These records imply the presence of alluvial scrub; it is likely that a mixture of willow and alluvial scrub was present through this reach (fig. 4.13).

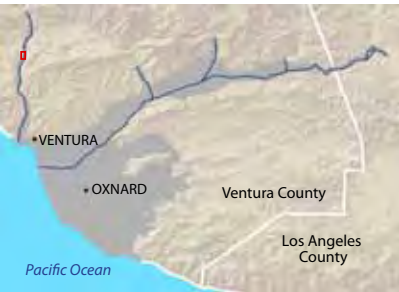
Fig. 4.14. Dense riparian corridor along the Ventura River, ca. 1840. An early depiction of the Ventura River for three miles below Foster Park shows continuous riparian forest flanking the river, of variable—and in many places, substantial—width. A small area of oaks is shown along one portion of the river (below the “I”); the small check marks that line the river are interpreted as mixed riparian forest. (U.S. District Court ca. 1840b, courtesy of The Bancroft Library, UC Berkeley)

Strongly supporting the concept of dense riparian forest in this reach, an 1840s *diseño* of the Cañada Larga ranch shows a continuous riparian corridor stretching the three miles from near Foster Park to Gosnell Hill/Cañada de San Joaquin (fig. 4.14). The riparian corridor is shown of variable width, including a short reach of oaks south of Cañada Larga and a lot of other trees (interpreted as willow-cottonwood forest). This map is supported by

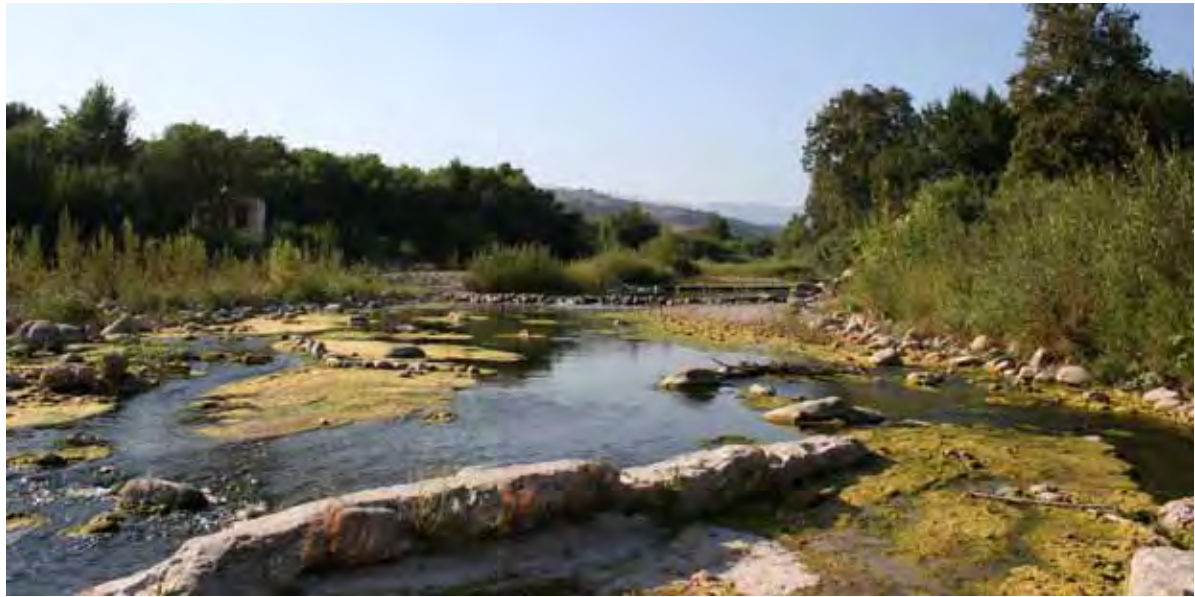
Fig. 4.15. Ventura River at Foster Park looking north from the bridge, July 2008. Cottonwoods and willows flank the river, and willows, mulefat, and *Arundo* colonize coarse bars and islands.

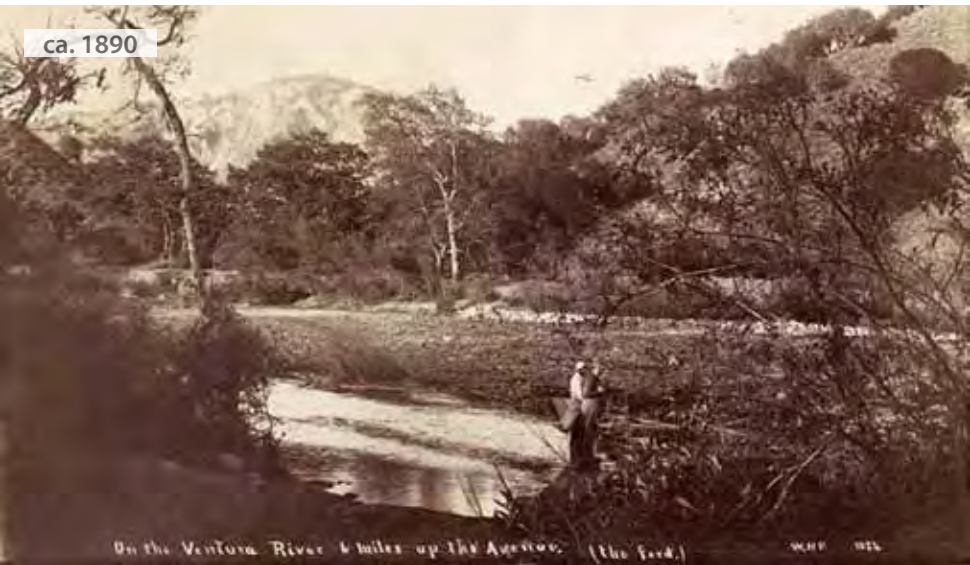
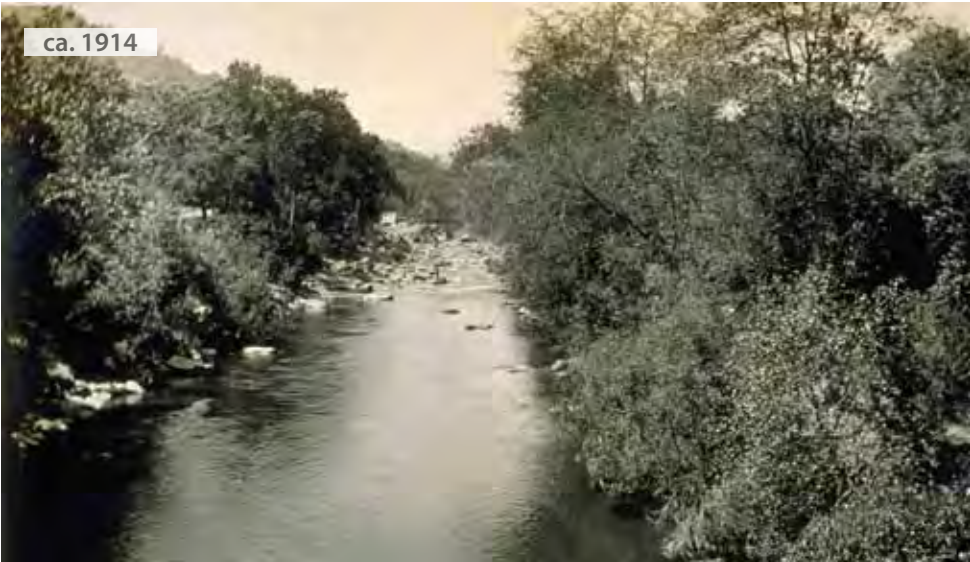
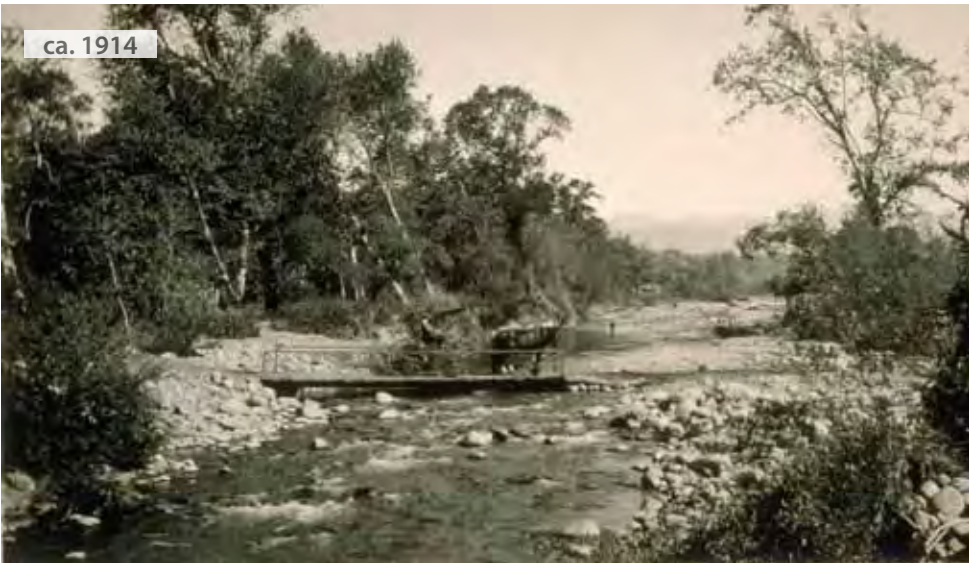
Figure 4.16. Three images of riparian vegetation near Foster Park/Casitas, ca. 1890-1914. Top: “On the Ventura River 6 miles up the Avenue (the ford),” ca. 1890. Middle: “Looking up Ventura River from the Bridge,” ca. 1914. Bottom: “Casitas – View of Ventura River Crossing,” ca. 1914. These images show three versions of the riparian corridor in the vicinity of Foster Park, including sycamore, live oak, willow, cottonwood, and alder. (Fletcher ca. 1890, courtesy of the California State Library; Unknown ca. 1914a and 1914b, courtesy of The Bancroft Library, UC Berkeley)

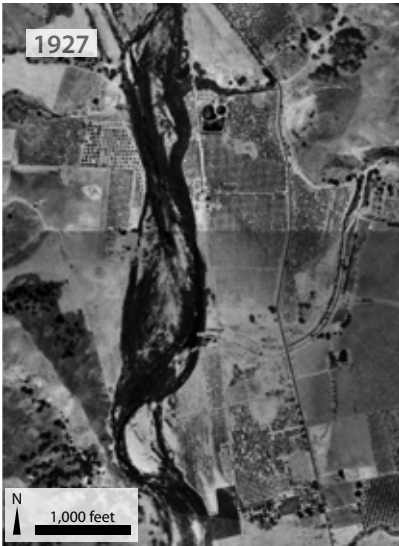
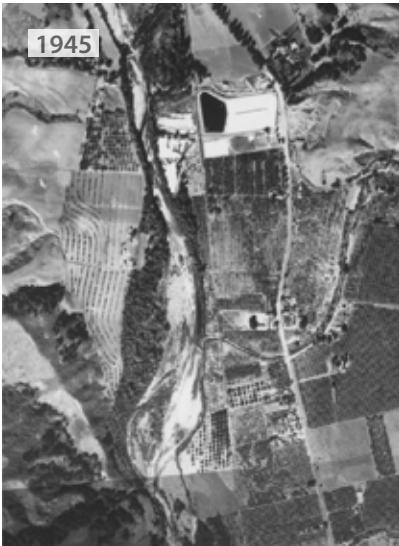
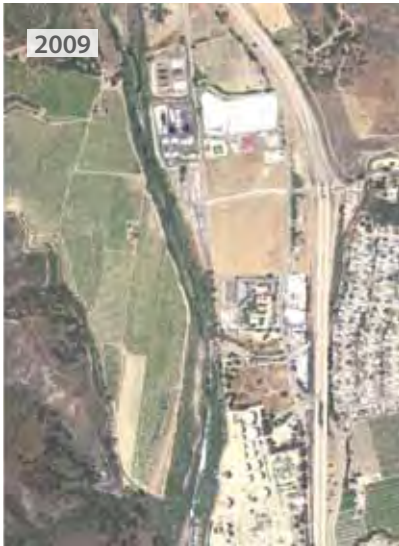
Fig. 4.17. A section of riparian corridor 1.5 miles south of Foster Park. Broad, dense riparian forest present in 1927 (left) and 1945 (middle) has been converted to agriculture by 2009 (right). (Fairchild Aerial Surveys 1927, courtesy of Whittier College; Ventura County 1945, courtesy of UC Santa Barbara Map and Imagery Library; USDA 2009)

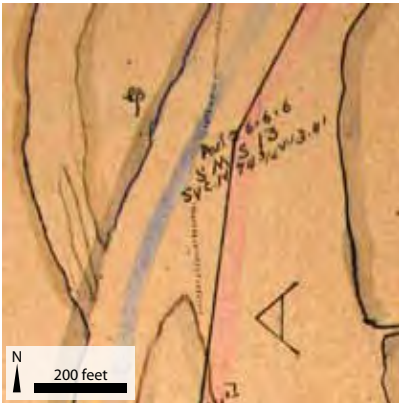
Fig. 4.18. Sycamore on island in the Ventura River, 1894. West of lower Ventura Avenue (and just above the persistent wetland riparian area at the river mouth), this small depiction shows a 24 inch diameter sycamore above the active channel of the river. (Barry 1894, courtesy of the Ventura County Surveyor’s Office)

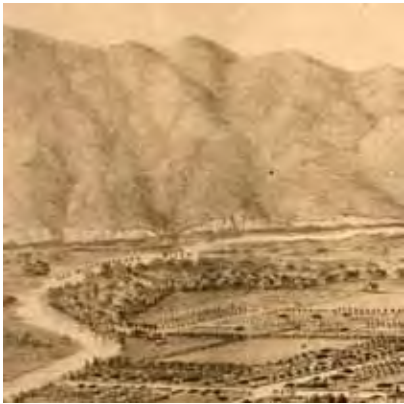
Fig. 4.19. Willows on the Ventura River, 1877 (above). A subset of the forest depicted on the T-sheets is shown in this bird's-eye view lithograph. The view is looking northwest across the river and Main Street in the city of Ventura, drawn seven years after the T-sheet re-survey. It further confirms the presence of trees, although the area appears reduced from the initial T-sheet depictions. (Glover 1877, courtesy of the California Historical Society)

The most persuasive evidence, however, comes from an early T-sheet and resurvey depicting vegetation at the river mouth (Johnson 1855c, Greenwell and Forney 1870; figs. 4.19, 4.20). Since these maps bracket the huge floods of 1861-2, they offer significant evidence of the feature’s resilience over time. For a detailed discussion of more recent ecological characteristics of the Ventura River mouth and estuary, see Ferren et al. (1990).
