HISTORICAL ECOLOGY **of the lower Santa Clara River, Ventura River, and Oxnard Plain:** an analysis of terrestrial, riverine, and coastal habitats

HISTORICAL ECOLOGY PROGRAM
CONTRIBUTION NO. 641 • AUGUST 2011

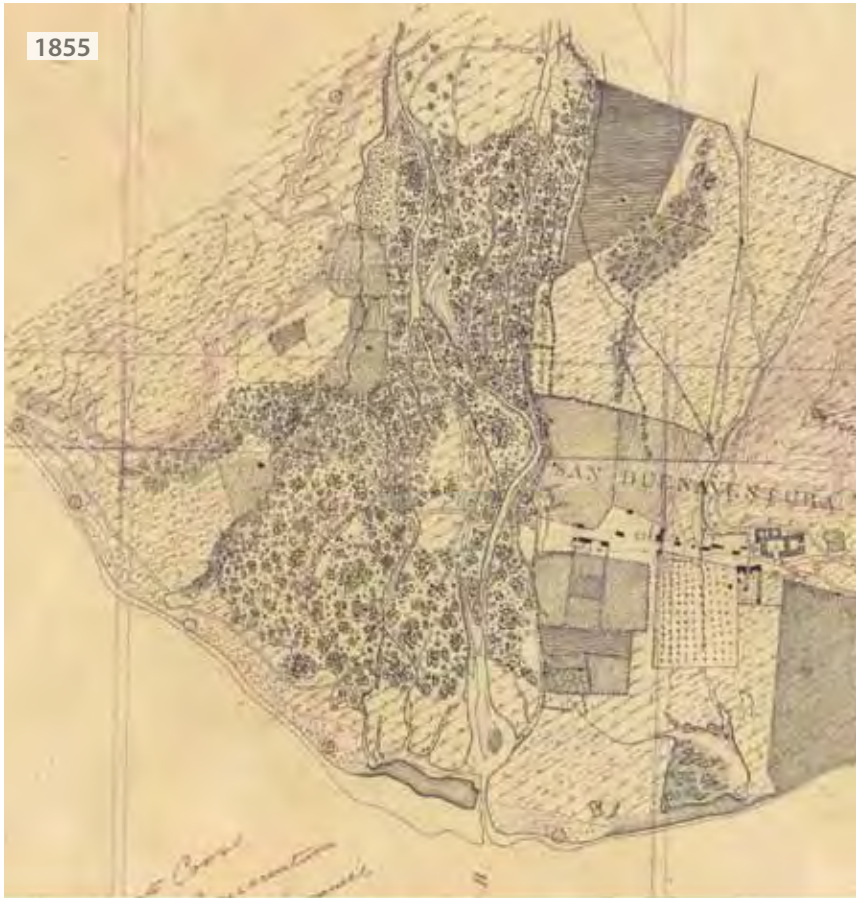
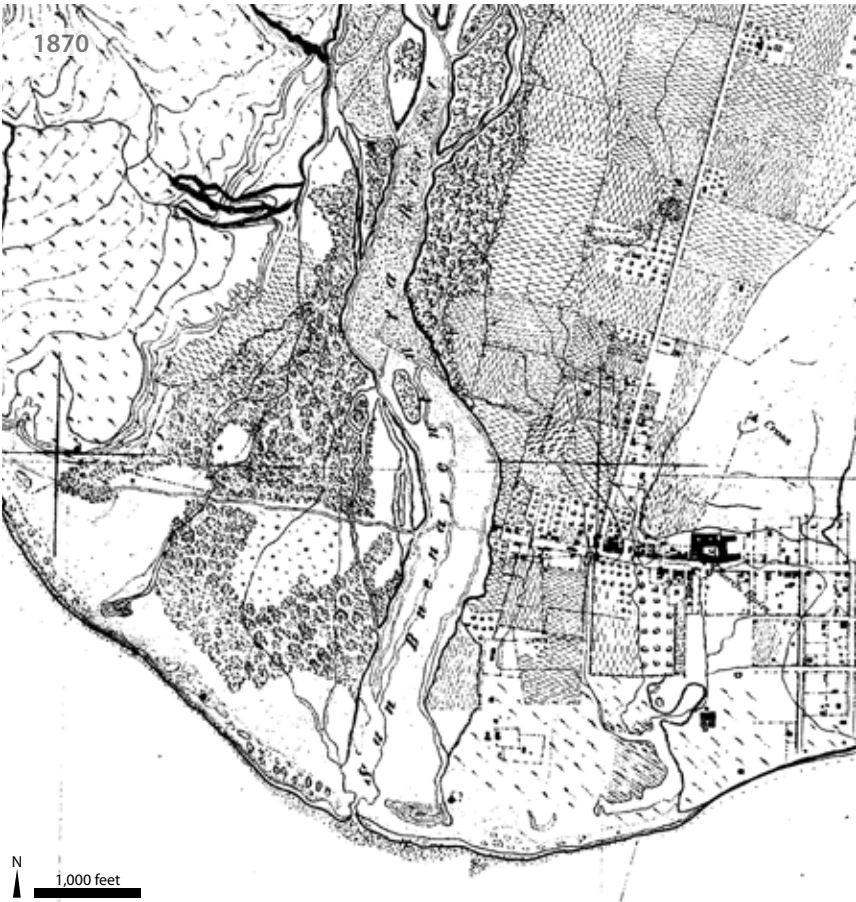
Fig. 4.20. Riparian forest at the mouth of the Ventura River, 1855 and 1870. While the initial survey of the Ventura River mouth by the U.S. Coast Survey (top right) provides evidence of the extent of willow-cottonwood forest at the mouth of the river, the re-survey 15 years later (bottom right) shows that, although trees have been scoured near the main channel, the feature transcended the floods of 1861-2. Dense trees near the mouth of the river taper towards the northern edge of the map. (The freshwater wetland marking a former river route can be seen on the earlier map just north of the nascent city of San Buenaventura; it was almost completely gone by 1870.) (Johnson 1855c, Greenwell and Forney 1870; courtesy of NOAA)

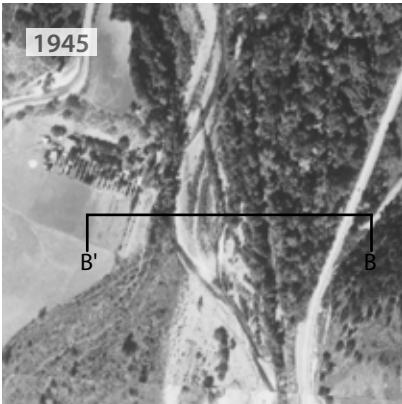
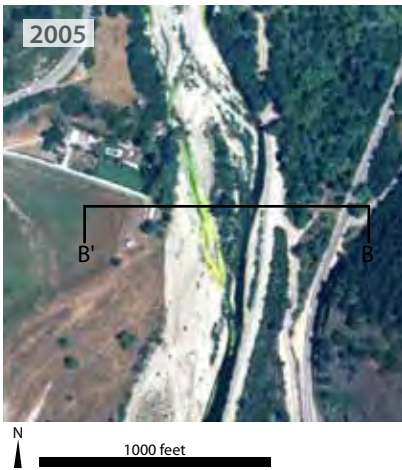
Fig. 4.24. Historical cross-sections at Casitas, 1877-2005. This series of cross-sections shows the Ventura River south of the San Antonio Creek confluence. The transect is in a reach with perennial flow, a relatively narrow river corridor (in comparison to other reaches of the river), and historically abundant live oak and sycamore. Like the Meiners Oaks reach to the north, this reach has retained many of its historical characteristics. Cross-sections are drawn with 5x vertical exaggeration. (Norway 1877; USDA 1945, courtesy of the UC Santa Barbara Map and Imagery Library; USDA 2005. Cross-sections produced by Jen Natali)

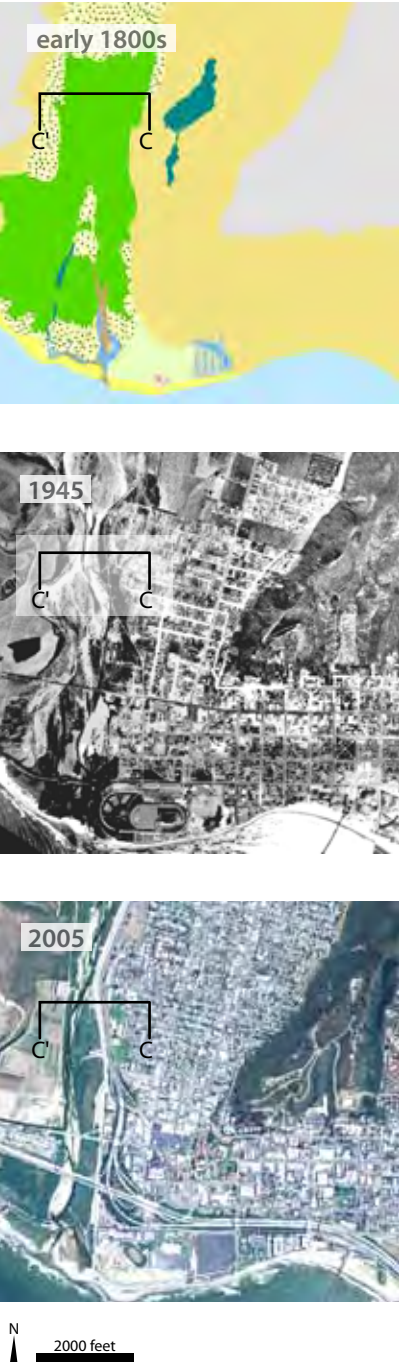
Fig. 4.25. Historical cross-sections at the Ventura River mouth, 1853-2005. This time series shows the Ventura River at its mouth, about ½ mile upstream from the Highway 101 bridge. The area was dominated by broad willow-cottonwood forest and shallow, multi-thread distributary channels. By the early 20th century, the floodplain had been converted into a much narrower, leveed channel to make way for northward expansion from the town of Ventura. The earliest cross-section is derived from GLO notes and the mid-19th century T-sheet drawn of the river mouth by the U.S. Coast Survey. Cross-sections are drawn with 5x vertical exaggeration. (Norris 1853, Johnson 1855c, courtesy of the National Oceanographic and Atmospheric Administration; Fairchild Aerial Surveys 1927, courtesy of Whittier College; USDA 2005. Cross-sections produced by Jen Natali)

We focus here on three sample reaches chosen to illustrate these concepts in cross-section: an upstream reach at Meiners Oaks (fig. 4.23), an intermediate reach at Casitas (fig. 4.24), and a lower reach near the river mouth (fig. 4.25). The transects and accompanying plan form representations illustrate the historical hydrology, morphology, and ecology of the river in these three very different locations in the 19th and early 20th centuries (1853-1903). We also produced cross-sections presenting conditions in these reaches during the mid-20th century (1927-1945) and early 21st century (2005) to depict the impacts of changing land use over this time. Taken together, these reaches represent a broad variability in vegetation and flow characteristics along the river.

river corridor. This may be a snapshot of a post-flood period of rebuilding, or it may be the beginning of a rapid urbanization of the lower watershed. By 2005, the city of Ventura had expanded fully into the floodplain of the river, fortified by a levee and bounded by the Ojai Freeway. *Arundo donax* has established on both sides of the narrowed river corridor; it was described as “well established for many miles along the river” as early as 1945 (Henry Pollard, in Ferren et al. 1990). Industrial agriculture and nurseries have replaced pasture on the west bank of the river.

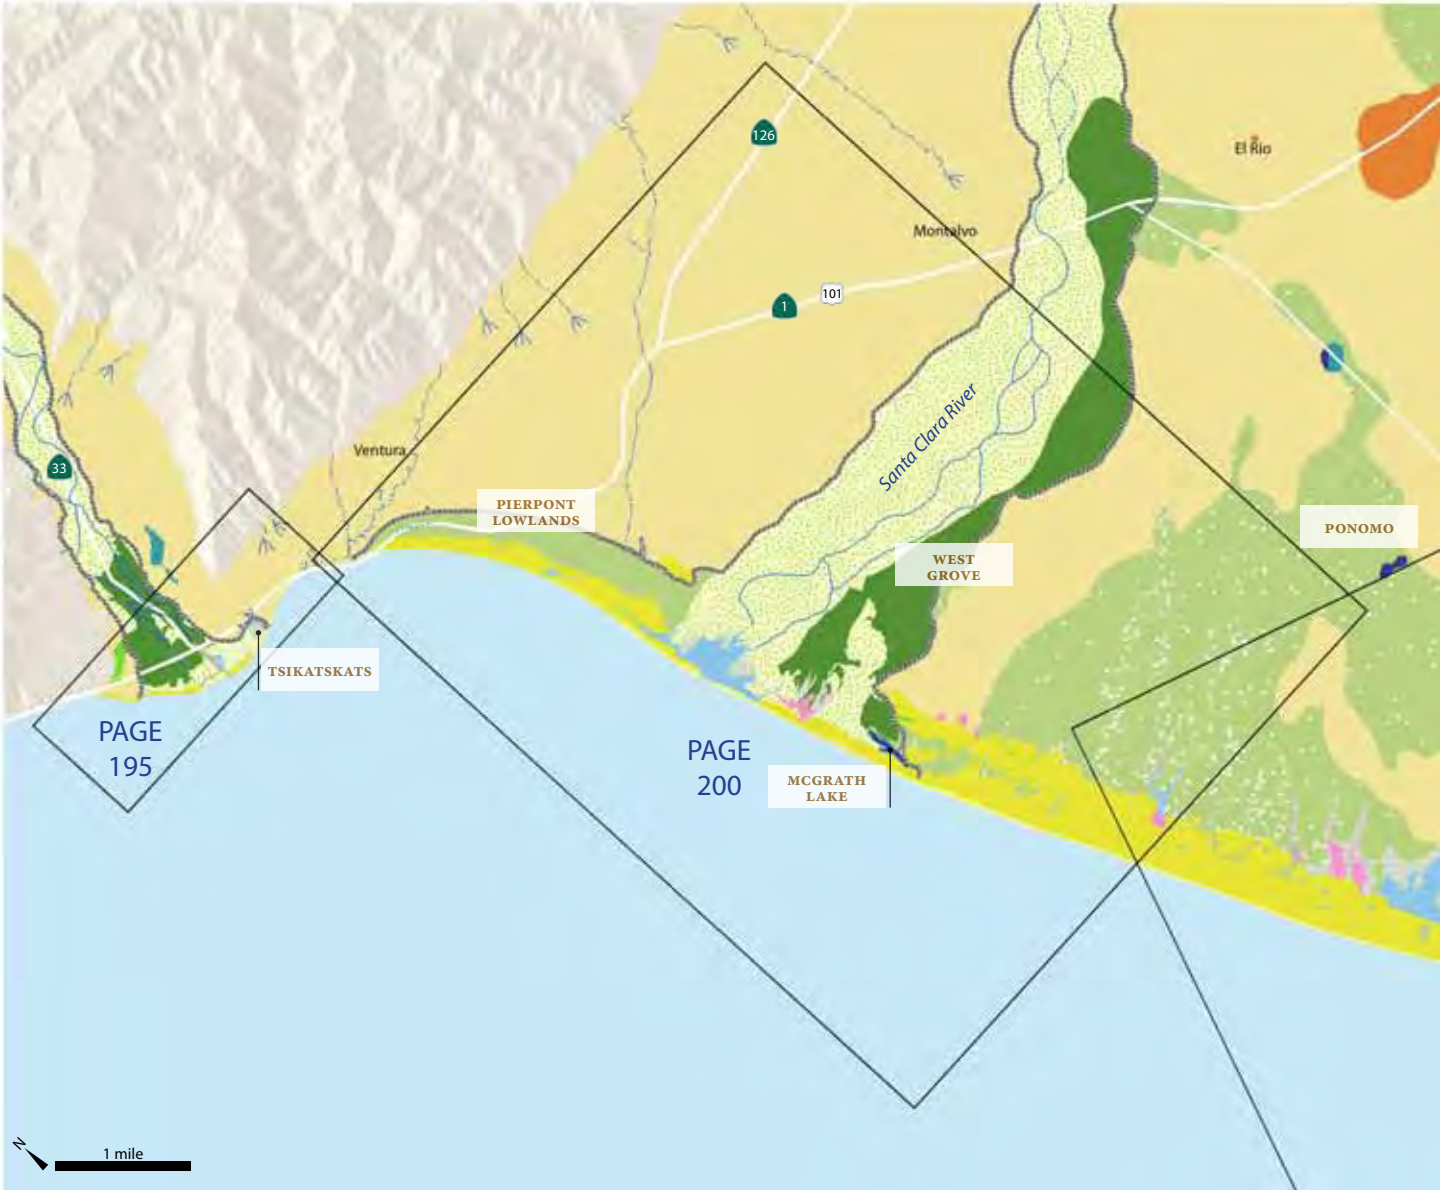
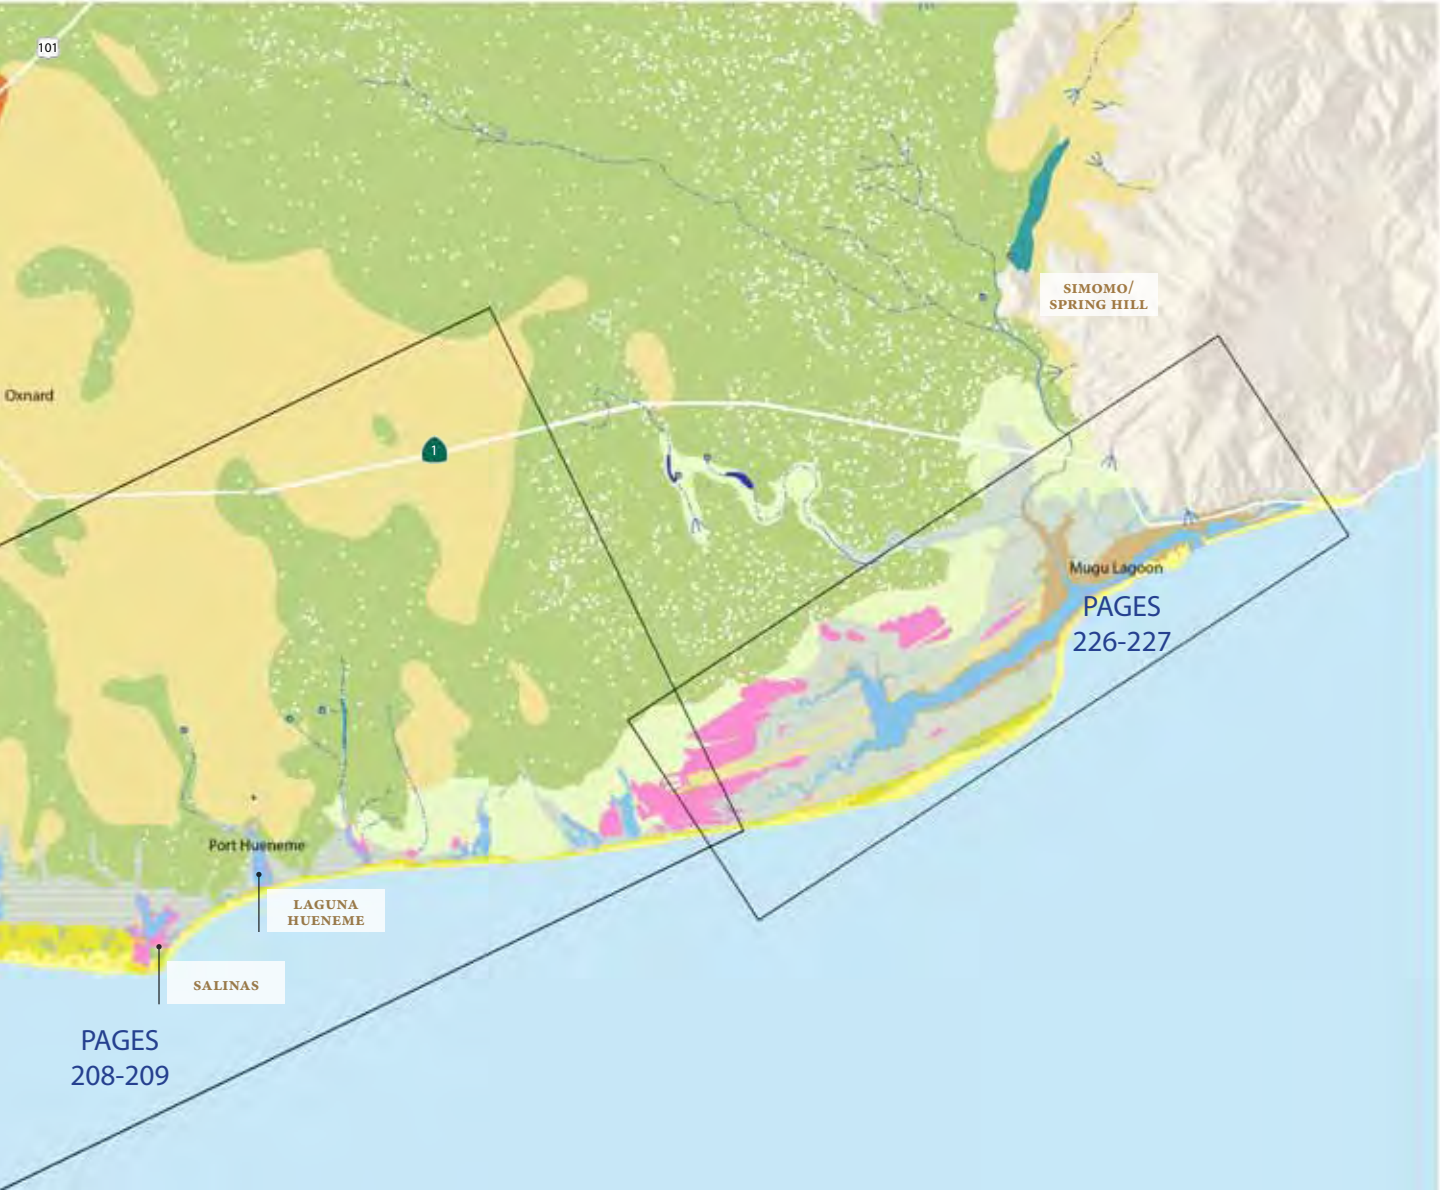
Fig. 6.2. Habitats of the Ventura County shoreline, early 1800s. At least three general types of coastal systems, or coastal archetypes, can be identified along the Ventura shoreline: freshwater-brackish estuaries associated with the Santa Clara and Ventura river mouths, dune-dammed non-tidal lagoon systems (with associated salt/brackish marsh and salt flats) marking former Santa Clara River mouths, and the large coastal wetland system at Point Mugu.

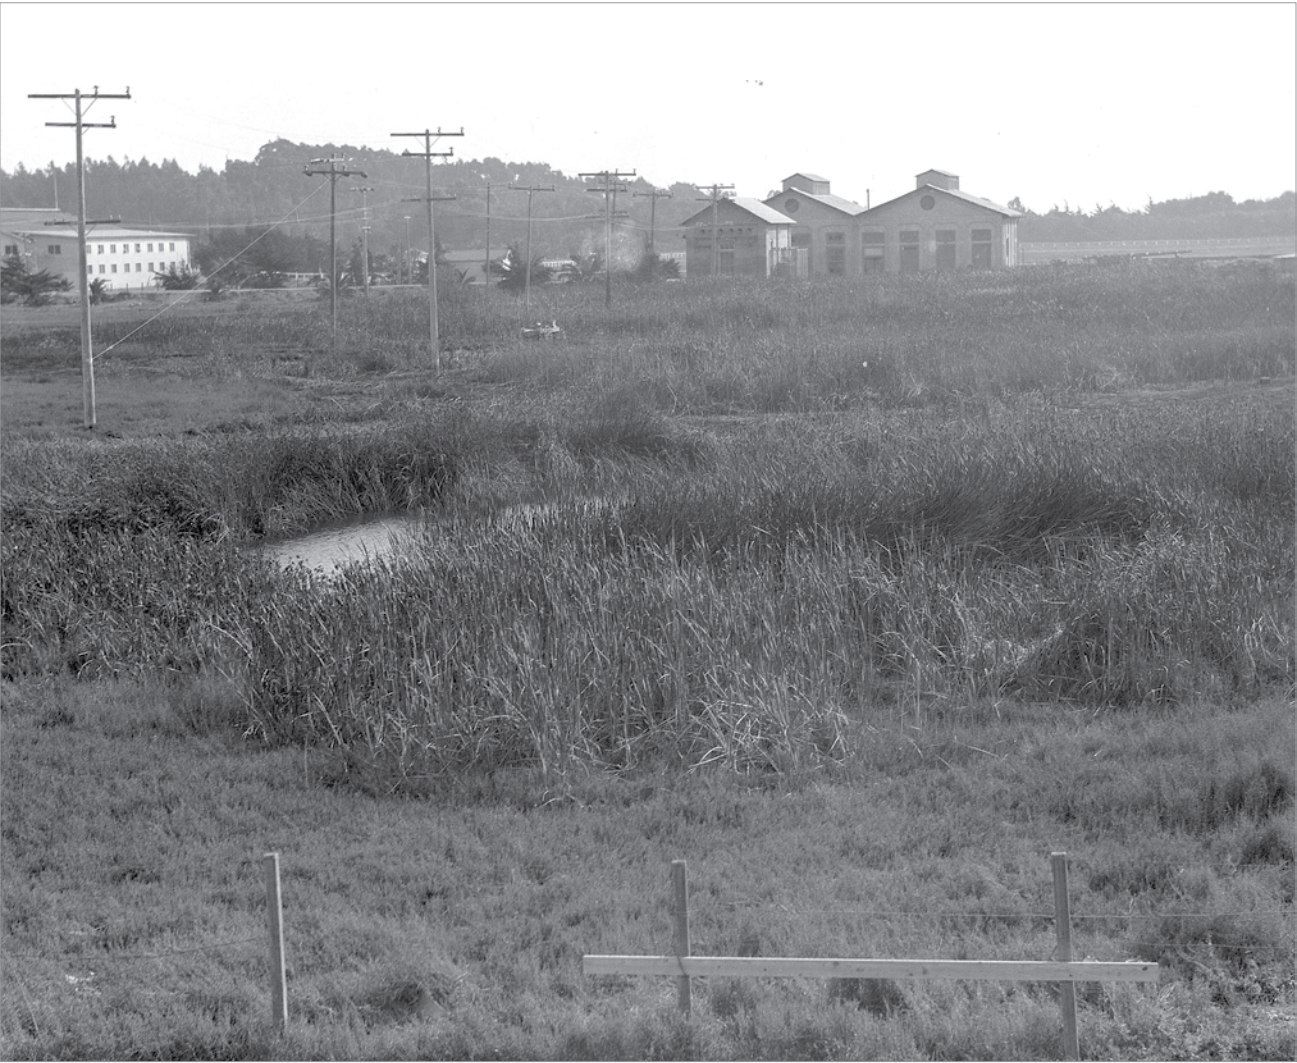
Fig. 6.5. Tsikatskats, the lake at the end of Figueroa Street. This photograph, taken in the fall of 1923, shows the remnant of what was once a well known brackish lake in the Ventura River floodplain. What are likely cattails (*Typha latifolia*) are visible in the foreground, along with stands of alkali bulrush (*Scirpus [Bolboschoenus] maritimus*) and bulrush/tule (*Scirpus [Schoenoplectus] californicus*; see particularly the matted vegetation to the right of the open water). Pickleweed (*Salicornia virginica*) dominates the foreground. (Harrington 1923b, courtesy of the Smithsonian Institution; plant interpretation, Baye pers. comm.)

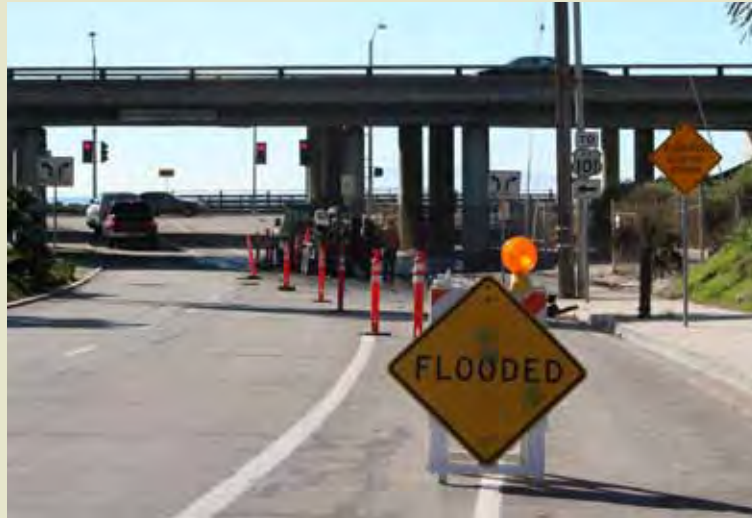
Fig. 6.29. San Jon Road at Highway 101, looking west. Areas of the Pierpont lowland are still susceptible to flooding, as shown in this December 2008 photograph.
