North Fork Matilija Creek Adult Steelhead Below Ojai Quarry Barriers

March 30, 2010

Matt Stoecker, Ecologist

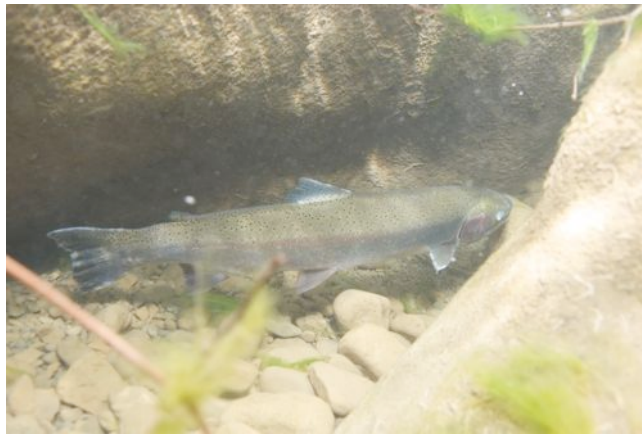
Approximately 24-25 inch male steelhead with damaged right eye.

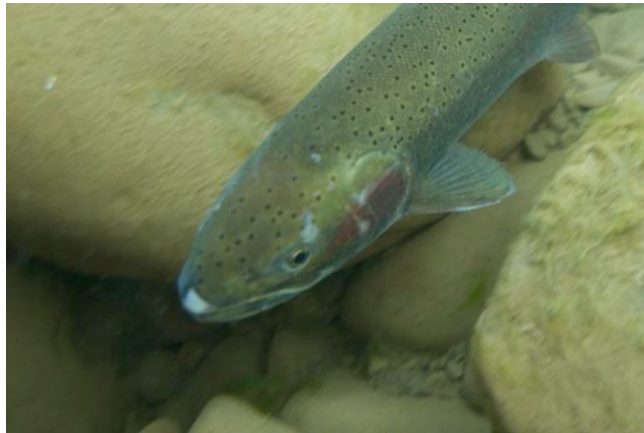
Head scarring possibly caused by attempting to jump quarry barriers.

Resource agencies have known about this Ojai Quarry steelhead migration barrier problem for several years and have been in contact with the owner. Immediate enforcement action is needed to require the elimination of these steelhead barriers and restoration of a natural, free-flowing North Fork. The survival and recovery of Ventura River steelhead depend on it.

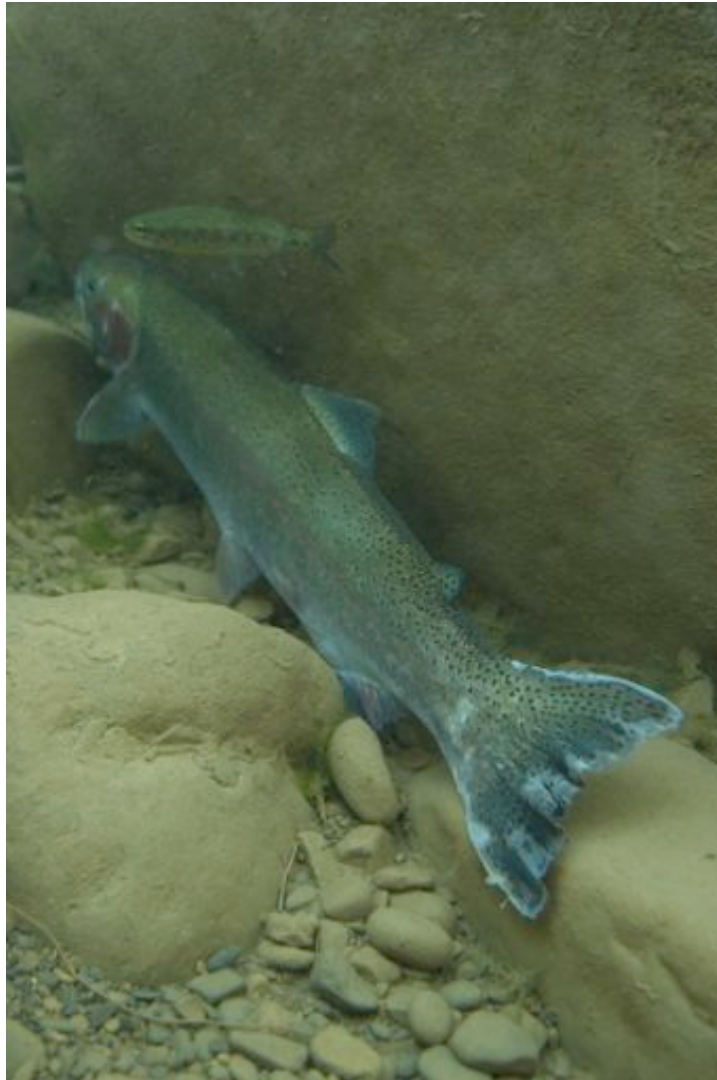
Approximately 7-inch juvenile steelhead next to the large adult.

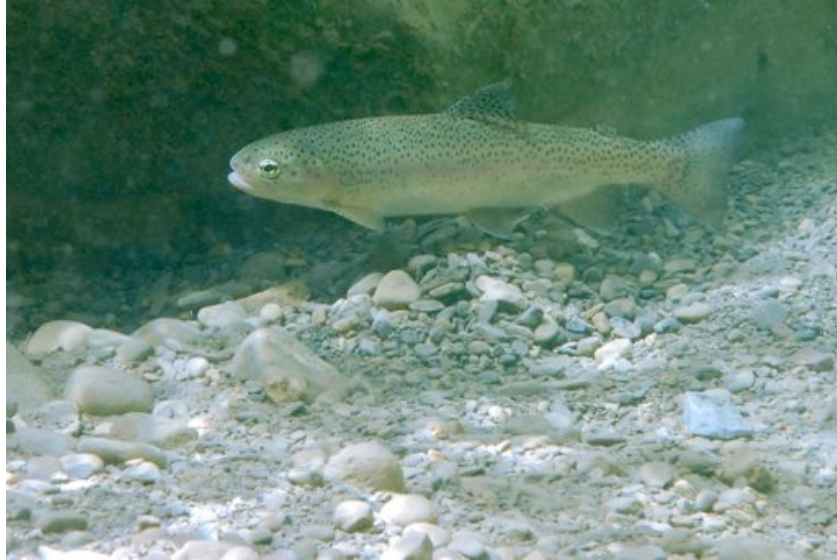
In addition, two steelhead measuring approximately 14 and 15 inches in length were observed below the Ojai Quarry barriers and in spawning behavior. It is unknown if these steelhead migrated upstream from a short period in the ocean or lagoon, but coloration and physical characteristics suggest the larger trout may have completed a short, coastal or lagoon residency. Several dozen juvenile steelhead were also observed. In addition to the migration barriers caused by the Ojai Quarry, a large hose was observed in the creek and going to a generator at the quarry where water diversions were assumed to be taking place.

Approximately 14-15 inch steelhead observed in spawning behavior.

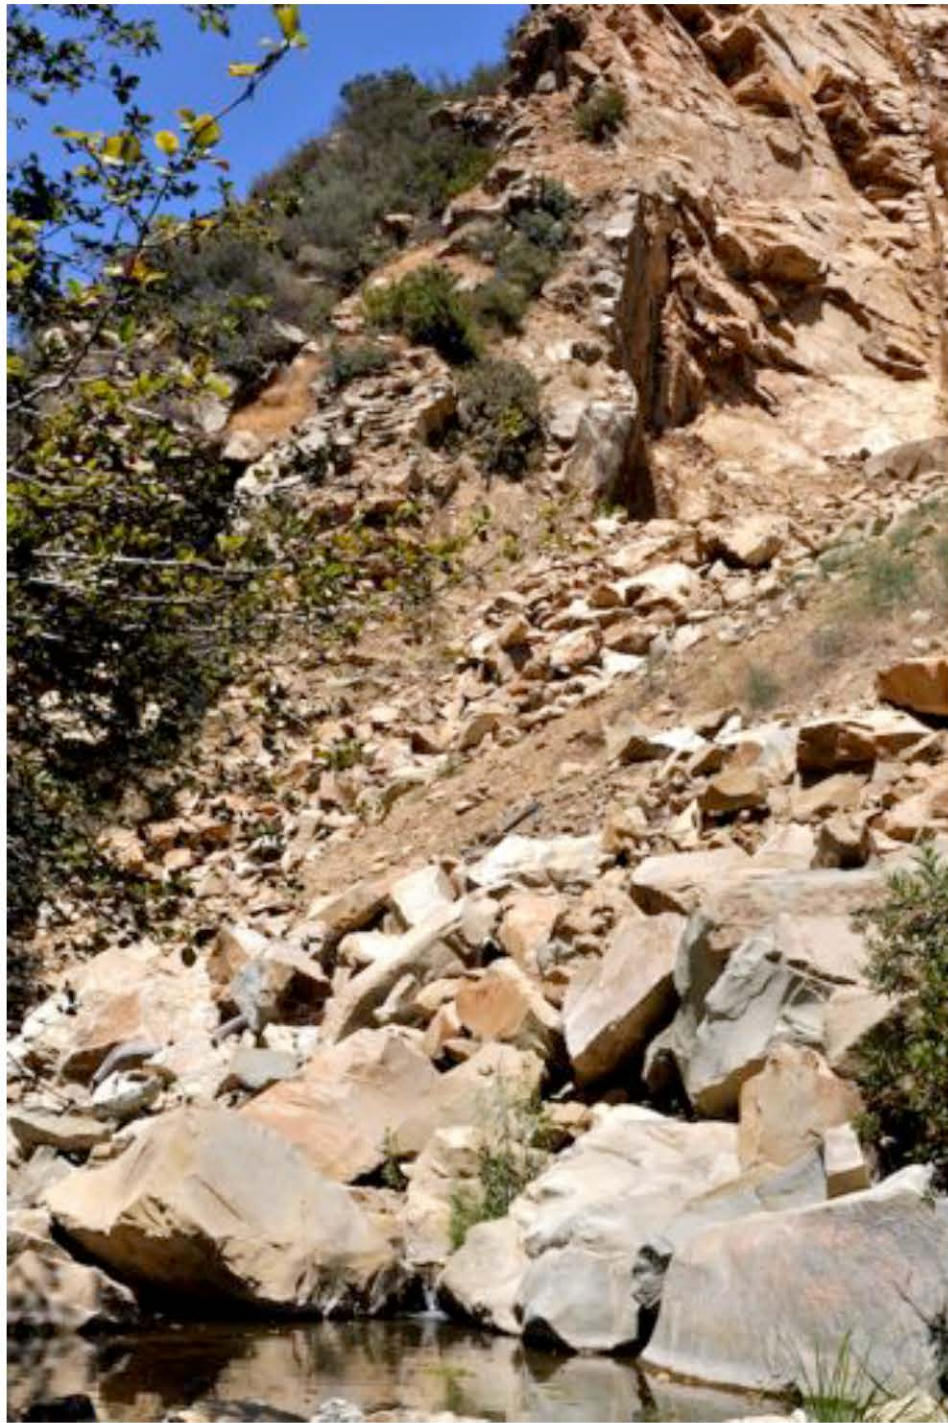
The below images are from July 2009 and show the large boulders being discarded from the quarry, at just one of the discard sites, and forming one of the migration barriers on the North Fork. In addition to being migration barriers to all life stages of endangered steelhead, the Ojai Quarry boulder jams have smothered streamside vegetation and caused surface flows to disappear and go underneath the boulder jam during low summer flows.

This below Ojai Quarry boulder slide has created a steelhead migration barrier as well as flows to go subsurface at the upstream side of the barrier during lower summer flows. The image is looking downstream at disappearing surface flows above the boulder barriers. This is the only location on the North Fork where summer flows were observed to go subsurface during summer of 2009 observations. This condition was observed to be caused by the quarry slide and high permeability of the discarded material.
