Presentation to Casitas Municipal  
Water District Board of Directors on  
preliminary results of the 2009  
monitoring and evaluation for the  
Robles Fish Facility.

By  
Scott Lewis  
and  
Mike Gibson  
Casitas Municipal Water District  
27 January 2010

# 2009 Robles Monitoring and Evaluation Progress Report

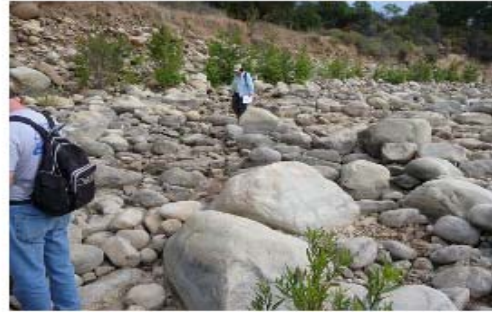
346 Looking US at head of unit

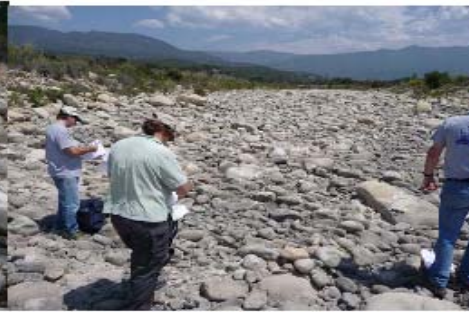
305 - Looking US - water flows from top right to bottom left

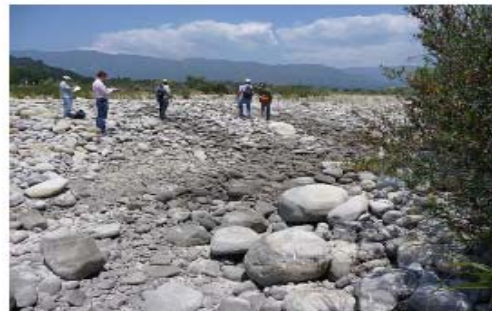
268 - Looking US from tail of unit

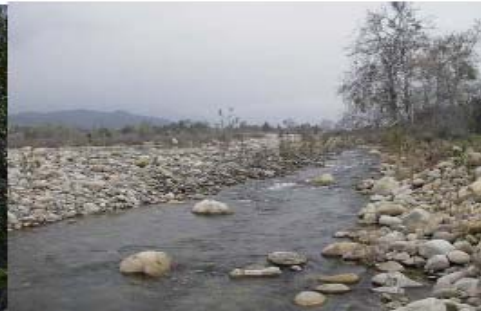
234 - looking US from unit 233

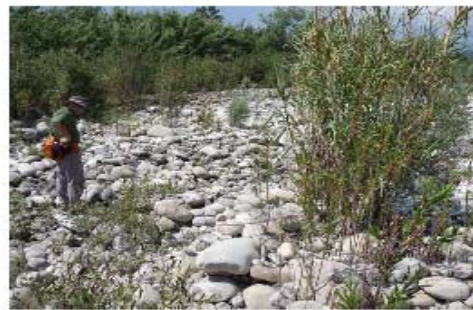
204 - Looking at LB from RB at head of unit

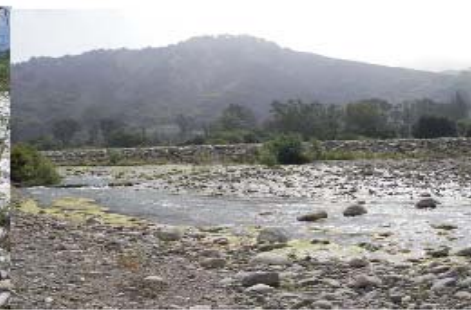
168 - looking US from LB of unit 167

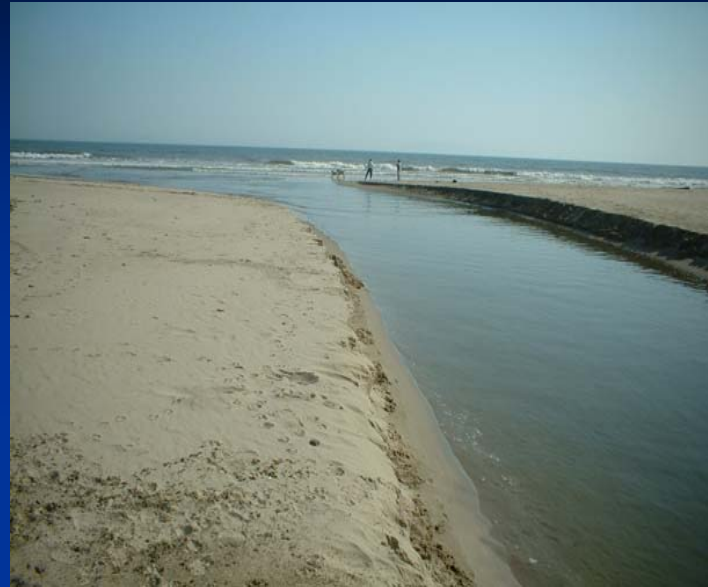
Objective: Monitor the timing and frequency of sandbar breaching to determine the initiation of the fish passage augmentation season.

2009: The sandbar was closed during mid January at low tides. The sandbar was open the remainder of the passage season.

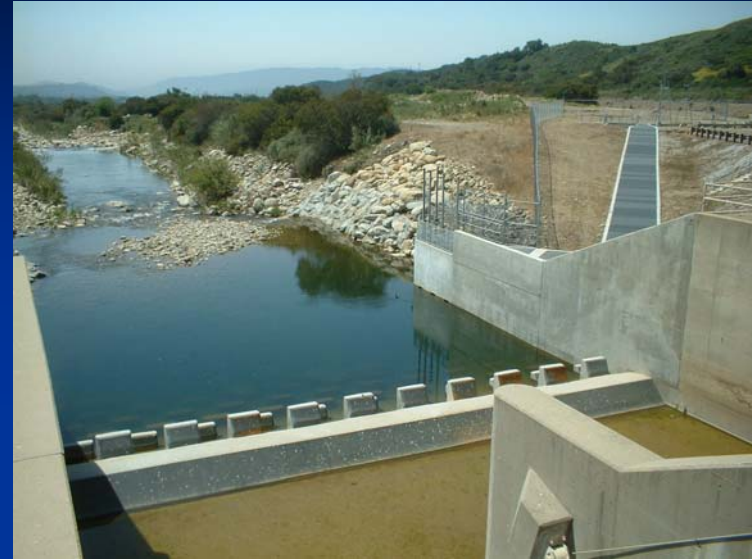
**Objective:** Determine if migrants are holding immediately downstream of the Robles Facility during the fish passage augmentation season.

**2009:** A total of 807 *O. mykiss* were counted. Counts peaked in mid April at 131. No adults were observed.

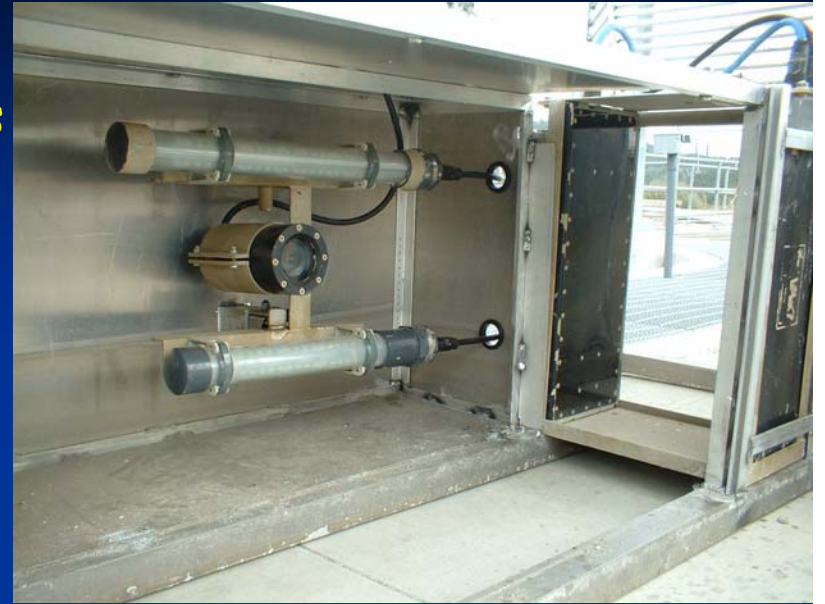
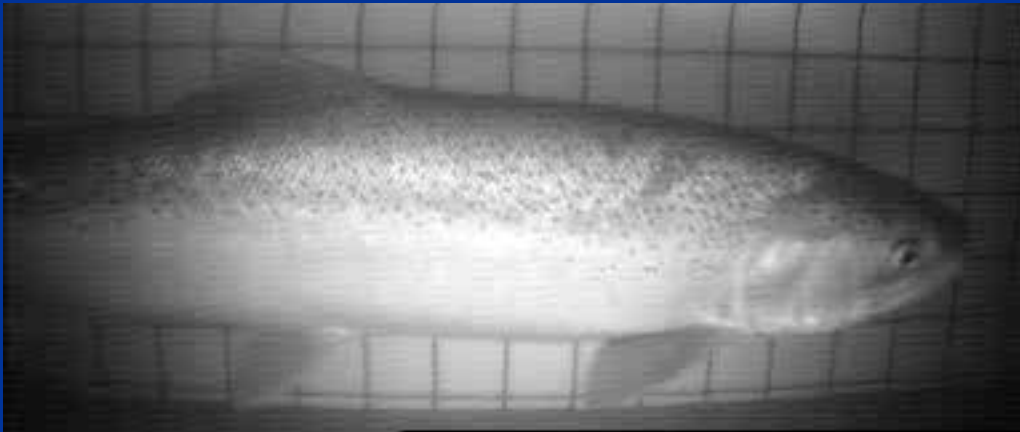
**Objective:** Determine the relative numbers and timing of upstream and downstream migrating fish using the Robles Facility.

**2009:** No adult steelhead detected.

Downstream *O. mykiss* = 42

Upstream *O. mykiss* = 55
