# The San Antonio Creek Watershed:

## AN AGRICULTURAL AND RURAL RESIDENTIAL LAND PROTECTION STUDY

Prepared by United States Department of Agriculture Natural Resources Conservation Service:  
Somis Field Office and Davis Watershed Planning staff.

March, 2010

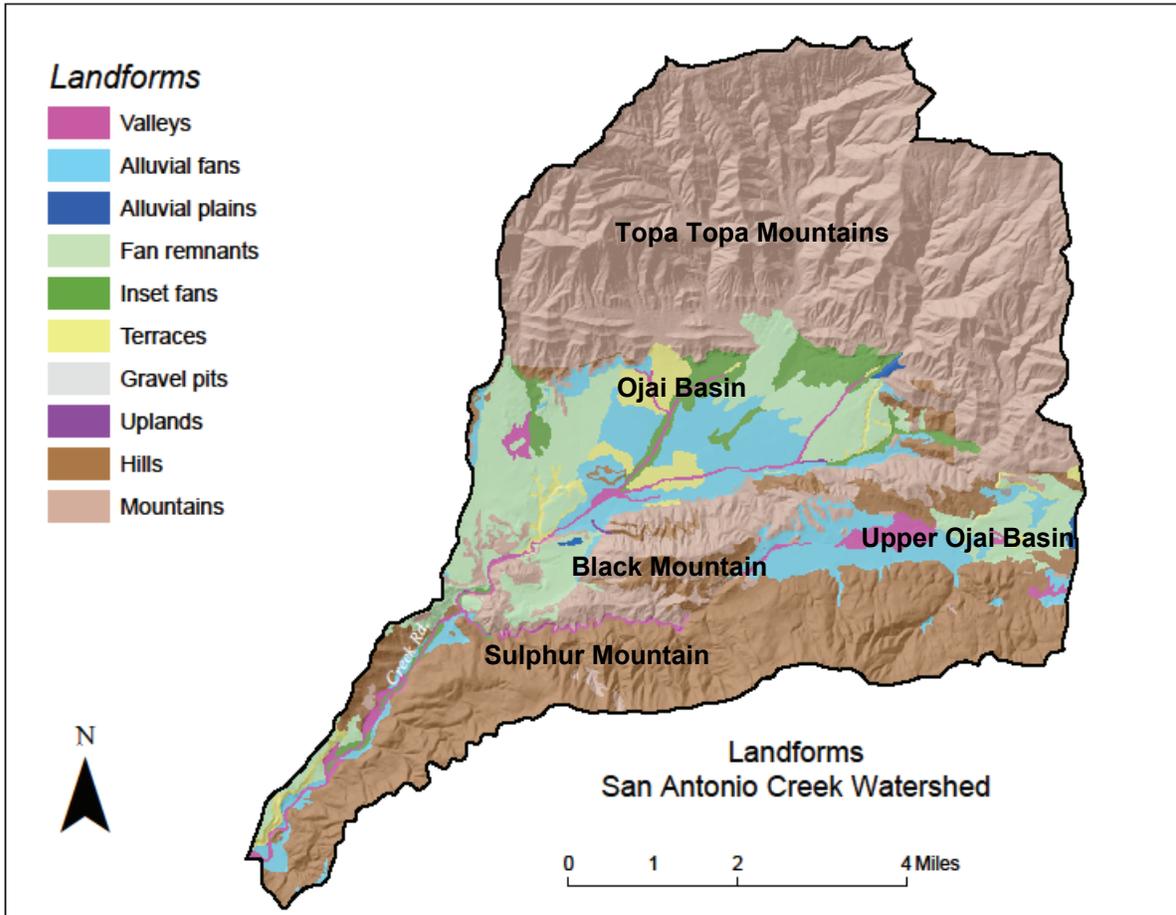
**Map 2:** Landforms of the San Antonio Creek Watershed. Most maps displayed in the main body of this report are also displayed as full-page figures in **Appendix A: Watershed Atlas**.

As shown in Maps 2 and 3, the topography of the San Antonio Creek Watershed is highly variable. Steep areas across the north are the Topa Topa Mountains, with flatter areas (in green) further south representing the Ojai Basin and the Upper Ojai Basin, with the Black Mountain area dividing the Ojai Basin from the Upper Ojai Basin, and the Sulphur Mountain area defining the southern border of the watershed.

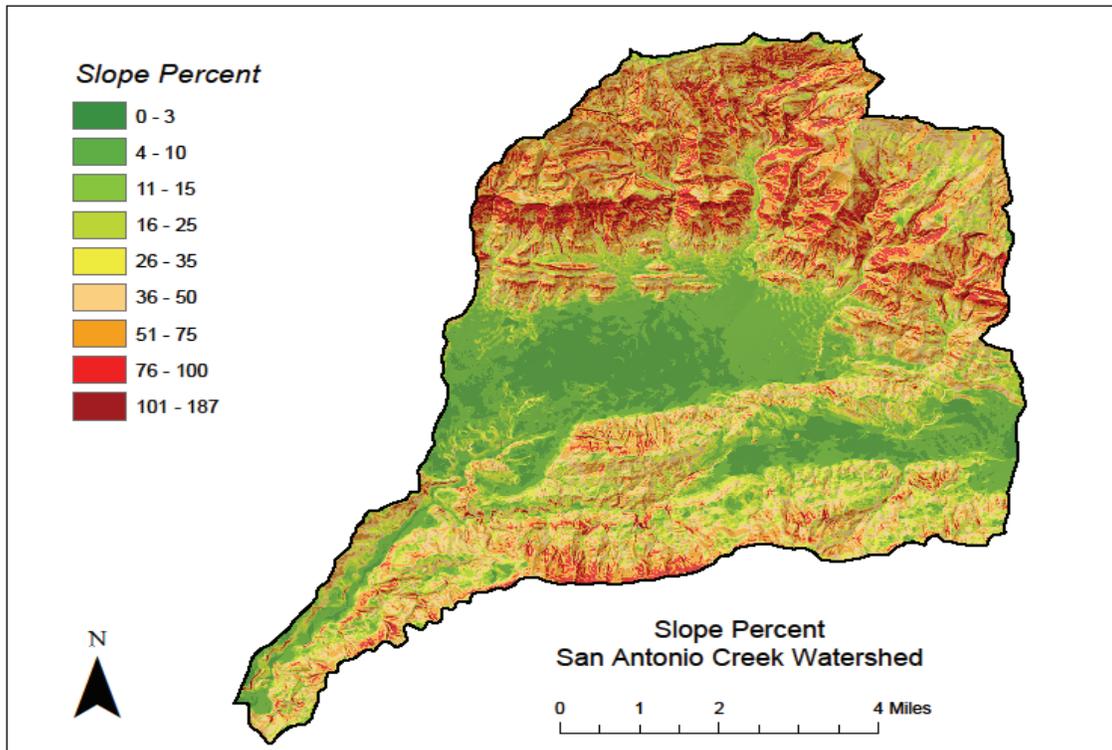
**Map 3:** Slopes (percent) in the San Antonio Creek Watershed. Most maps displayed in the main body of this report are also displayed as full-page figures in **Appendix A: Watershed Atlas**.

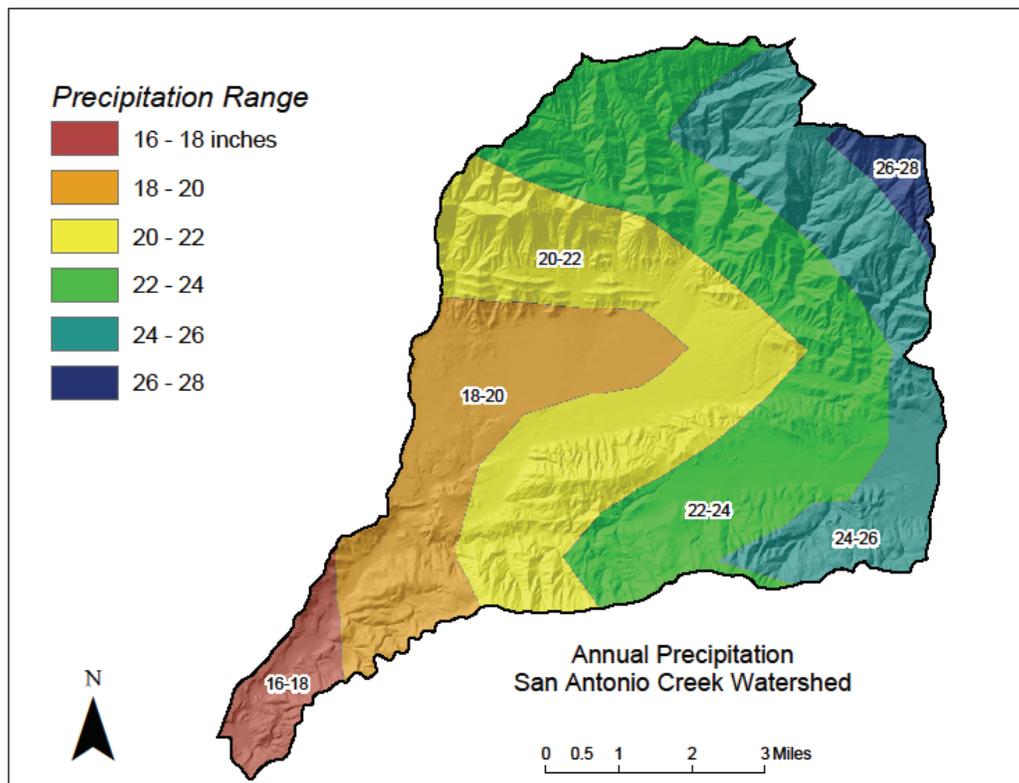
**Map 4:** Precipitation patterns in the San Antonio Creek Watershed.

Rainfall has varied from 5 to 48 inches annually over the last 50 years (Kear, 2007), with an average of 22 inches. Groundwater basin storage is limited and highly dependent on recent rainfall (see table 1).

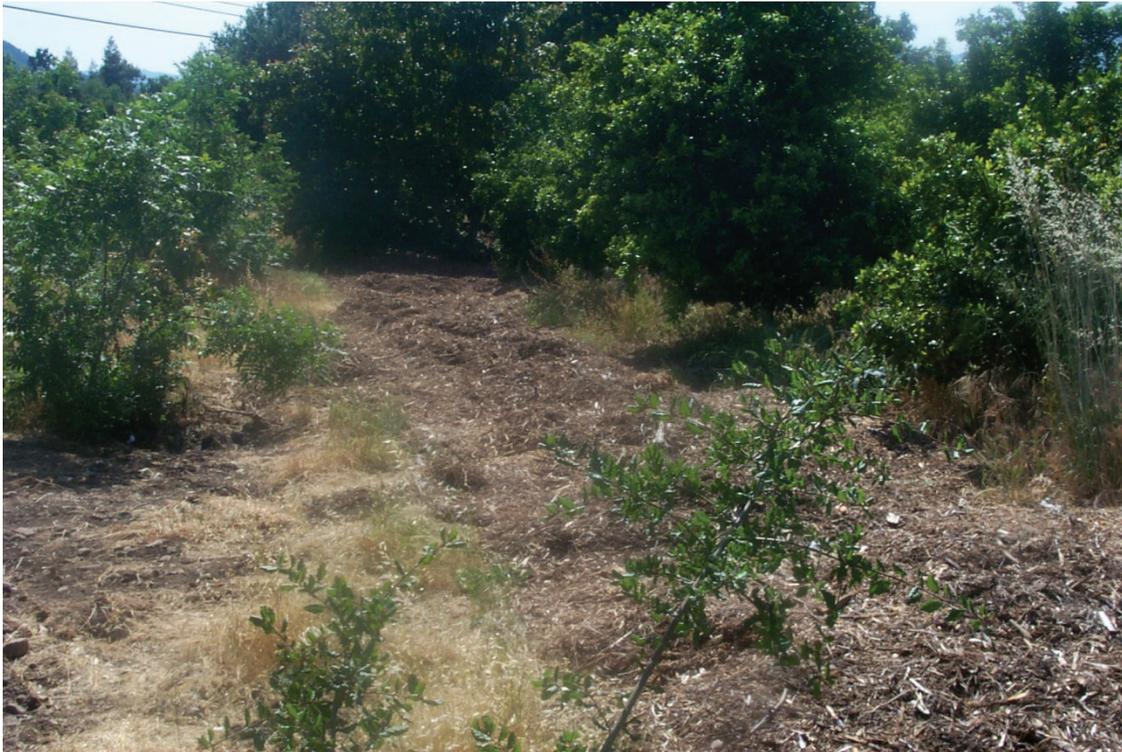
**Photograph 1:** *Citrus orchard with recent mulch application. Mulch reduces soil erosion, improves soil fertility and tilth, improves water use efficiency and provides weed control.*

Mulch is applied on some orchards, a soil improvement and erosion prevention practice. At times sufficient quality and quantity of mulch material in the watershed may not be available, as the watershed is distant from major sources, such as Los Angeles-area yard and street wastes, which are used in other parts of Ventura County.

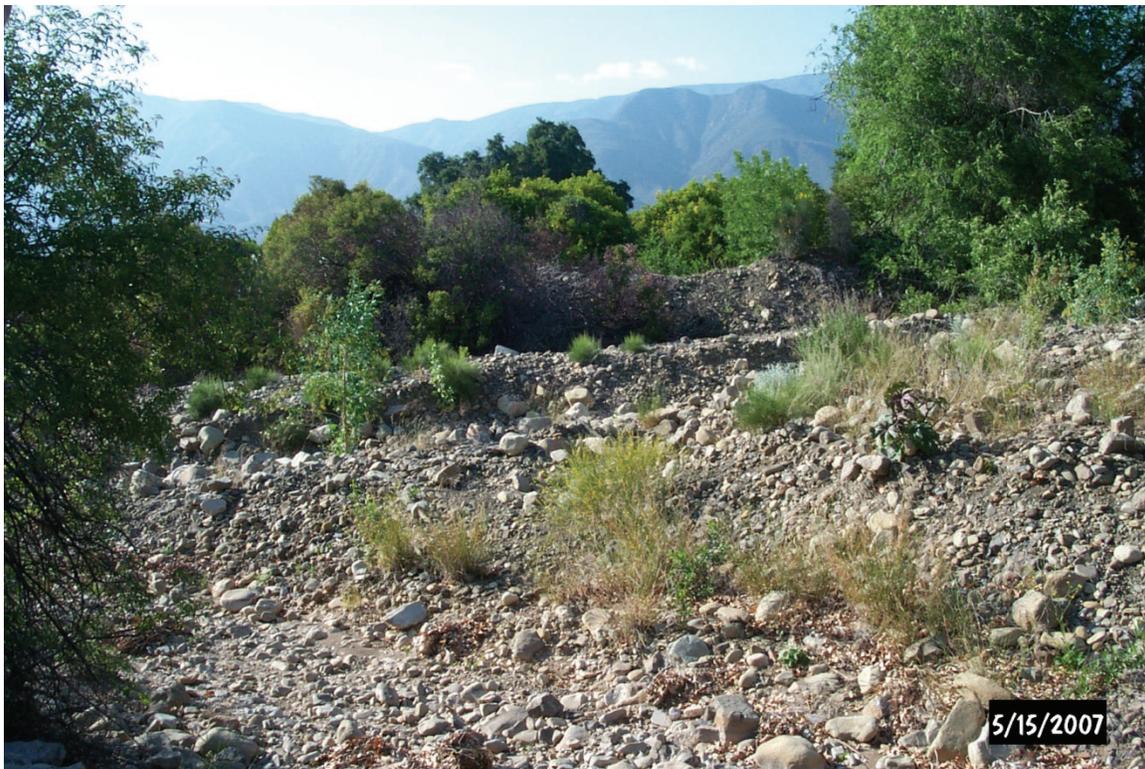
**Photograph 2:** an Ojai Basin stream is in the foreground. A citrus orchard protected by temporary embankments of coarse sediment is in the background.

Numerous orchards adjacent to streams have non-engineered levees built up over time to provide flood protection. In some areas, ditches are used to direct overland flood-flows around and away from orchards.

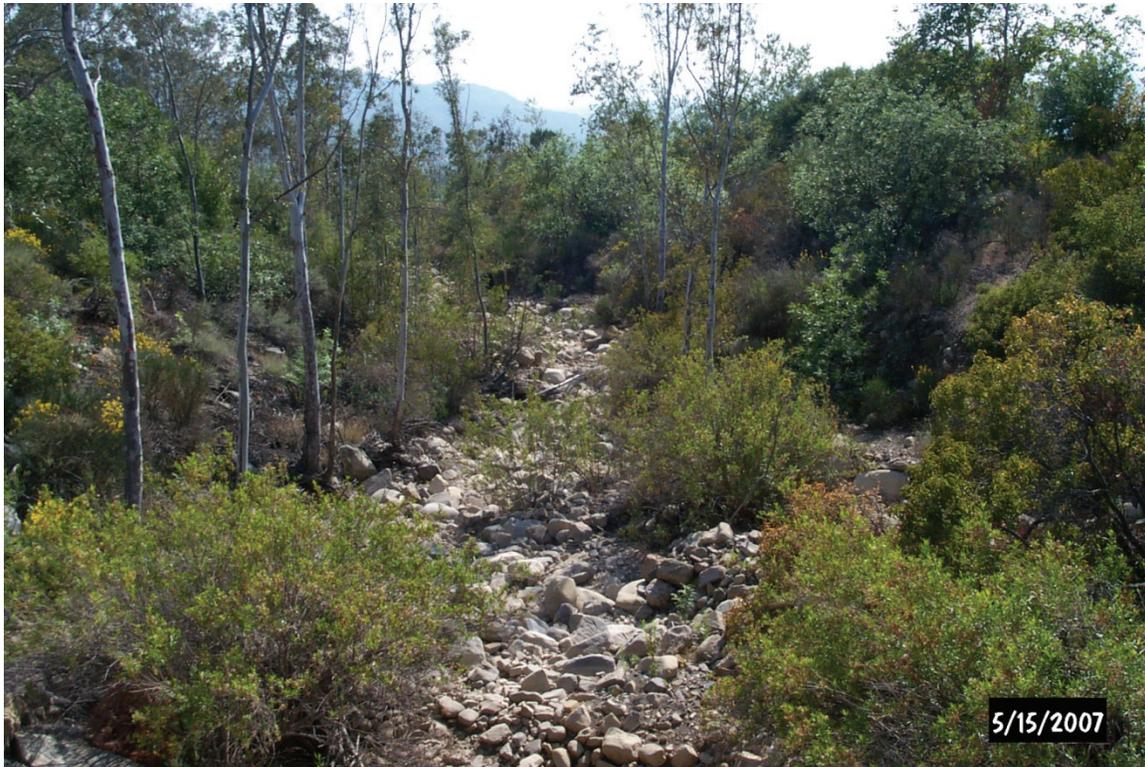
*Photograph 3: A San Antonio Creek tributary, Topa Topa Mountains in the background.*

The upland portions of the watershed include canyons and steep terrain. This portion of the watershed produces large volumes of debris and sediment due to its steep slopes, higher rainfall intensity, and potential for vegetative cover changes resulting fire or drought. Vegetation in upland areas of the watershed is predominantly chamise and chaparral, with some coastal oak woodland at lower elevations and in the canyons.

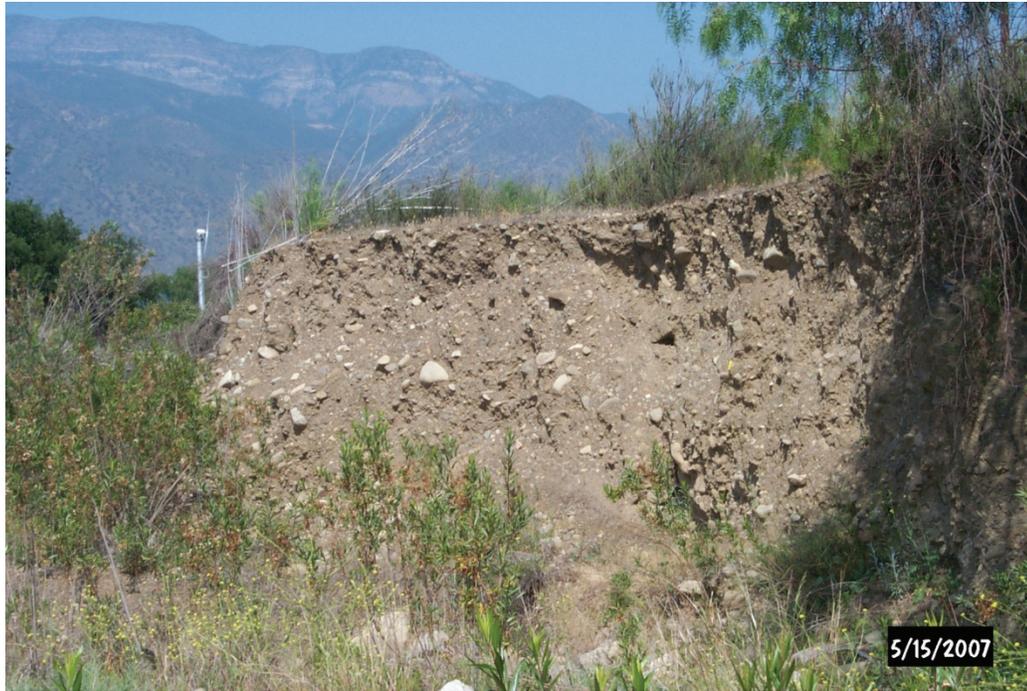
cha  
ne **Photograph 4:** A San Antonio Creek tributary, through alluvial fan remnants below the Topa Topa Mountains (background).

Cropland damages from flooding would be heavily concentrated on citrus groves on alluvial fans and flood plains in the Ojai Basin. Floods in alluvial fans are not highly predictable (United States Army Corps of Engineers - ACE, 1973), as they tend to break through and form new channels in loose fan sediments, delivering water to unexpected locations from unexpected directions. This is exacerbated by channel obstructions in the fan-areas.

In the plains and lower alluvial fans of the Ojai Basin, stream channels are well defined, but tend to meander. Stream banks are formed from coarse cobble material which is easily eroded. Debris and sediment are deposited in the stream, forcing both low and high flows to be directed into the stream banks, causing stream-bank erosion.

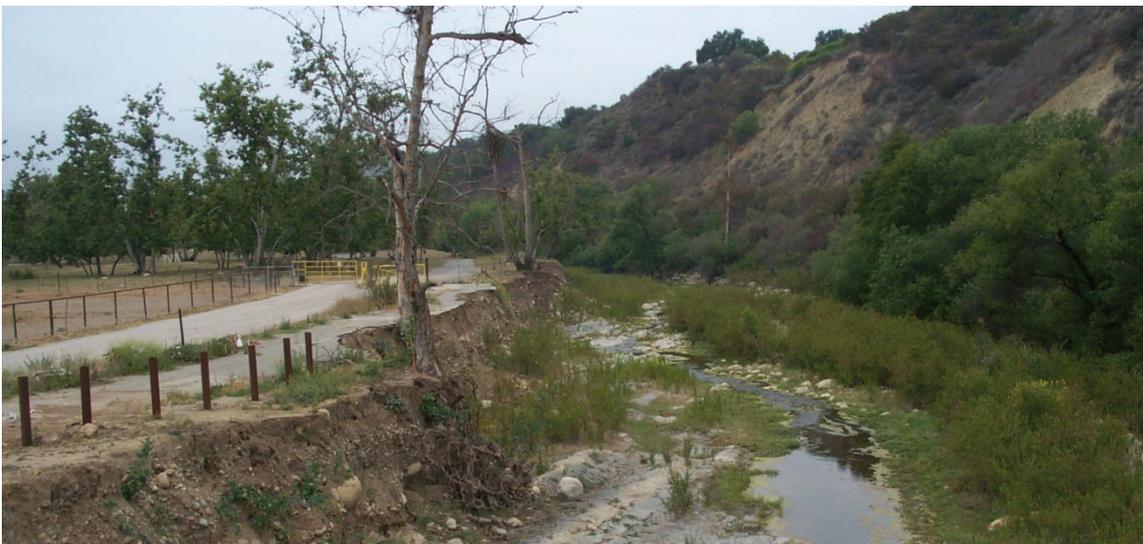
**Photograph 5:** Lower San Antonio Creek, May, 2007.

San Antonio Creek downstream of Ojai is relatively confined, with limited floodplain development and sediment storage. Woody riparian vegetation along the lower portion of the creek is well established and helps promote a stable stream cross-section, although the storms of January 2005 caused widespread flooding and bank erosion along this reach.

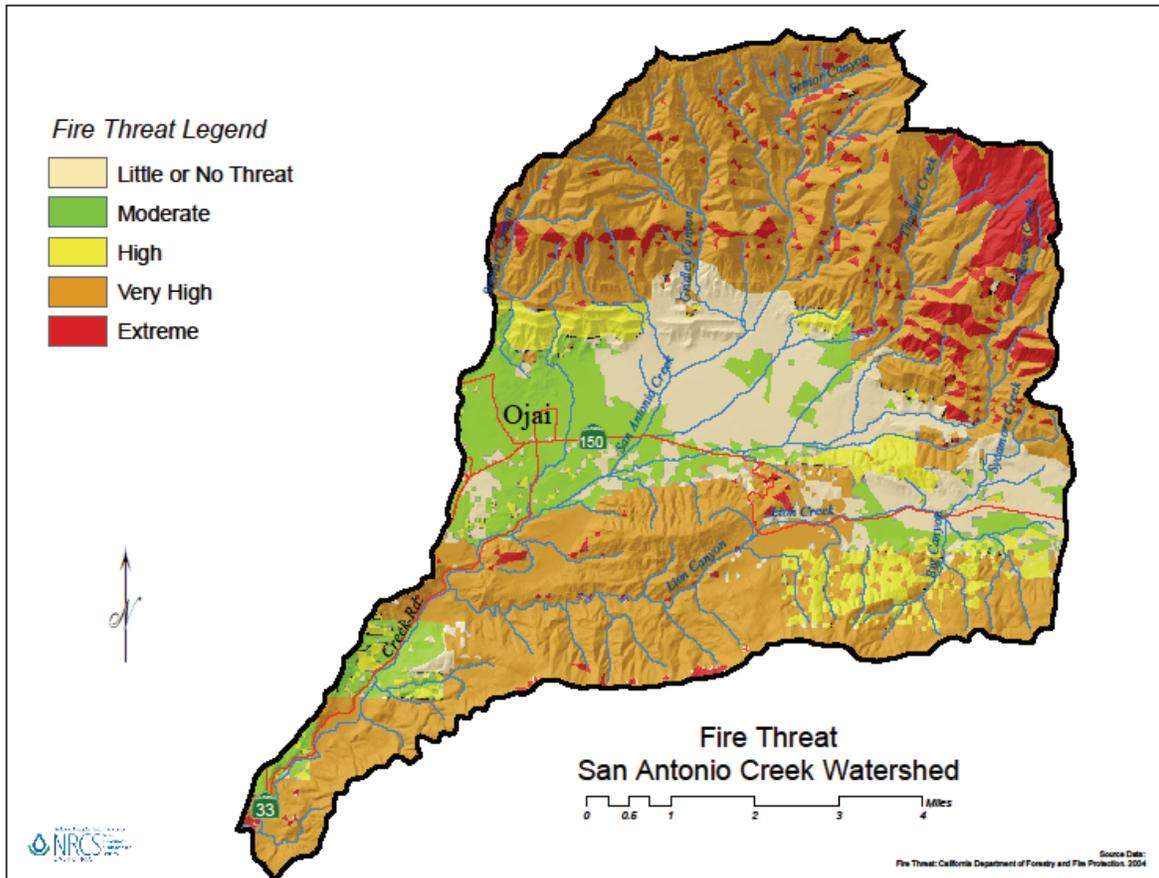
**Map 5:** Fire Threat Levels in the San Antonio Watershed. [Data from FRAP \(Calfire\), 2009.](#) (FRAP - Fire and Resource Assessment Program)

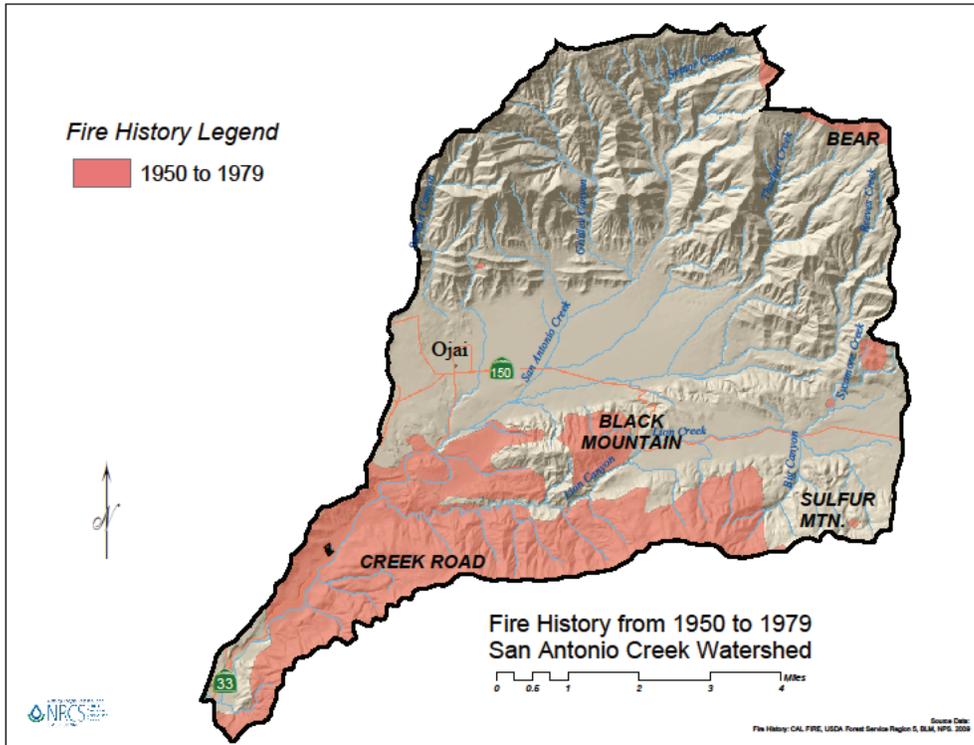
**Map 6:** Fire History of the San Antonio Watershed, 1950 to 1979.

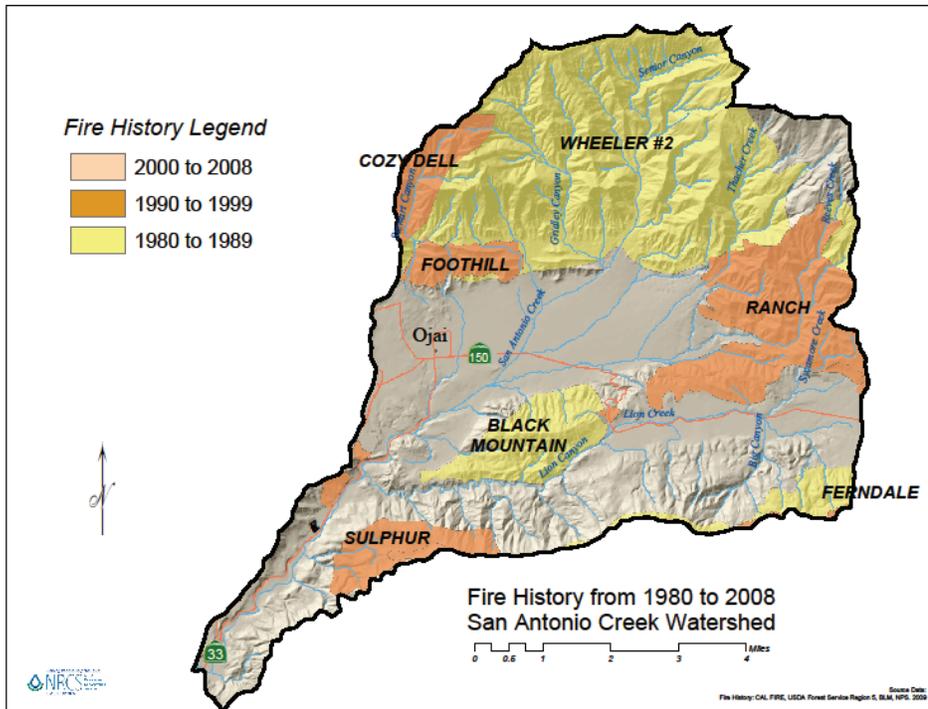
**Map 7:** Fire History of the San Antonio Watershed, 1980 to 2008.

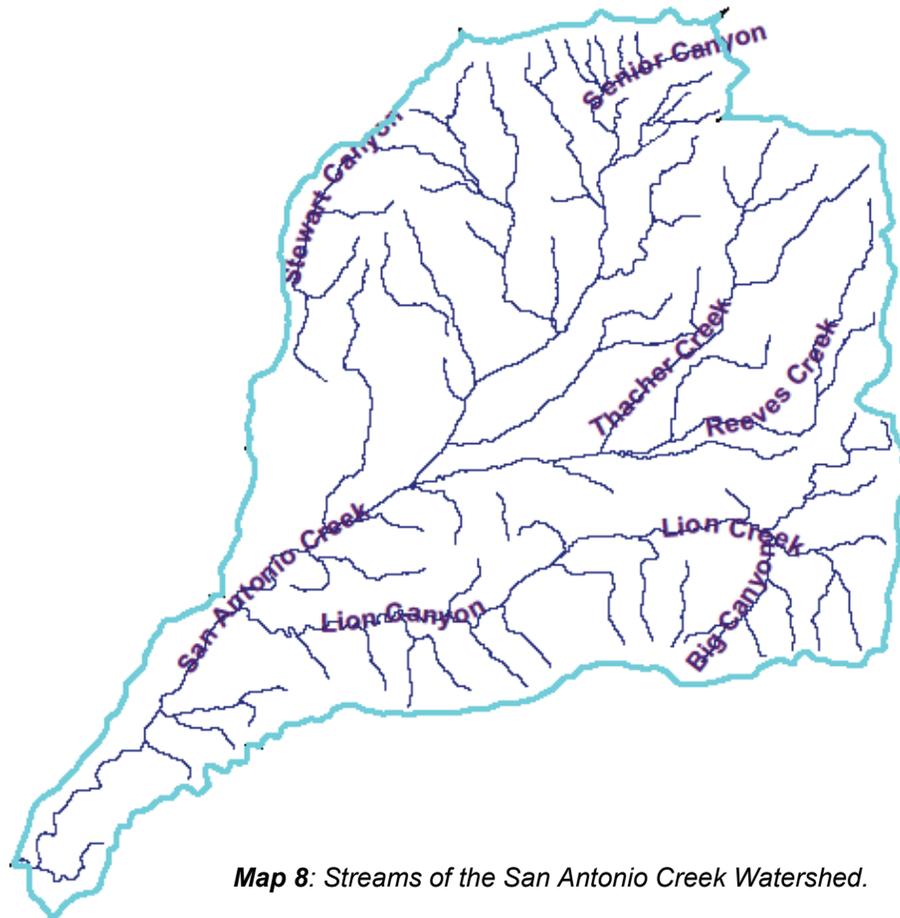
**Map 8:** Streams of the San Antonio Creek Watershed.

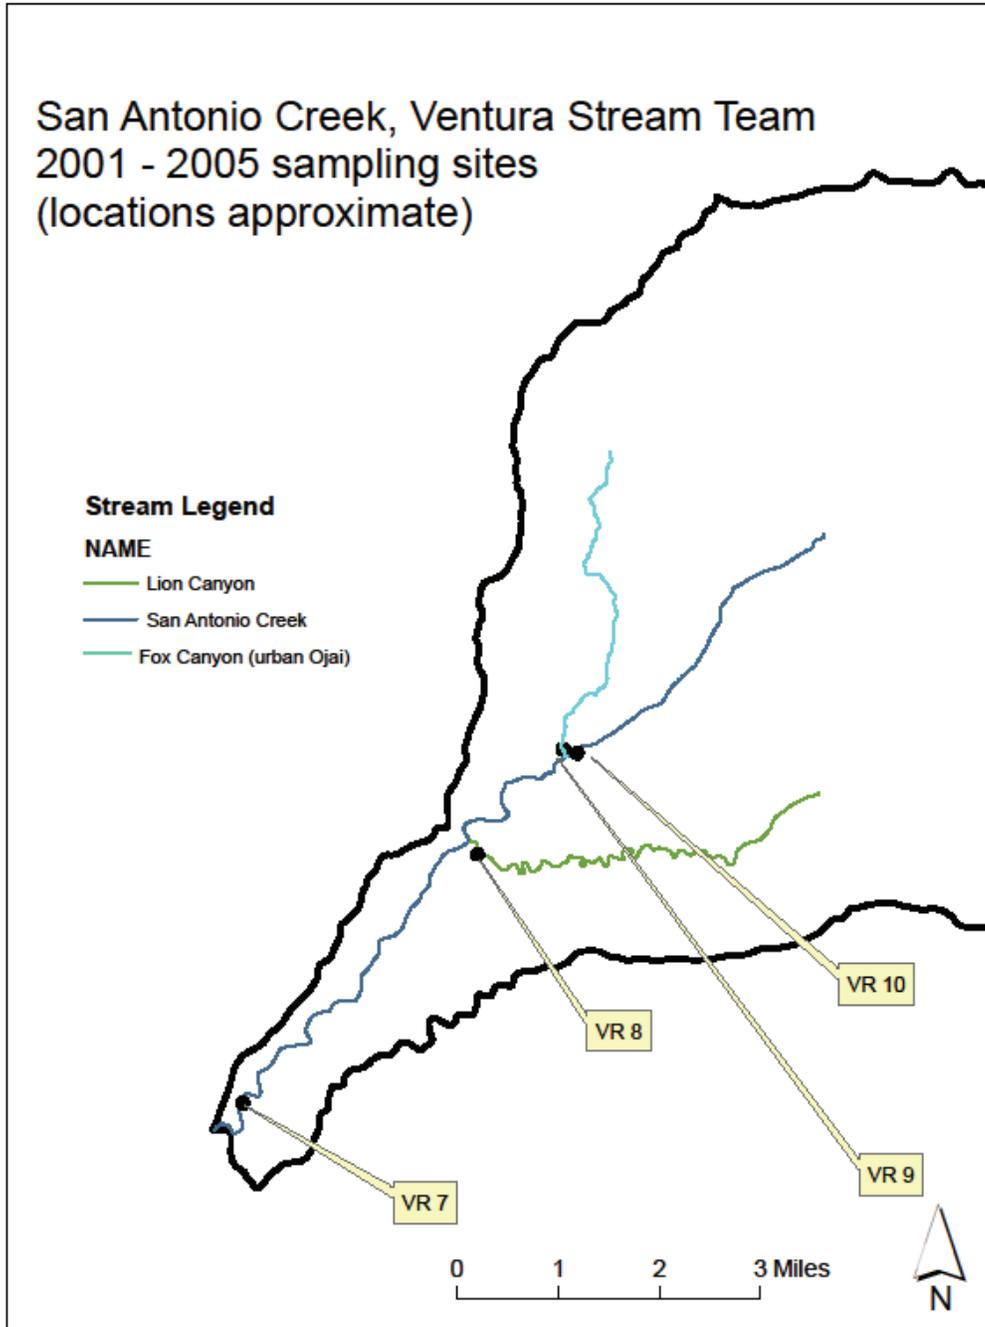
**Map 9:** Ventura River (VR) Stream Team sampling sites in the San Antonio Creek Watershed. Data is for 2001 to 2005.

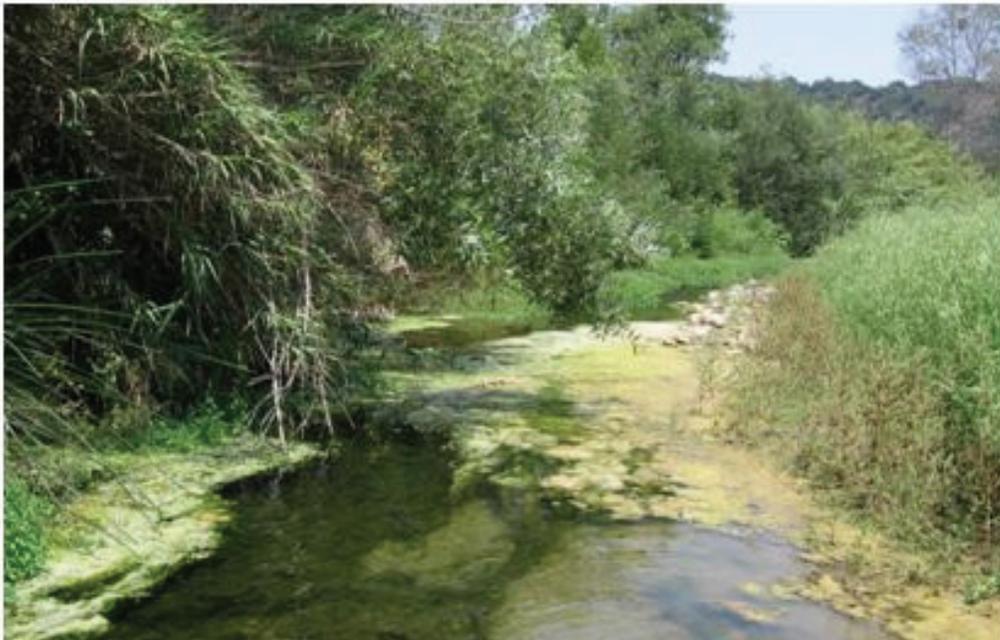
**Photograph 7:** San Antonio Creek near Ventura River, July 2008 (from [SBCK, 2008 figure 10](#)).

Dissolved oxygen (DO): For resident steelhead trout, a dissolved oxygen level above 8 mg/L is suggested. Minimum DO levels at Stream Team sample sites in the watershed were much too low by this standard. Dissolved oxygen is reduced by excessive algal growth, in turn induced by excessive nutrient concentrations. Dissolved oxygen is also reduced by higher water temperatures.

Analyses from across all Ventura River sample sites over time suggest that algae reduces dissolved oxygen most in late summer and early fall. The first major stream flows in the fall tend to flush much of the algae out, and algal re-growth is suppressed by both high water flows and low temperatures until spring. This seasonal effect suggests it is uncertain what effects algae and DO have on steelhead survival and reproduction.

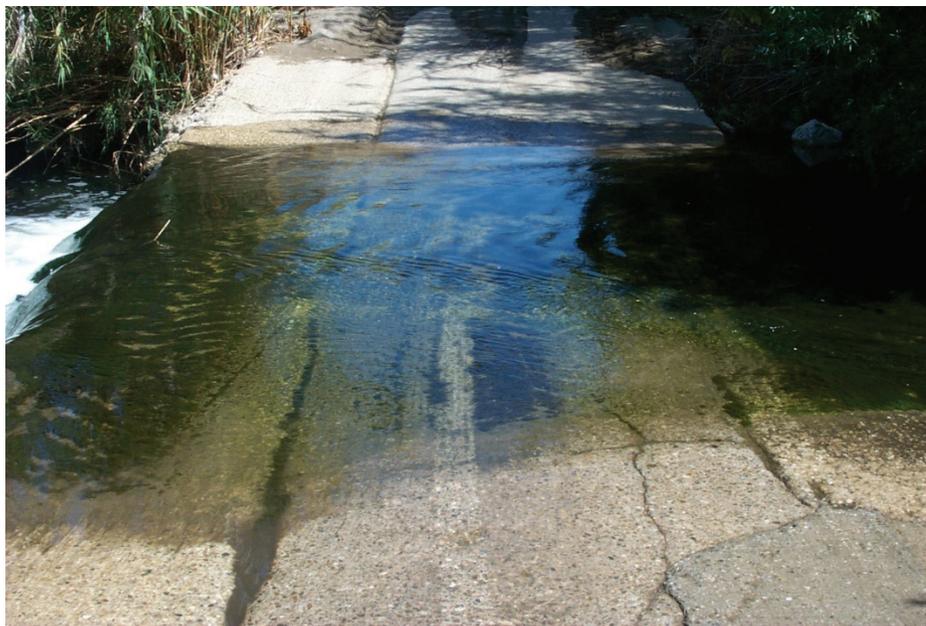
***Photograph 10:** Concrete low water crossing in the San Antonio Creek Watershed.*

Low water crossings are feasible for home owners because they are relatively inexpensive and require minimal maintenance. However, over time, the channel bed immediately downstream of the crossing tends to cut down, potentially causing a barrier for anadromous fish and other species. San Antonio Creek, from its confluence with the Ventura River to Ojai (Polakovic and Cooper, 1999), is known to support the anadromous Southern Steelhead Trout (*Oncorhynchus mykiss irideus*), an endangered subspecies (see **Steelhead Trout** section, this report).

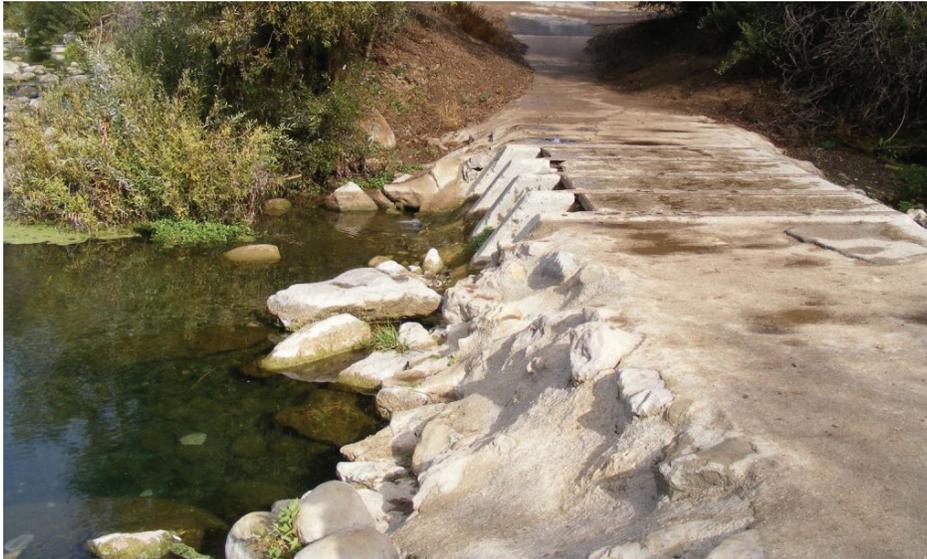
**Photograph 11:** Trail crossing, confluence of Ventura River and San Antonio Creek. It is designed to allow water to flow under the structure, minimizing scouring and down-cutting downstream from the structure.

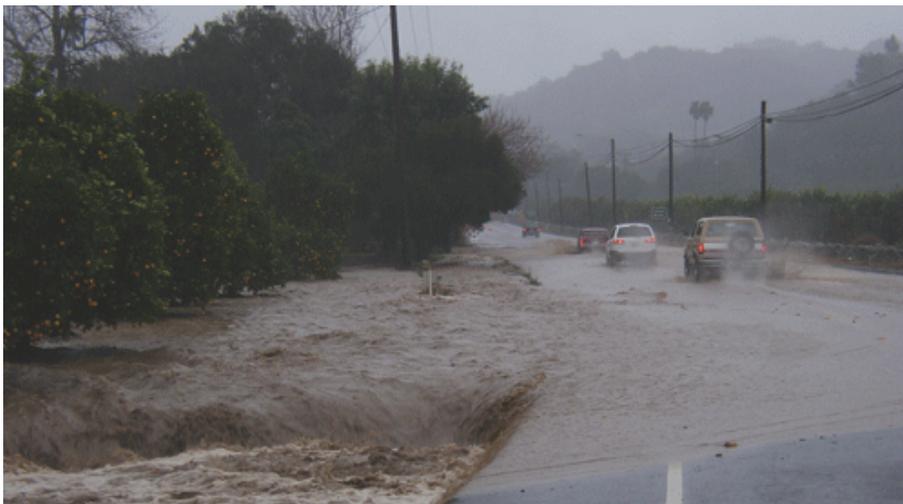
**Photograph 12:** An inundated road during a large storm in the watershed.

Home owners who do not have private roads which cross streams are often impacted as well during large storm events when public roads are inundated, as shown in Photograph 12. So, flooding and access is a community, as well as a private, concern.

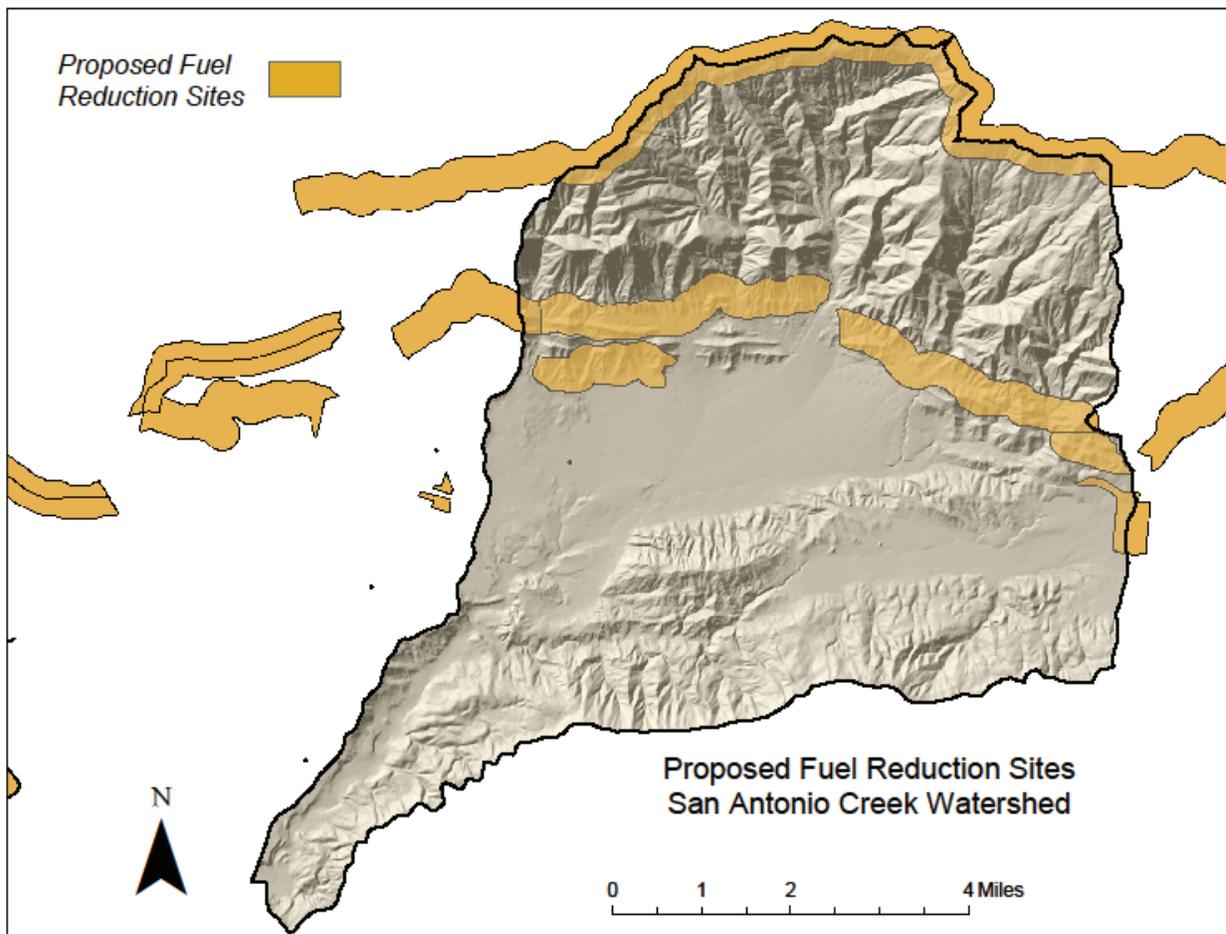
**Map 10:** Treatment areas displayed, using unpublished information provided by the [Ventura County Fire Department](#) (2008), are similar to but may not exactly match maps prepared by [USFS](#) (2008).

The Community Defense Zone Project focuses on maintaining existing fire breaks by removing vegetation through mechanical treatment, hand cutting, piling and burning, and burning (of cut vegetation) in place. Mechanical treatments include discing, crushing, and use of a brush rake or grappling hook (USFS, 2008, page 4). Creation and maintenance of fuel breaks slows down and reduces the intensity of wildfire in strategic areas, making it easier during a fire event to contain fires with a minimum of damage and hazard to human life.

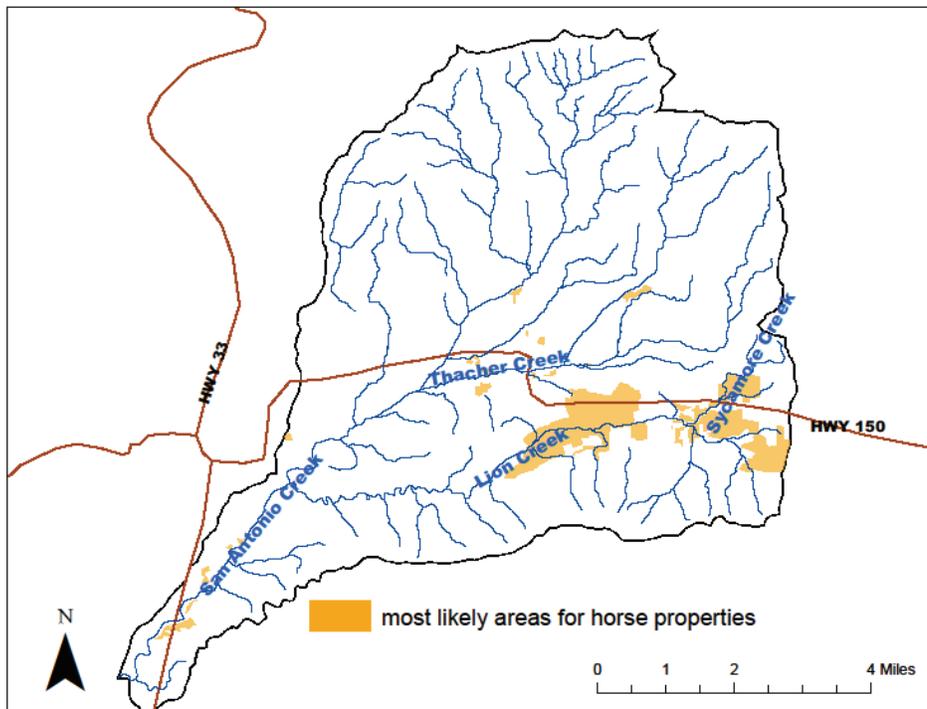
**Map 11:** Areas most likely to support horse properties, based on land-use and vegetative cover analyses.

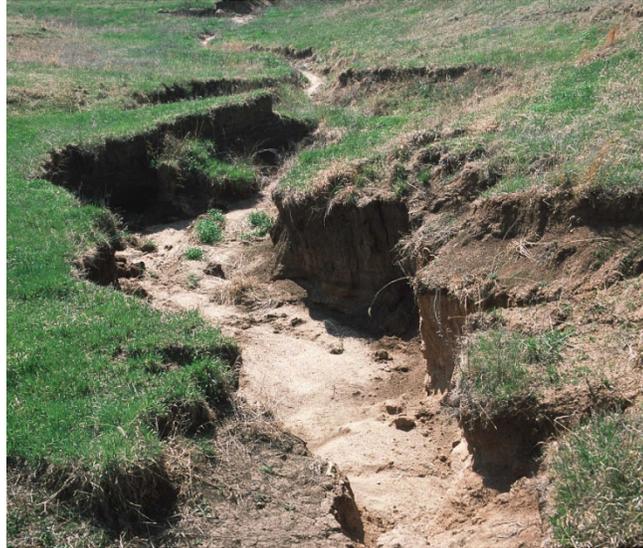
**Photograph 13:** [Gully erosion in pasture \(Kansas, 2002\).](#)

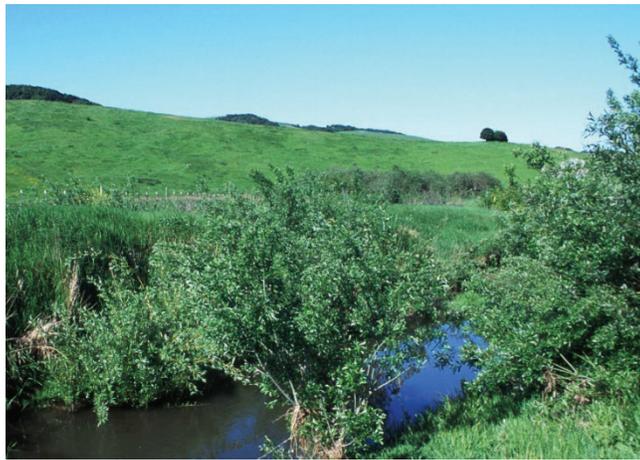
**Photograph 14:** [Buffered stream in pasture \(Sonoma County, CA, 2000\).](#)

Because of the potential impacts to wildlife habitat and water quality, streams and riparian areas are particularly sensitive to livestock impacts. In particular, where stream channels intersect properties supporting livestock, their impacts may need to be buffered, using fencing to control livestock access to streams. This will prevent manure and sediment from entering stream channels, and riparian vegetation is protected from over-grazing.

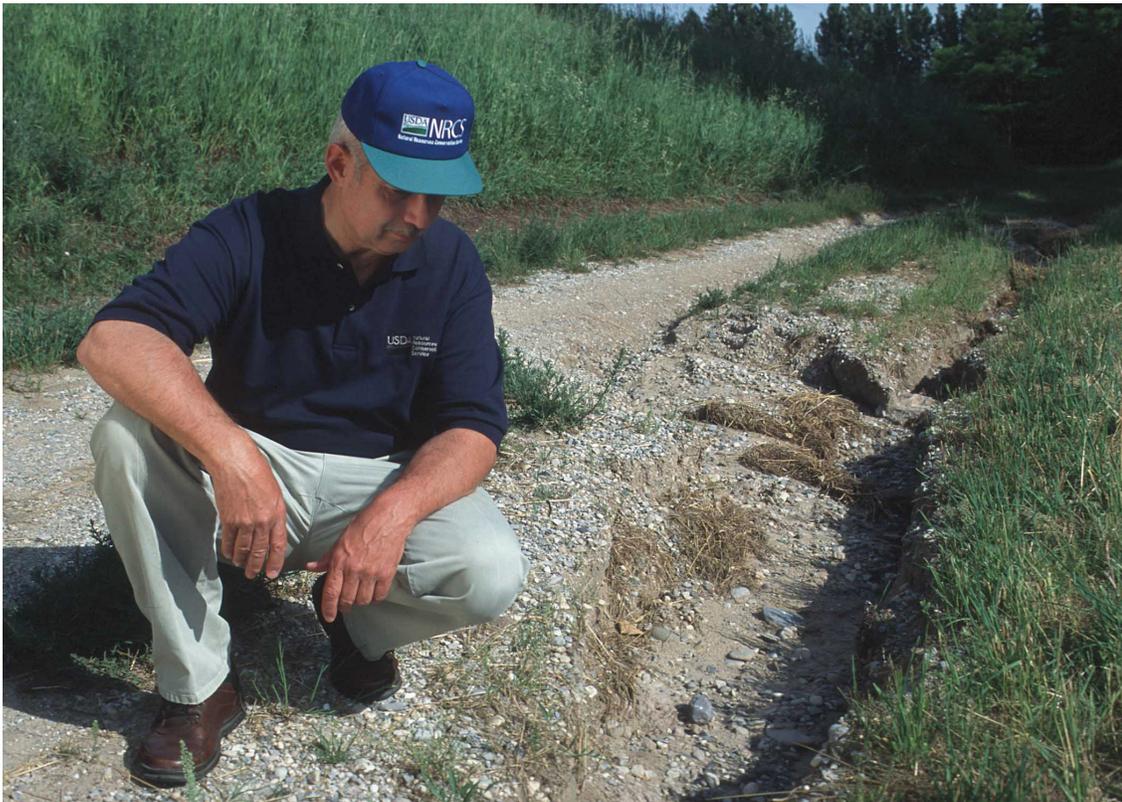
**Photograph 15:** [Eroded orchard access road, Michigan, 2002.](#)

Roads, even seldom-used dirt roads, are typically compacted. Because of that, storm-water tends to run across and down them. When this water is not accommodated by properly designed structures, such as water-bars, the results can be pot-holes, gullies, and erosion downstream where the water exits the road. This can threaten the road, nearby structures, and downstream values affected by sediment.

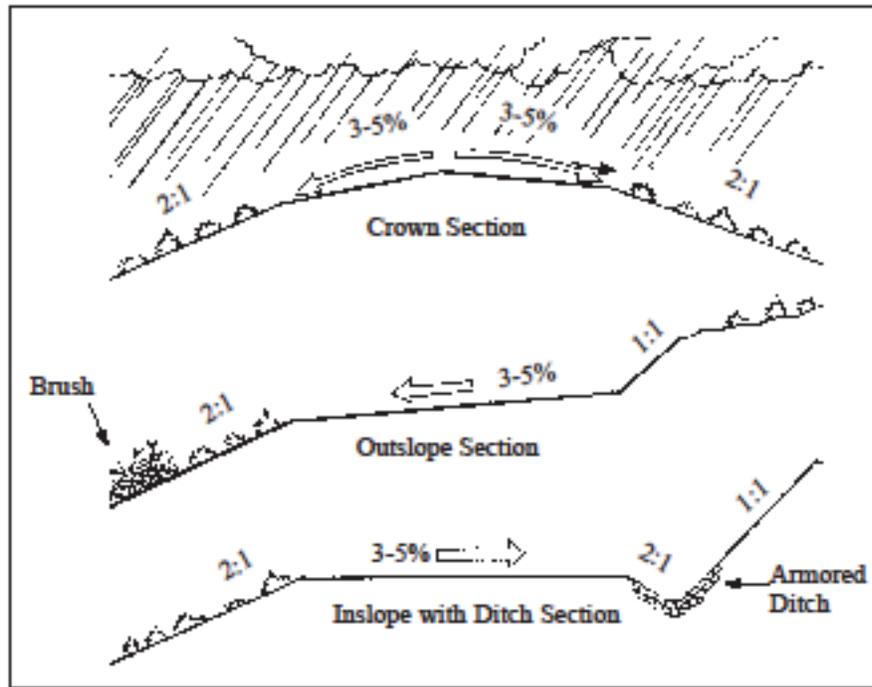
**Figure 3:** From Gordon & Sherar, (2003), page 54.  
[http://ntl.bts.gov/lib/24000/24600/24650/Index\\_BMP\\_Field\\_Guide.htm](http://ntl.bts.gov/lib/24000/24600/24650/Index_BMP_Field_Guide.htm)

The NRCS has practice standards and specifications for properly constructed access roads, to minimize maintenance and repair costs, ensure emergency access, and minimize environmental damage from eroding road surfaces. Links to other information is provided in the **Outreach** section and **Appendix F** of this report. Companion practices often recommended to support this practice are: Critical Area Planting, Stream Crossing, and Structures for Water Control.

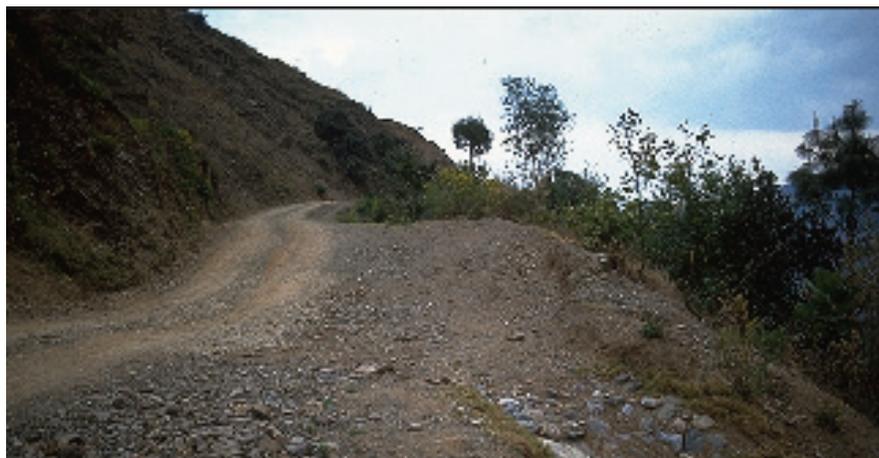
**Photograph 16:** From Gordon & Sherar, (2003), page 54.  
[http://ntl.bts.gov/lib/24000/24600/24650/Index\\_BMP\\_Field\\_Guide.htm](http://ntl.bts.gov/lib/24000/24600/24650/Index_BMP_Field_Guide.htm)

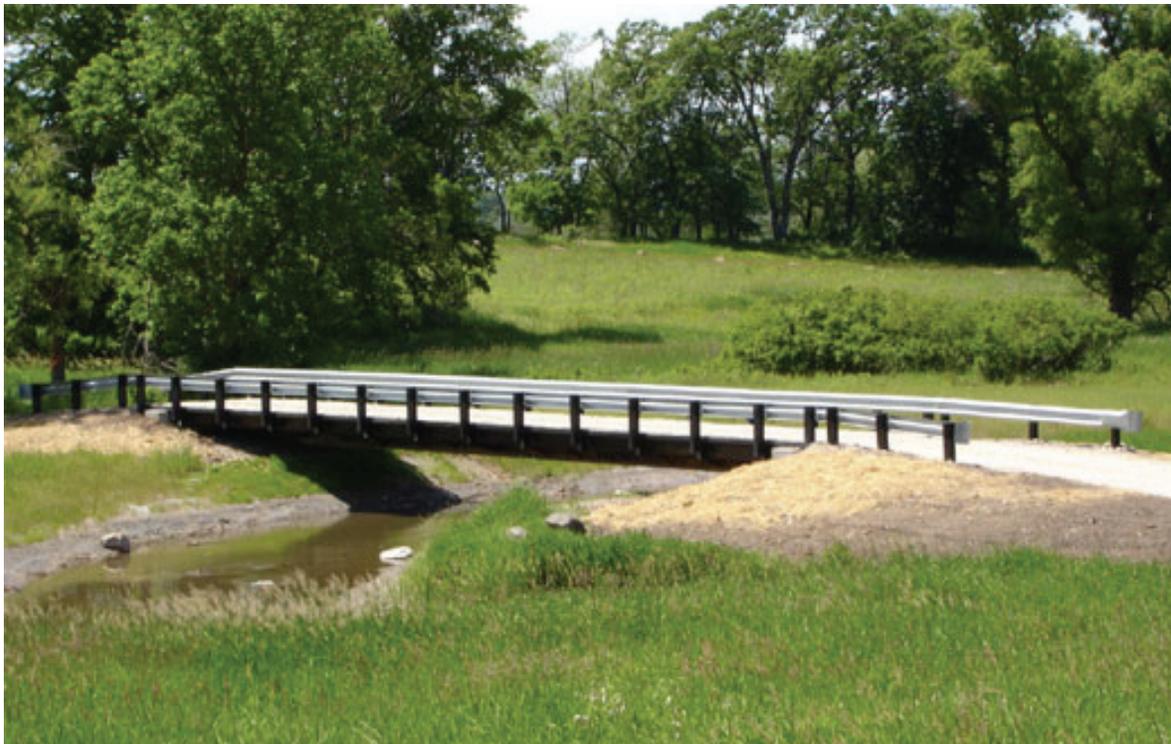
**Photograph 17:** Example of a railcar bridge, from outside of the San Antonio Creek Watershed.

In all cases, the bridge design should be checked and approved by a professional engineer to ensure that it can withstand the anticipated loads.

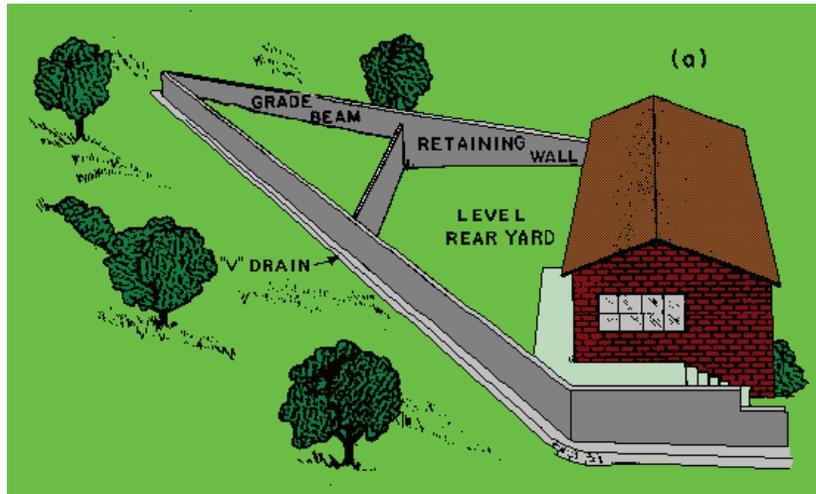
**Figure 4:** Diversion to protect home from sediment and debris, from Barrows et al., 2003, third page <ftp://ftp-fc.sc.egov.usda.gov/CA/programs/EWP/MudslideHazards.pdf>

Homes located on alluvial fans are subject to some risk of damage from debris and sedimentation, particularly during major storms. Home sites immediately at the base of steep slopes or near existing drainages typically have the highest risk of damage. An alternative for protecting homes and structures includes the installation of diversions. The figure below depicts a proposed diversion used for protecting homes from sediment and debris (Barrows, et al., 2003; Hollingsworth and Kovacs, 1981):
