FEBRUARY 12, 1992 FLOOD:
VENTURA BEACH RV RESORT

A SPECIAL REPORT
SUBMITTED BY FRIENDS OF THE VENTURA RIVER
TO THE
SAN BUENAVENTURA CITY COUNCIL

April 20, 1992

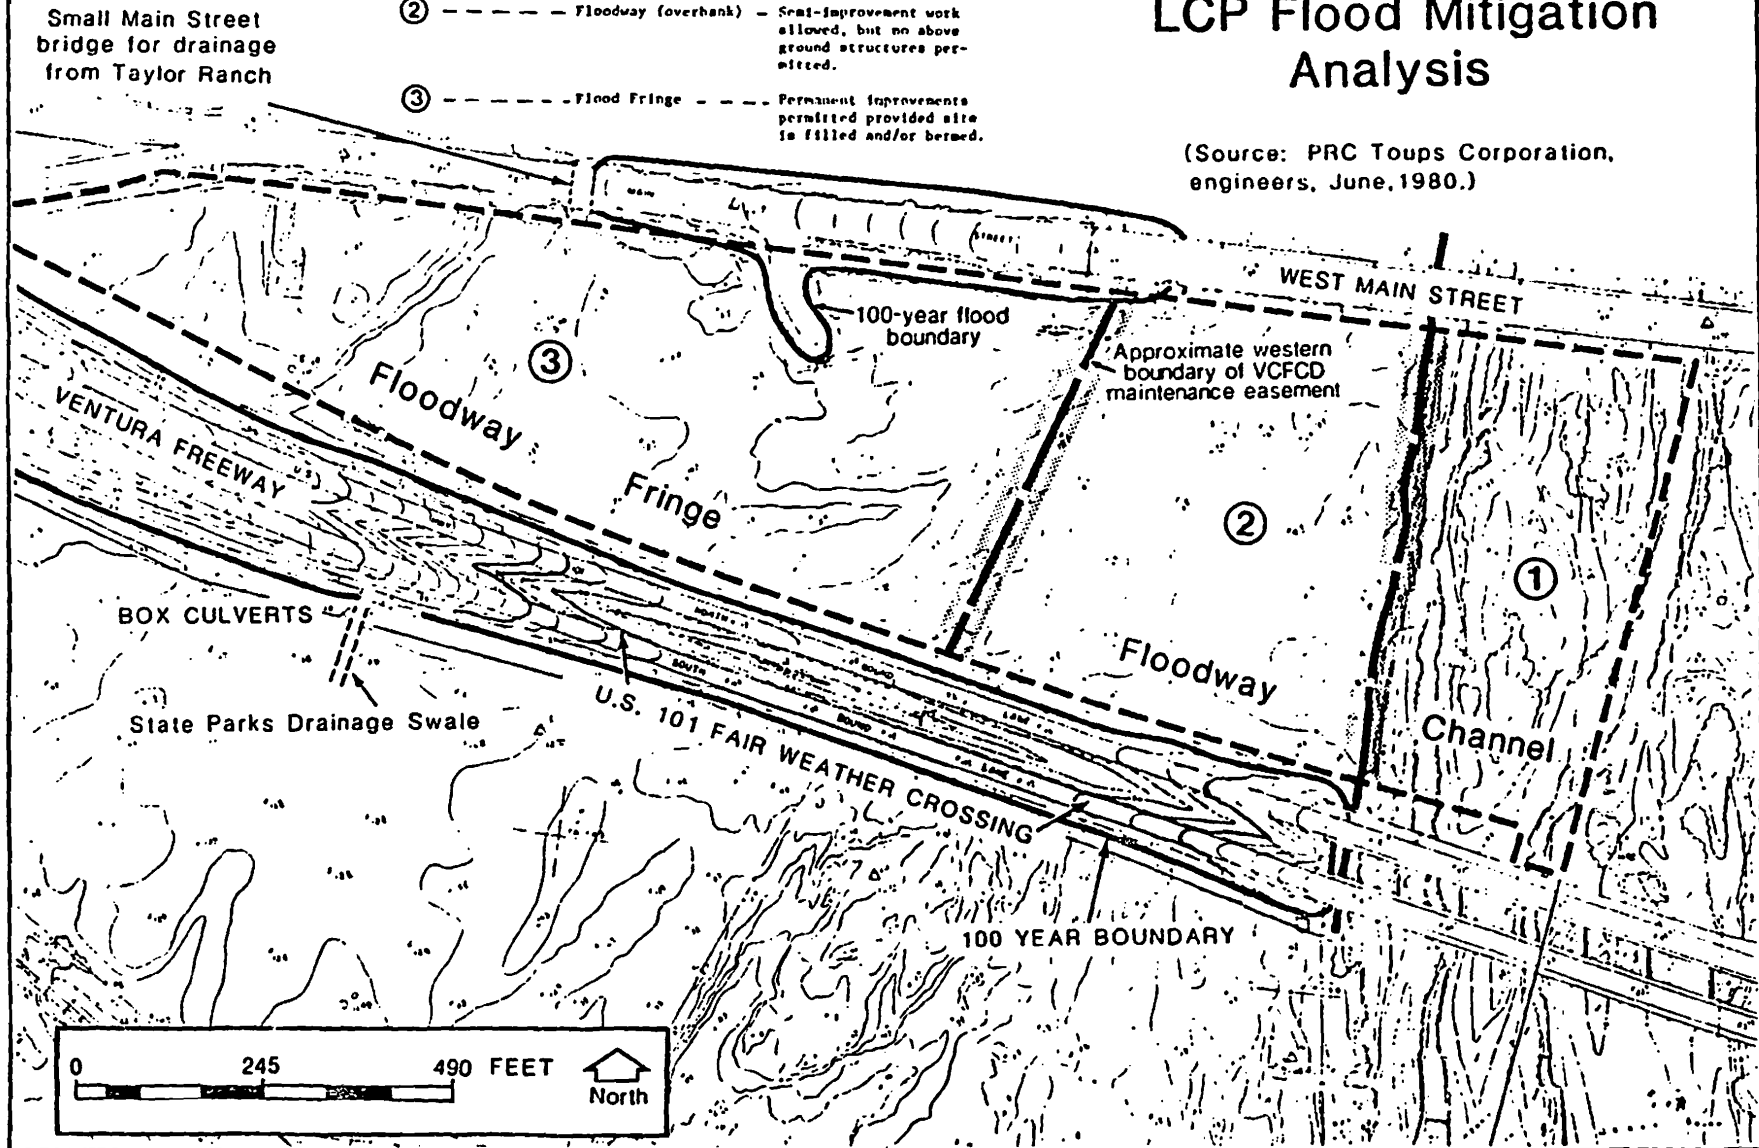
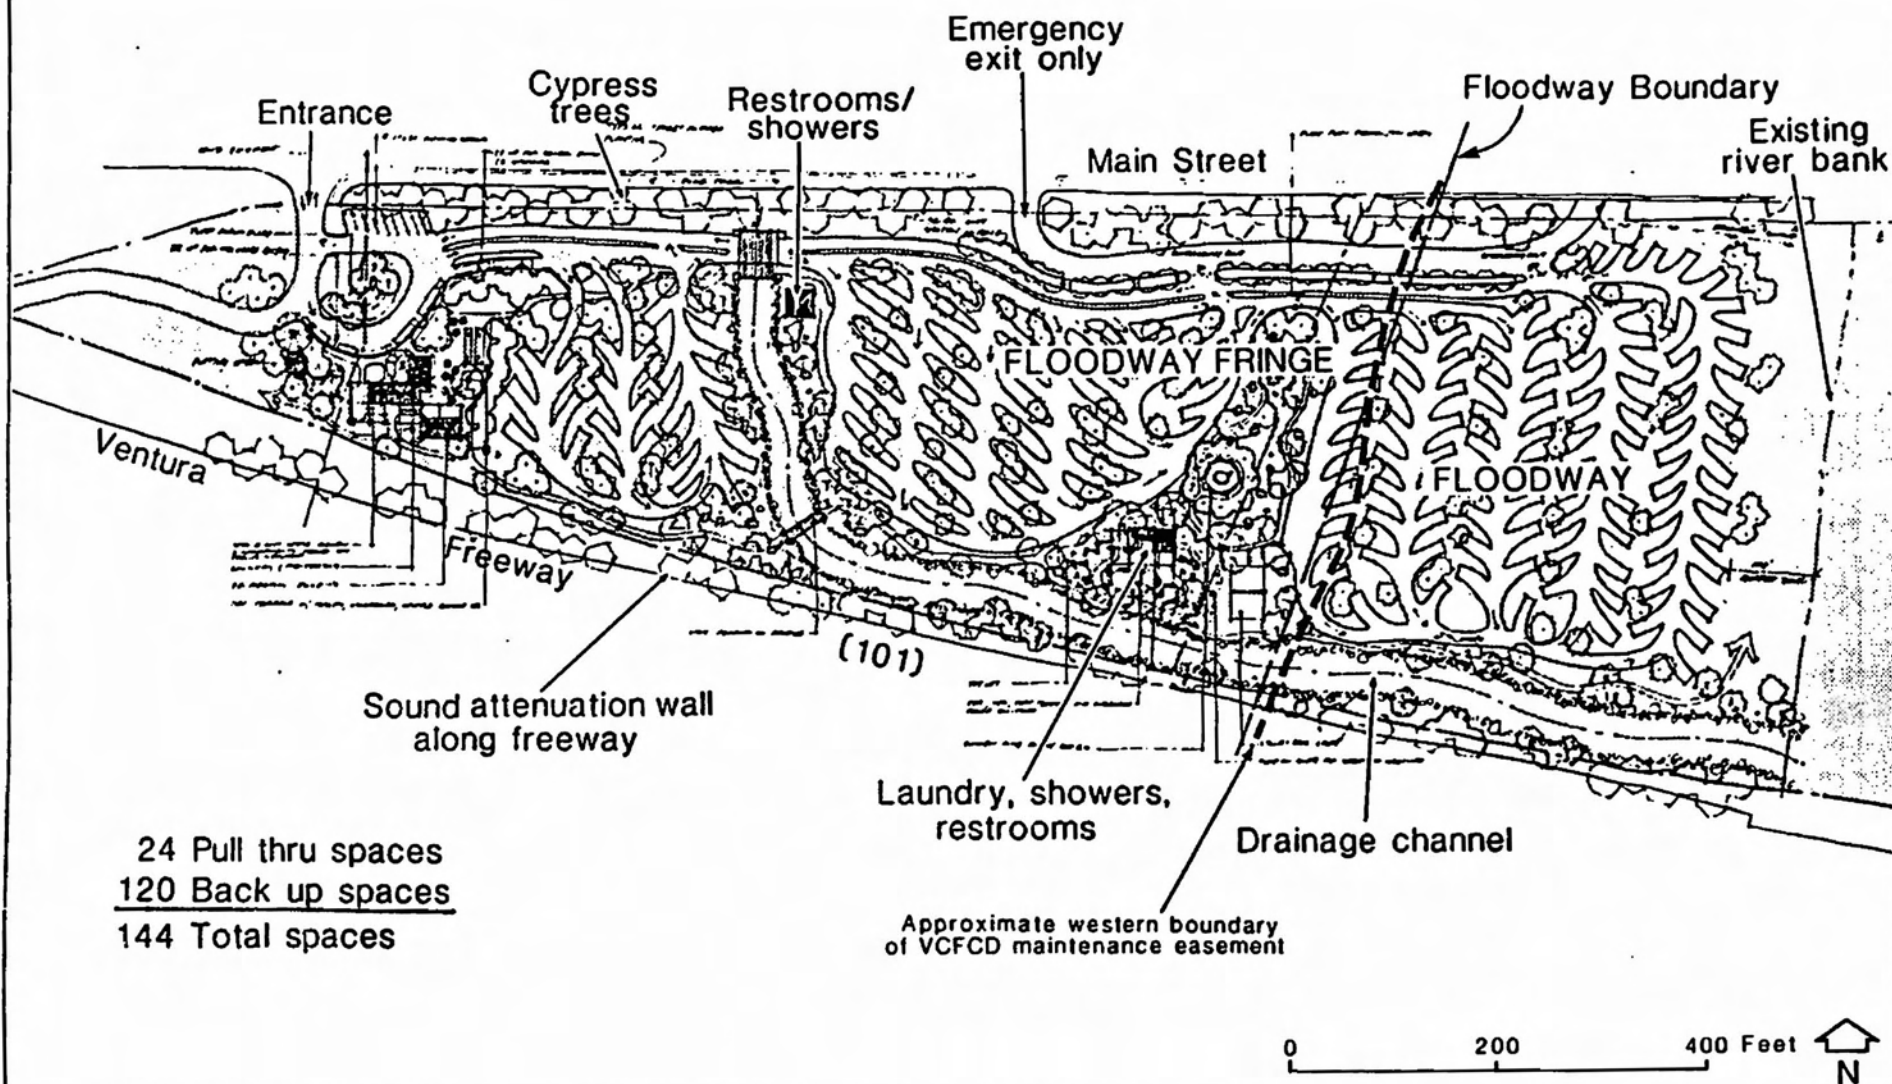
FLOODWAY MAP

FLOOD MITIGATION ANALYSIS

Area	Designation	Improvement Status
①	----- Main Channel Waterway	None permitted
②	----- Floodway (overbank)	Semi-improvement work allowed, but no above ground structures permitted.
③	----- Flood Fringe	Permanent improvements permitted provided site is filled and/or bermed.

LCP Flood Mitigation Analysis

(Source: PRC Toups Corporation, engineers, June, 1980.)

The analysis misrepresented the nature of flooding patterns by misapplying the Federal Emergency Management Agency (FEMA) flood insurance terminology "floodway" and "floodway fringe" to the project site, using them for planning purposes for which they were not originally intended.

The term "floodway" is a technical term used by FEMA to designate a **lateral** area into which a discharge from a 100 year frequency storm can be squeezed without increasing the **vertical** height of the flood flow more than one (1) foot. Significantly, this term does not designate those areas which will be inundated **only** during a 100 year frequency storm. Similarly, the term "floodway fringe" is a technical term used to designate that portion of the natural 100 year flood plain which would be **theoretically** left dry after squeezing the 100 year flood flow into the "floodway". It does not designate that portion of the flood plain which is necessarily less prone to flooding.

Both of the terms are artificial in the sense that they do not purport to describe the **natural** pattern of flooding, but rather areas in which flood flows can be **artificially** channeled. They specifically were not intended to describe the pattern of flooding in either braided channels or on deltas with a system of distributary channels such as displayed by the Ventura River. Nevertheless both terms were used throughout the planning and decision making process to designate areas on the Ventura Beach RV Resort which would experience projected levels of flooding under uncontrolled conditions.

It must be emphasized that the "floodway fringe" areas are **not** necessarily less susceptible to flooding than "floodway areas: they are simply, and only theoretically, what is left of the flood plain for development without special flood insurance requirements when a 100 year frequently flood is squeezed laterally into the point where its vertical rise is no more than one (1) foot.

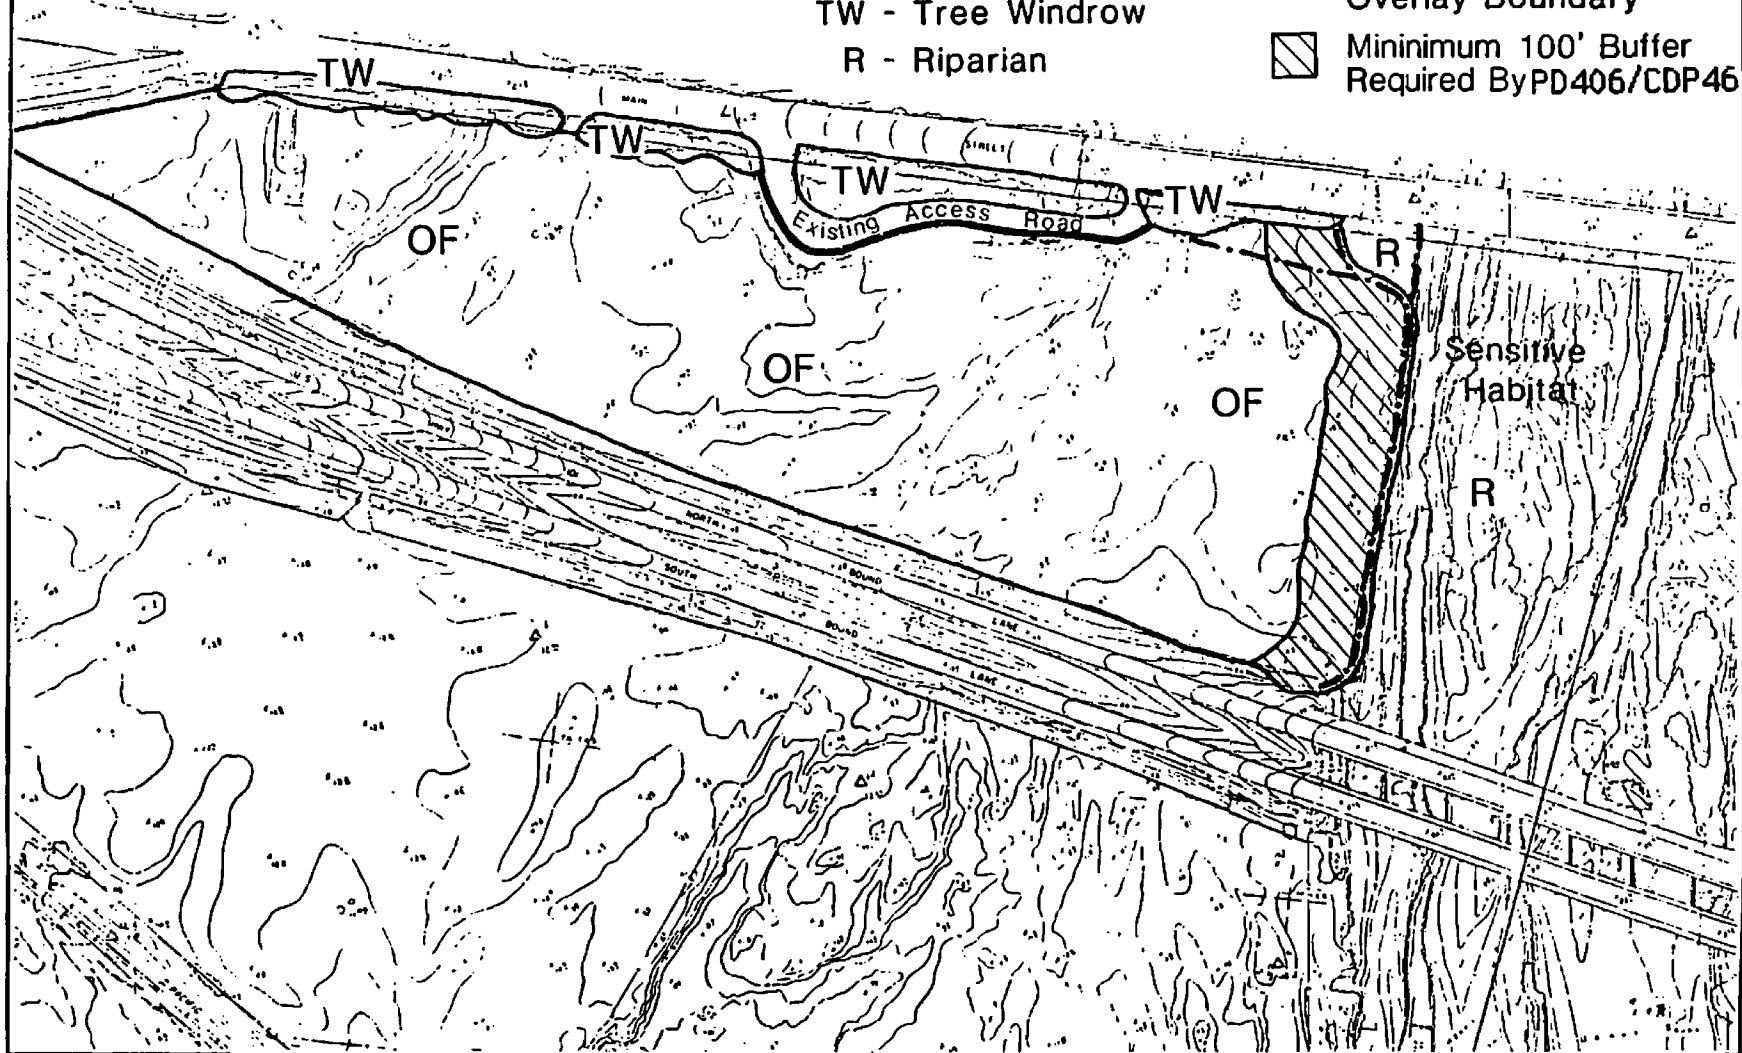
Site Plan

ONSITE VEGETATION

OF - Old Field
TW - Tree Windrow
R - Riparian

--- Sensitive Habitat
Overlay Boundary

▨ Minimum 100' Buffer
Required By PD406/CDP46

2. Permit Compliance. Vigorously pursue violations associated with the operation of the Ventura Beach RV Resort including: (a) the unpermitted placement of 26,000 cubic yards of soil within the designated buffer area adjacent to the main Ventura River channel; and (b) the unauthorized length of stay of patrons in the Ventura Beach RV Resort.
