CHAPTER 3: HYDROLOGY

Hydrology Overview

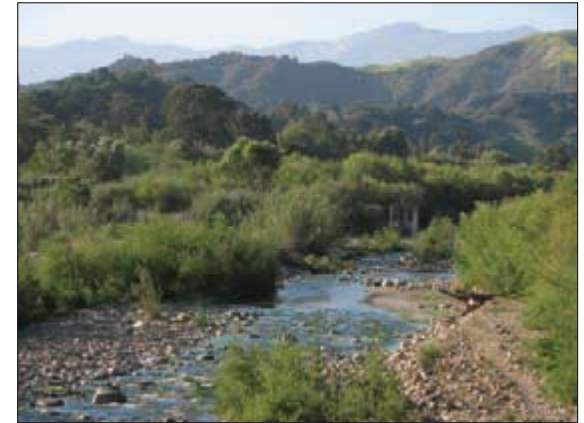
FIGURE 3.2 *Looking upstream from the top of the proposed parkway corridor.*

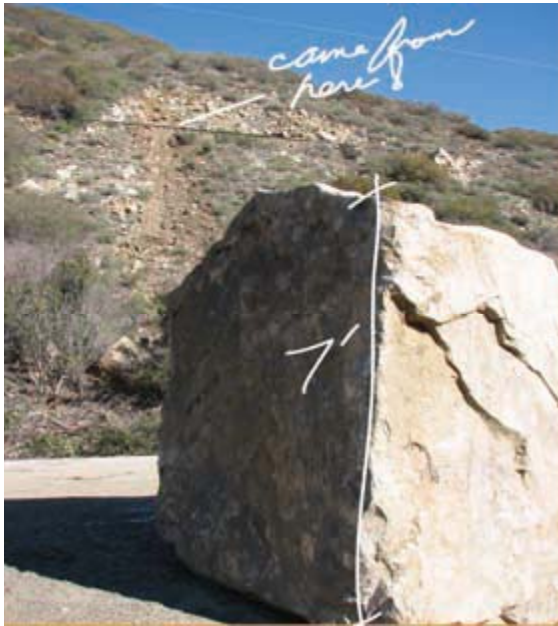
FIGURE 3.10 Tectonic uplift, steep slopes and soft sandstone bedrock result in a lot of rock moving in the upper watershed. This boulder appeared overnight in the road above Matilija Dam.

rocks to detach from the slopes (Scott and Wouldiams 1978, cited in Greimann 2006) (figure 3.10).

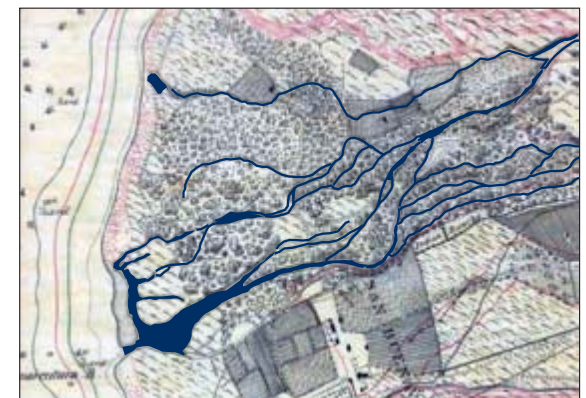
FIGURE 3.12 This 1855 map of approximately the lowest mile of the Ventura River shows its naturally braided character. Map: Museum of Ventura County (highlighting added).

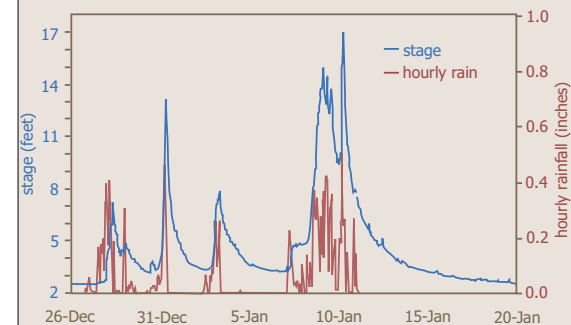
FIGURE 3.13 Flood hydrograph at Foster Park, December 2004 – January 2005. Adapted from Leydecker 2006.

A hydrograph is a way of showing visually how long it takes for floods to build up in response to rain. The example below compares the intensity of rainfall (in red) with the flood stage (water height, in blue) in the Ventura River at Foster Park during the December 2004–January 2005 flood event. Once watershed soils were saturated by the earliest stages of the rainstorm, dramatic changes in flood height followed almost immediately after corresponding changes in rainfall. This illustrates the flashy character of the river. Urban development, with its increase in storm water runoff, can aggravate this effect. However, this data was recorded at Foster County Park, upstream from most urban development in the watershed, and it illustrates a natural condition.

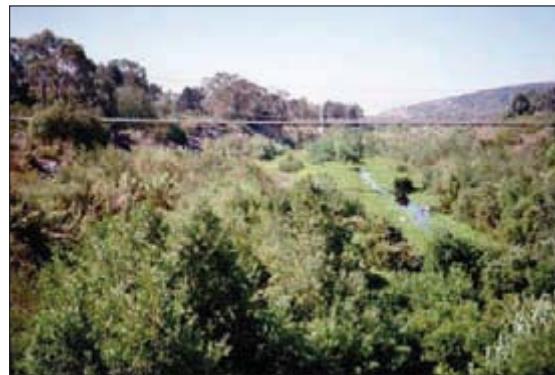
FIGURE 3.15 Flood scouring. Looking downstream at the Ventura River from Shell Road on October 2, 2004 and February 2, 2005, before and after the flood event in early 2005. Photo source: Leydecker 2006.

Frequent high-energy flood events – the result of extreme rainfall variability in the watershed – have a dramatic cyclical effect on the form of the Lower Ventura River and its habitat. On an average of every seven years (the actual historical interval has varied from three to thirty years), a flood event occurs that is forceful enough to scour the banks and beds of the channels and the floodplain around them, removing gravel, fine sediment, and aquatic life from the river bottom and also removing most riparian vegetation from the banks and sections of the floodplain. The result is a combination of higher water temperature (due to absence of canopy), the release of high concentrations of nutrients (nitrogen and phosphorus) that have accumulated in groundwater prior to the wet season, and the disappearance of gravel and sediment exposing larger stones and bedrock.

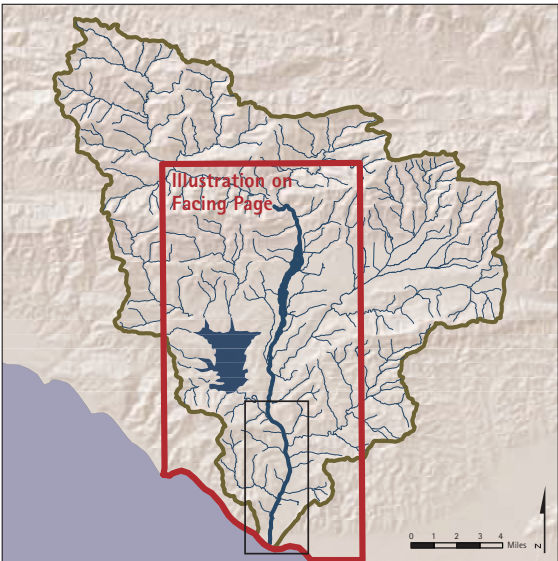
- ① Matilija Dam
- ② Robles Diversion Dam
- ③ Debris Basins (approximate locations)
- ④ Casitas Lake and Dam
- ⑤ Foster Park Wells/Groundwater Dam
- ⑥ Ventura Water Plant and Ojai Valley Wastewater Plant
- ➔ Storm Drains into Ventura River
- Levees
- Robles Diversion Canal
- Concrete Channel or Culvert

[FACING PAGE AND ABOVE] FIGURE 3.16 The illustration on the facing page shows major structures altering the function of the Ventura River. The diagram above locates the illustration within the watershed. Orthophotography from CIRGIS.

Three major levees (figure 3.16), at the community of Live Oak, the community of Casitas Springs, and the city

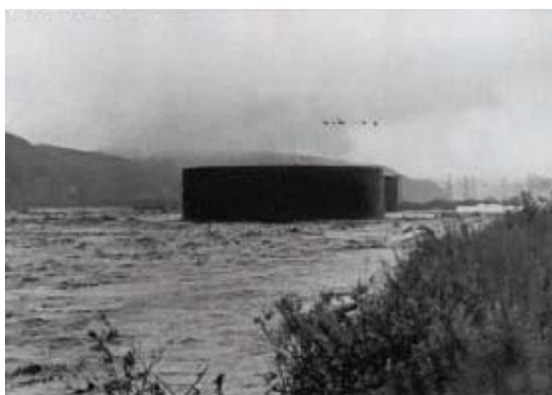
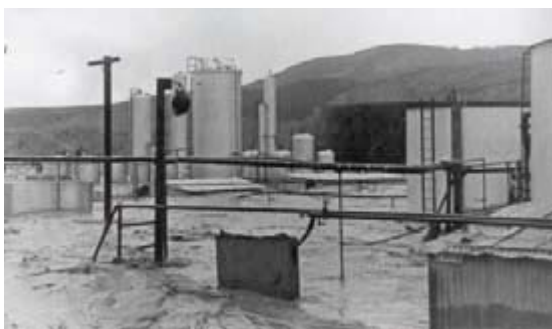
FIGURE 3.18. *The 1938 flood was smaller than several events that have occurred during the past twenty years. However, it caused over one million dollars in damage (URS 2004) and inundated oil fields along Ventura Avenue. Nine years later, the Army Corps of Engineers completed construction of a levee to protect structures that intruded on the floodplain in this area and in the city of Ventura to the south. Photos: Museum of Ventura County; Ventura County Star.*

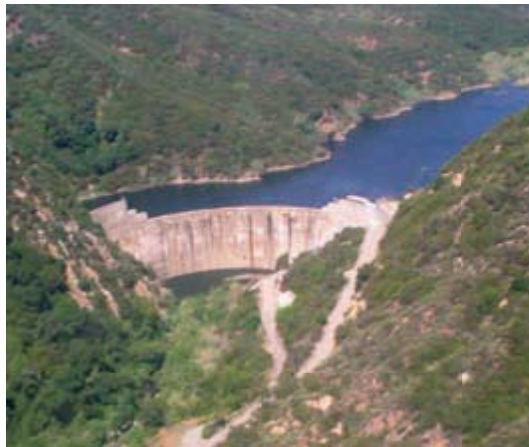
FIGURE 3.20 Matilija Dam, approximately ten miles upstream from the top of the proposed parkway area, holds back approximately 53% of the sediment that would otherwise flow in the Ventura River. Photo: Greimann 2006.

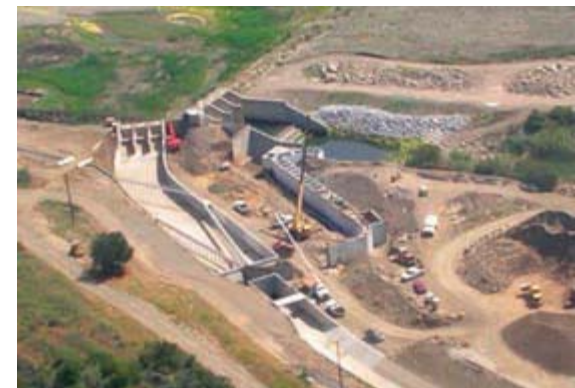
FIGURE 3.21 The Robles Diversion Dam removes up to 500 cubic feet per second of surface water from the Ventura River approximately eight miles upstream from the proposed parkway area. The canal to Casitas Lake can be seen leading from the diversion structure on the left. To the right of that diversion is a fish passage facility constructed in the mid-1990s. Photo: Greimann 2006.

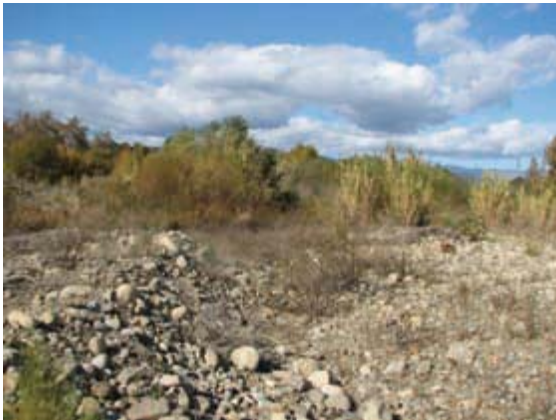
FIGURE 3.22 During dry months, the Lower Ventura River often runs dry on the surface in some areas downstream from the Los Robles diversion dam. Some groundwater still flows under the surface.

During the dry months in late summer and fall, the Lower Ventura River often runs dry on the surface in some areas downstream from the Robles diversion dam.

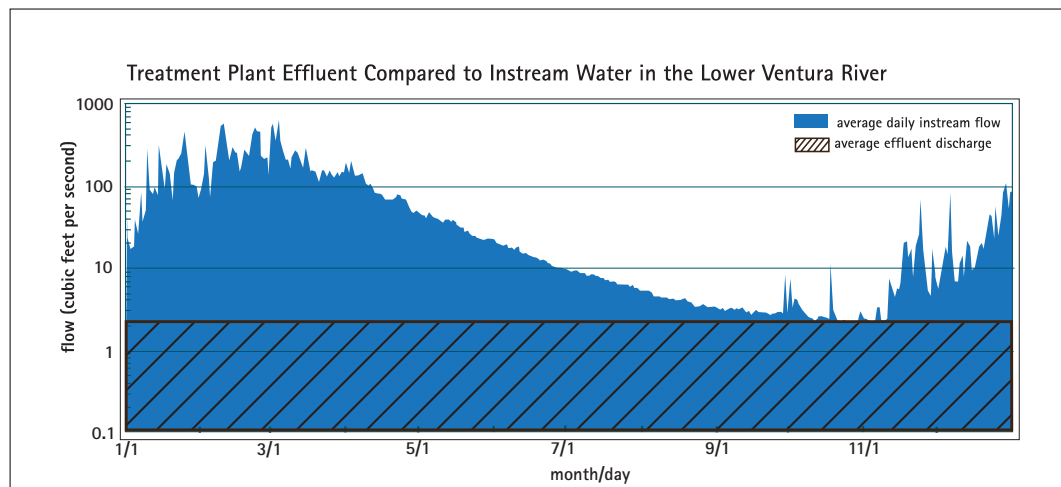
FIGURE 3.28 Comparison of average wastewater treatment plant effluent and average instream flow. During dry periods, effluent may make up a large percentage of the water in the lower river. Adapted from Cappelli 1997; RWQCB 2003; Ventura County Watershed Protection District.

Effluent from the Ojai Sanitation District Water Treatment Plant makes up two-thirds or more of water in most of the Lower River during dry summer and fall conditions, making the temperature of that effluent a critical factor for water quality during the dry season. When the discharge permit for the Plant was renewed in 2003 by the Regional Water Quality Control Board (CRWQCB-LA), the Board found that despite a major engineering upgrade during the 1990’s, “the data from the downstream station showed much less of the diurnal character” of natural stream water for both dissolved oxygen and temperature, and the temperature difference between water upstream and downstream of the Plant exceeded five degrees Fahrenheit. The Board concluded that
