APPENDIX A

PRELIMINARY SITE SPECIFIC ALTERNATIVES EVALUATION

Wheeler Gorge Campground – Lower North Fork Matilija Creek Crossing

Wheeler Gorge Campground – Bear Creek Crossings

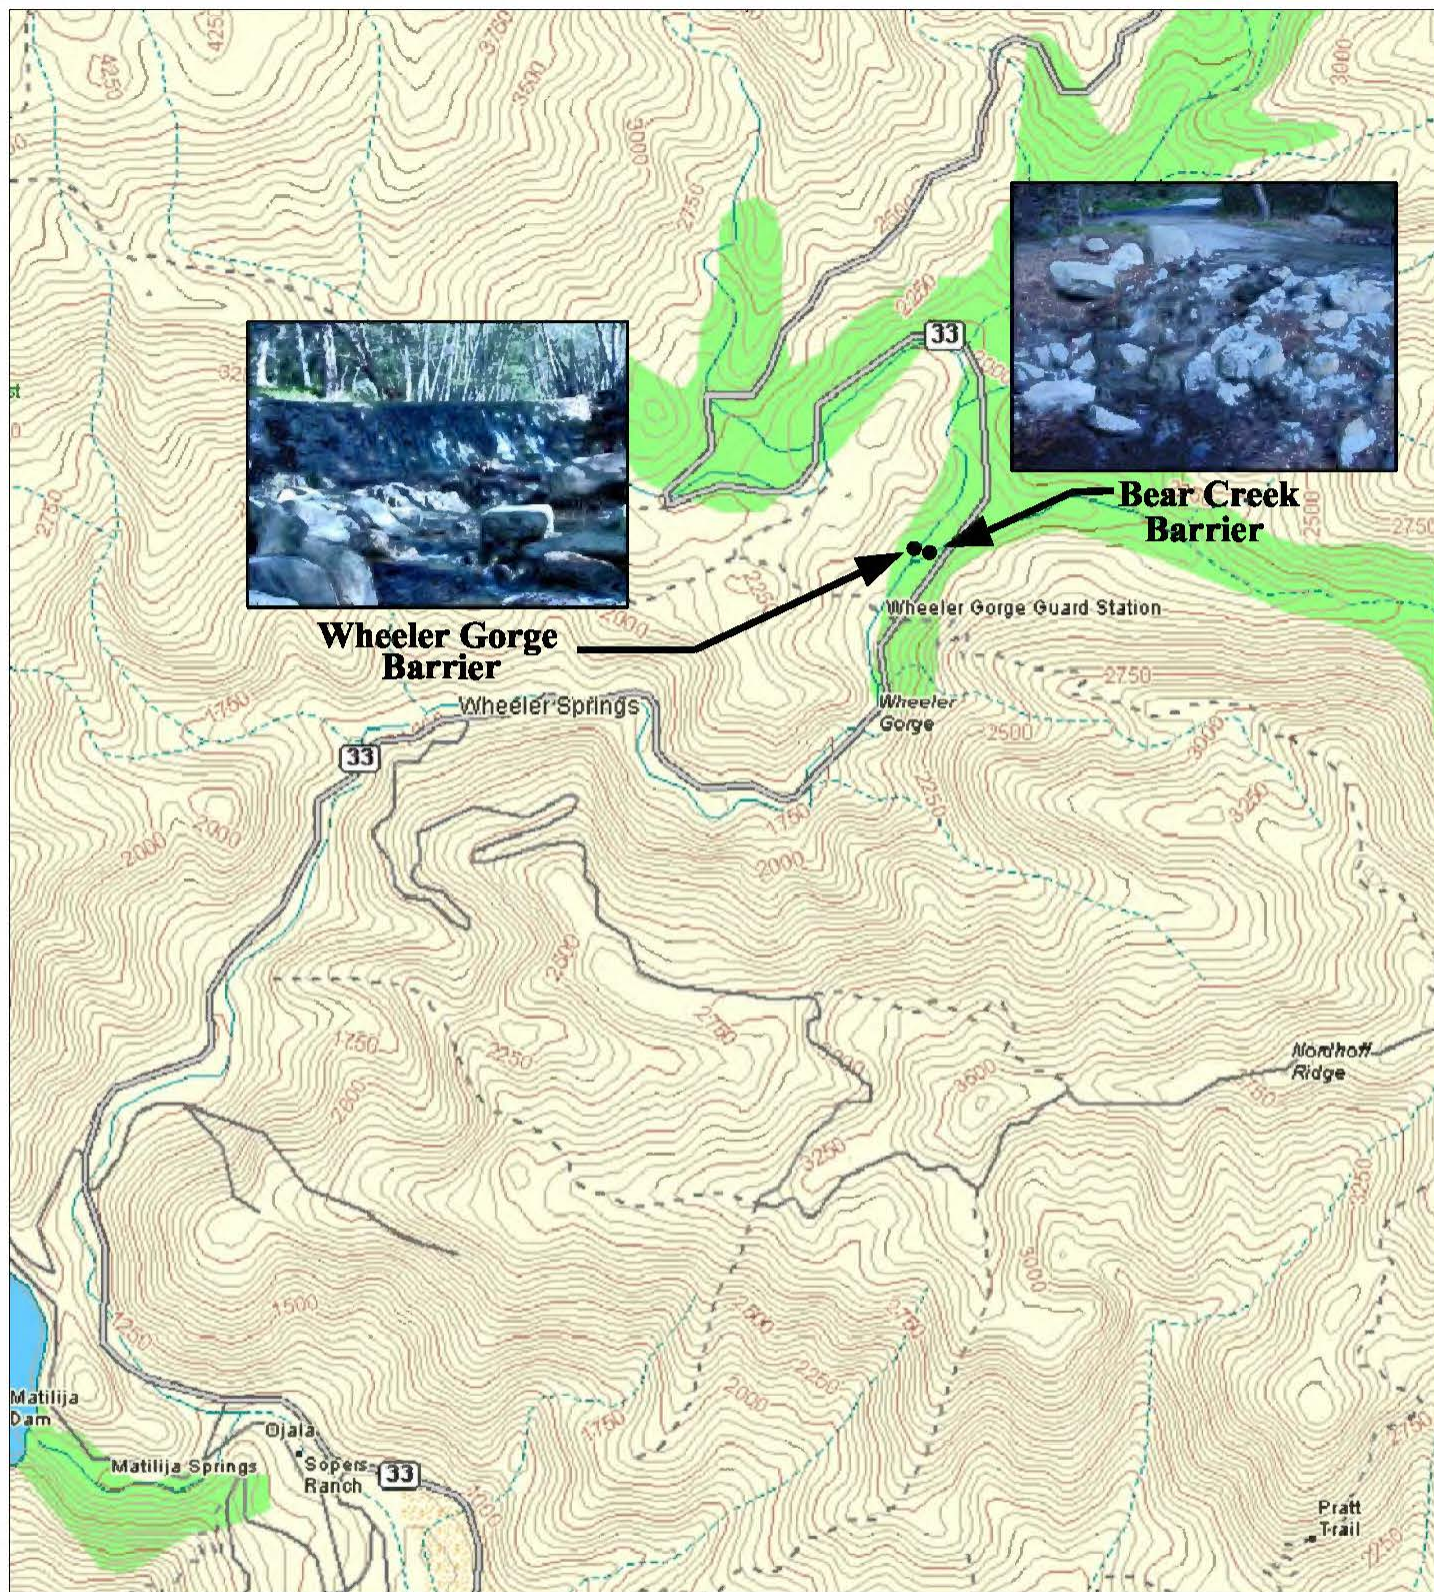
FIGURE A-1

**Location of North Fork Matilija and
Bear Creek Fish Passage Barriers**

The access road within the Wheeler Gorge Campground (Figure A-1) crosses North Fork Matilija Creek at three locations (Figure A-2). The downstream-most crossing is a bridge and does not impede steelhead movement. The other two crossings are both low-flow crossings designed for water to pass over the surface of the road at higher flows and for the road to be passable only at lower flows. The downstream low-flow crossing represents a complete barrier to fish passage (Photos 23 and 24) and the upstream road crossing represents a partial barrier with passage likely at moderate and higher flows. The downstream crossing consists of an “Arizona” or “fairweather” type crossing which is constructed of concrete. The road crossing is approximately 45 feet long and a near vertical (approximately 0.5:1 slope) concrete apron is situated along the downstream edge of the road crossing. The road crossing presents a physical barrier to passage as the road surface is situated approximately 12 feet above the downstream streambed.

The access road within the Wheeler Gorge Campground crosses Bear Creek at two locations (Figures A-1, A-2). Both of the road crossings represent partial barriers to fish passage (Photo 25). Enhancement of fish passage across the downstream crossing could be addressed during the construction of the bypass channel for enhanced passage in North Fork Matilija Creek and therefore a description of this barrier was provided in Section 2.1.2 above. Both barriers on Bear Creek are “Arizona” or “fairweather” type road crossings and therefore their alternatives for modification are similar. The text below focuses on describing the upper Bear Creek crossing although the alternatives are applicable to both crossings.

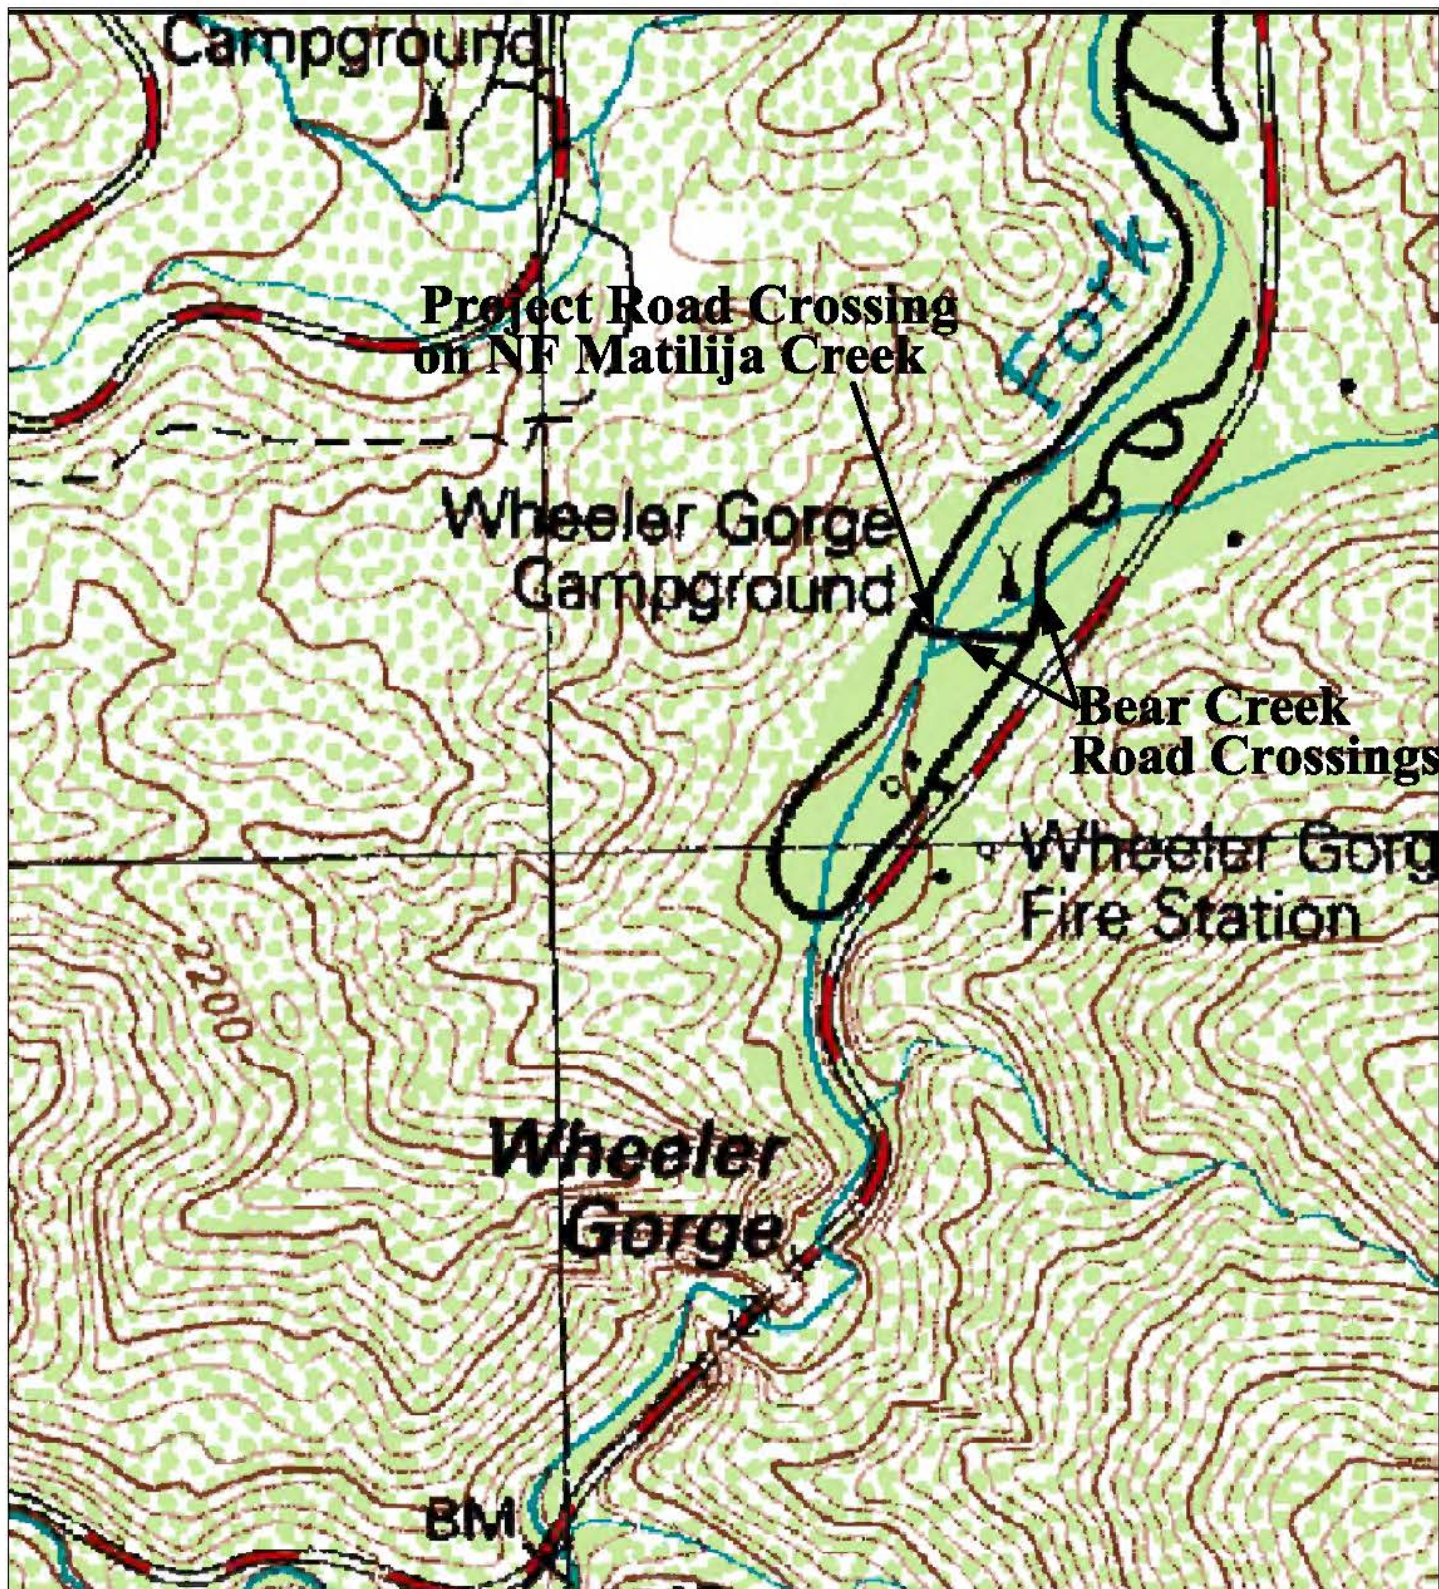
FIGURE A-2

**Site Map of North Fork Matilija and
Bear Creek Passage Barriers**

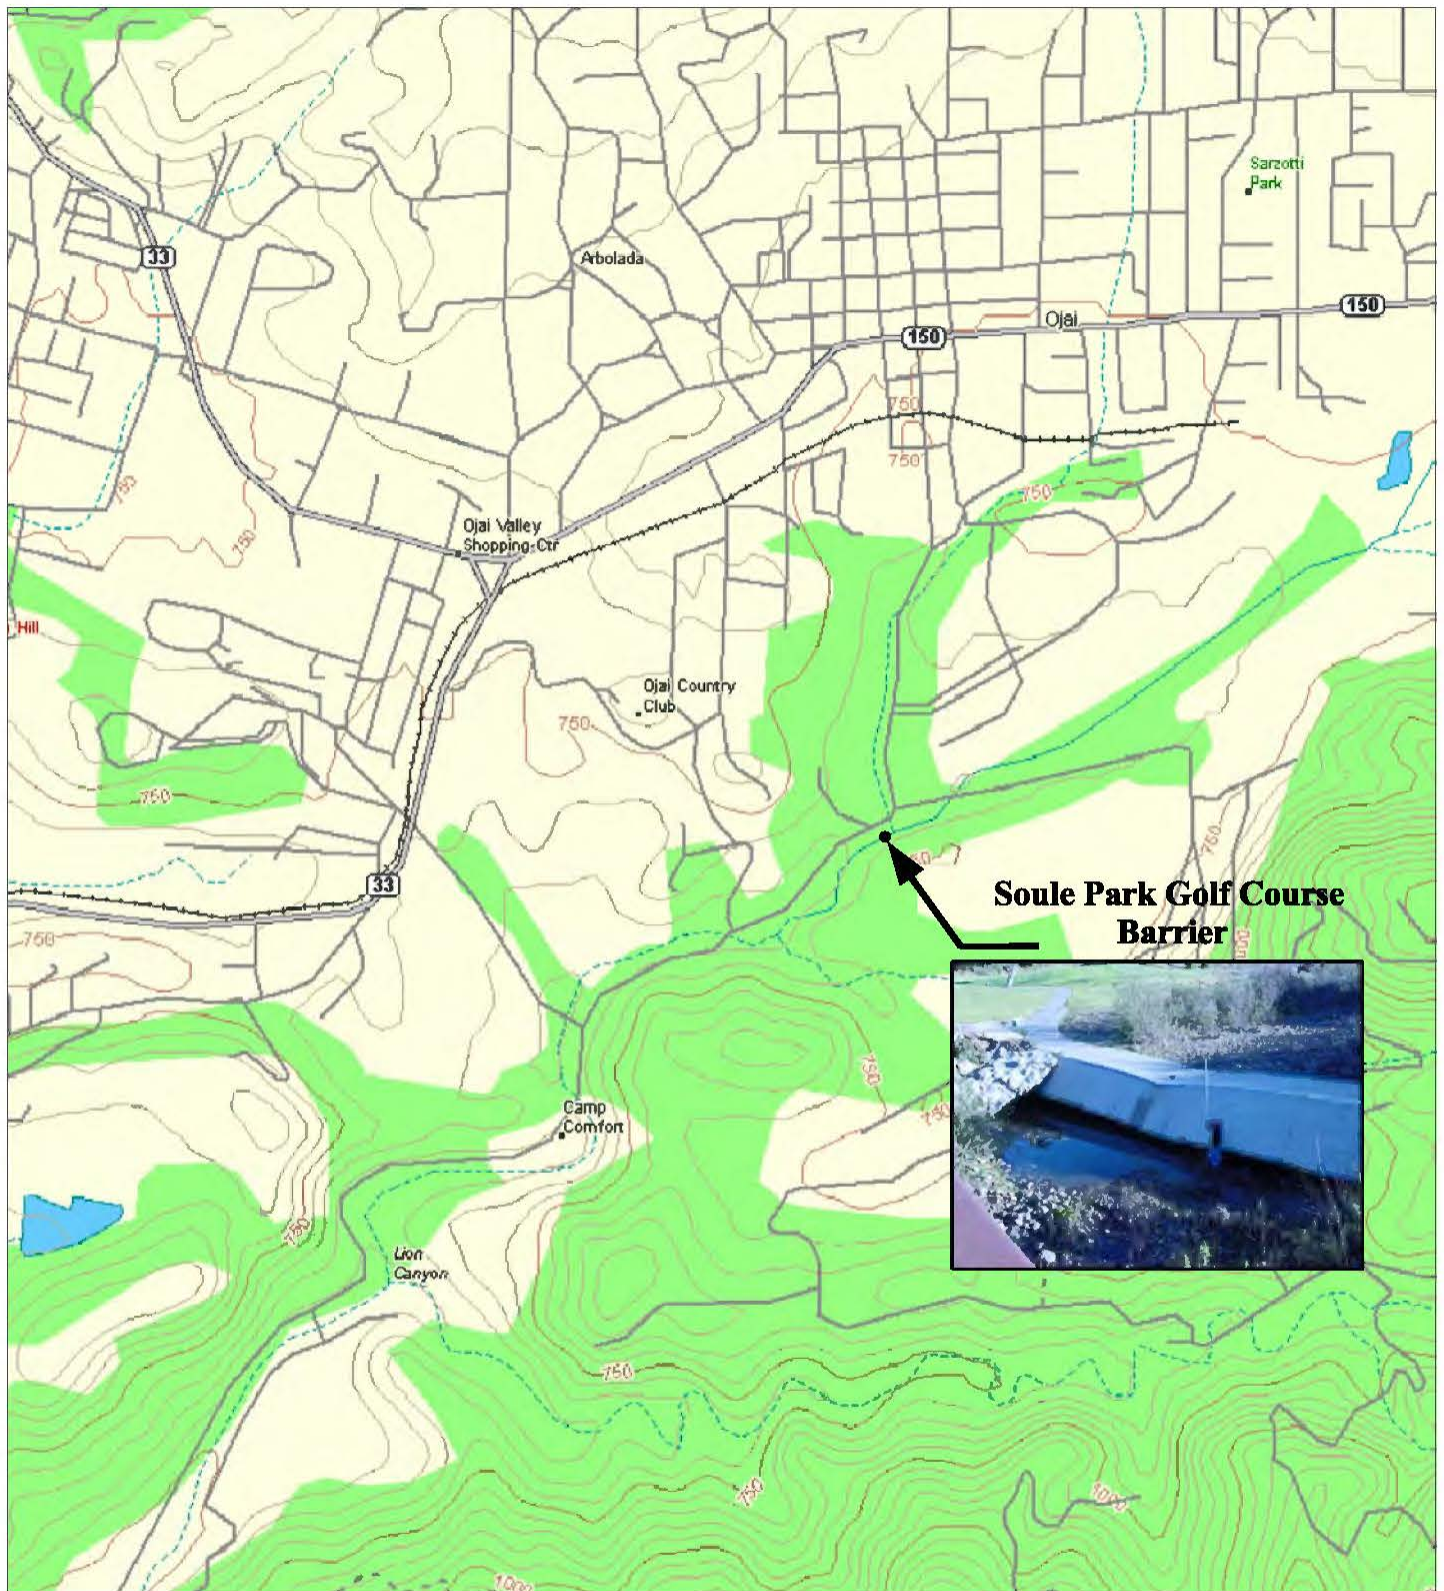
FIGURE A-3

**Soule Park Golf Course
Barrier**

**Location of Soule Park Golf Course
Fish Passage Barrier**

This project area consists of a concrete “Arizona” or “fairweather” type crossing used for equipment access along San Antonio Creek at the Soule Park Golf Course. A golf cart access bridge which also spans the stream channel is situated approximately 50 feet downstream of the fairweather crossing. The fairweather crossing likely presents a complete barrier to fish passage. The road crossing is approximately 110 feet long and a near vertical (approximately 0.5:1 slope) concrete apron is situated along the downstream edge of the road crossing. The concrete apron is undercut approximately 6 feet. The road crossing presents a physical barrier to passage as the road surface is situated approximately 11 feet above the downstream streambed. The road crossing is situated approximately 150 feet downstream of the confluence of Thatcher Creek. The location of the road crossing is provided in Figure A-3 and the crossing is shown in Photos 33 and 34.
