Habitat Restoration Opportunities for the Lower Ventura River

December 2010

**SANTA BARBARA
CHANNELKEEPER®**

Ben Pitterle

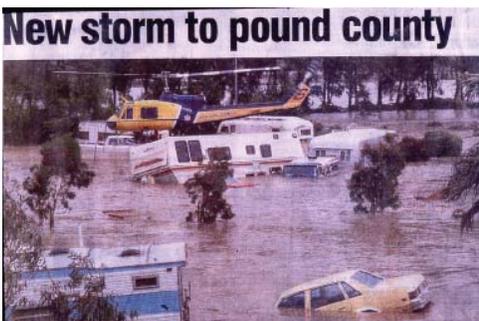
Figure 7: Evacuations at the Ventura Beach RV Camp in 1993.

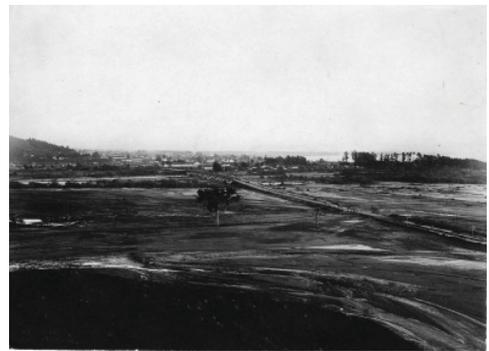
Figure 4: Ventura River flood at Main Street in 1914 Photo Credit: Ventura County Museum of History & Art.

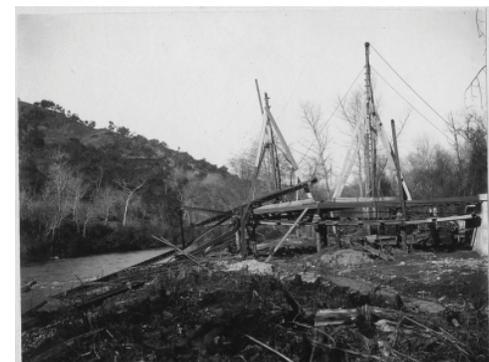
Figure 5: Foster Park bridge washed out by flooding in 1914. Photo Credit: Ventura County Museum of History & Art.

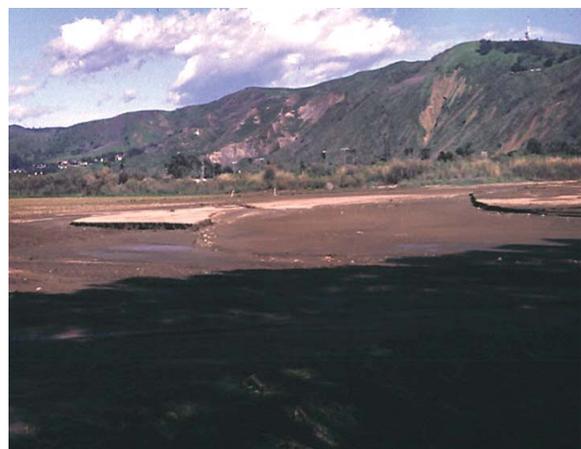
The acreage to the northwest of the Ventura River Estuary (north of Main Street) has been developed as agricultural land for decades. Based on analysis of historical photographs, portions of agricultural development have encroached onto the floodplain, where infilling has also apparently occurred. Flooding of this area during major storms, along with stormwater runoff transports nutrients and other pollutants bound in agricultural sediments into the lower river and estuary. Additional impacts to wildlife, riparian habitat and water quality are also likely to exist due to the immediate proximity of row crops to the river and riparian corridor. Throughout most of the area, the only buffer between row crops and the riparian zone is a compacted dirt access road. This facility is off-limits to the public and provides no recreational value to the surrounding community.

Figure 8: Flooding of agricultural lands adjacent to the Ventura River Estuary is known to occur. Photo credit: Mark Capelli.

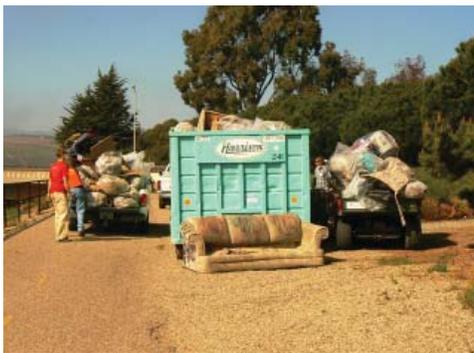
Figure 10: In 2010 alone, over 16 tons of garbage were removed from the Ventura River Estuary.

Sadly, this problem has persisted. In recent years, numerous volunteer cleanup efforts hosted by the City of Ventura and community groups have continued to target the estuary. In 2010 alone, nearly 16 tons of garbage were collected from the lower river and estuary by volunteers during two massive cleanup events (Brown, pers. Comm.). These events targeted only a small portion of homeless encampments in the area. The garbage produced by homeless encampments is harmful to wildlife, hazardous to the public, a nuisance, and source of pollution to the river, estuary, and ocean.

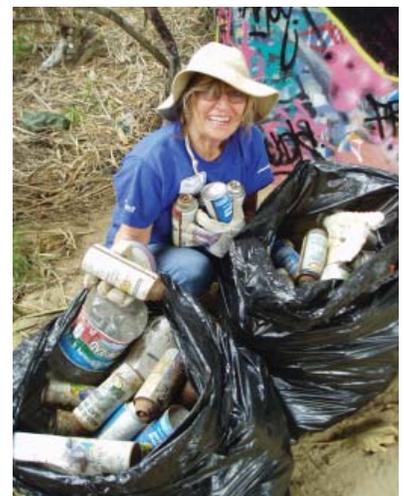
Figure 11: A community member removes hundreds of paint containers from the estuary during a volunteer cleanup event.

Graffiti artists are another significant source of pollution in the Ventura River Estuary. After using the walls and support beams of the Main Street and Highway 101 bridges as canvasses for their artwork, graffiti artists leave behind paint cans and spray paint bottles. Over time, large quantities of spent or unused containers of paint are discarded in the river bottom. Many of these containers are not completely empty and are left open leaking paint into the environment. Volunteers regularly remove hundreds of paint containers from the area, but abandoned containers often end up in the river and lagoon nonetheless.

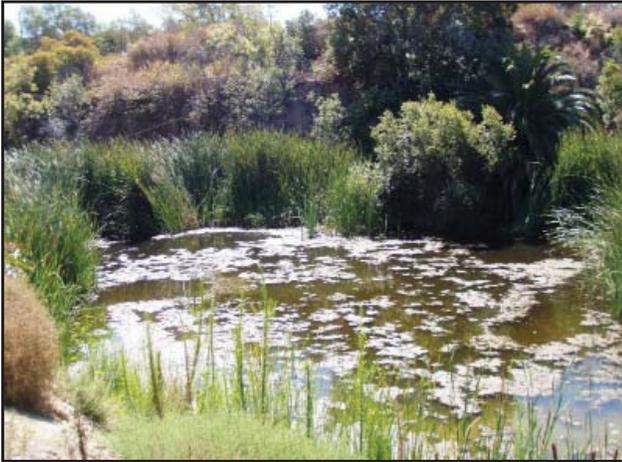
once known as 2-mile hole), used to be located at the oil field just west of the two-mile bend along Ventura Avenue. The Gosnell Hole, named after a physician that lived nearby, was once connected to the Ventura River and was large enough that locals occasionally launched boats there for fishing. The Gosnell Hole was a well-known location for steelhead. It is believed that hyporheic exchanges between ground and surface water kept water temperatures in the Gosnell Hole cool, creating productive steelhead habitat that was frequently used by so called “early arrival” fish that had just migrated upstream from the estuary (E. Henke, Pers. Comm.). In the late 1930s, extensive channel modification was performed along the river by the oil companies for flood control and construction purposes. By the early 1940s, the Gosnell Hole had been permanently detached from the river and severely degraded.

Figure 18: Gosnell Hole remnant pond.

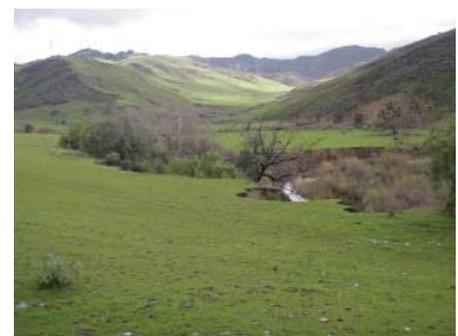
A choke point in has been created approximately 2.75 miles up Cañada Larga Creek by the construction of a bridge along Cañada Larga Road. Severe erosion has occurred downstream of this choke point. Widespread, year-round cattle grazing has also severely impacted stream banks and hillsides, likely exacerbating erosion problems. As a result, stream bank erosion is quite severe along Cañada Larga Creek. Along significant stretches of the creek, stream banks appear to be vertical in angle and bank collapse is causing a loss of pasture area. It is likely that significant erosion will continue to occur until a new hydrogeological equilibrium is achieved.

Figure 21: Severe erosion has affected stream banks along Canada Larga Creek.

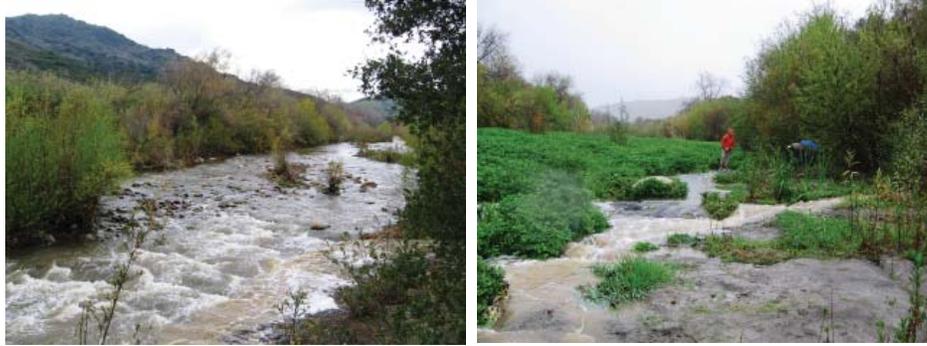
Figure 22: The Canada Larga Creek confluence with the Ventura River. Canada Larga Creek enters from the right of each frame. These photos were taken during storms that occurred on February 7, 2009 and February 6, 2010 (left to right).

Turbidity is also extremely high at this location within the creek during and after storms. Widespread grazing has removed most of the vegetation that would otherwise hold soil in place during storms, exacerbating erosion and causing large volumes of sediment to enter the creek. During storms, turbidity levels are often high enough in Cañada Larga Creek that they exceed the maximum detection limits of Stream Team monitoring equipment (1,100 NTUs). The severity of the problem can often be viewed during storms at the confluence of Cañada Larga Creek and the Ventura River where, by contrast, cloudy creek water is orders of magnitude greater in turbidity than the relatively clear river water (Figure 22).

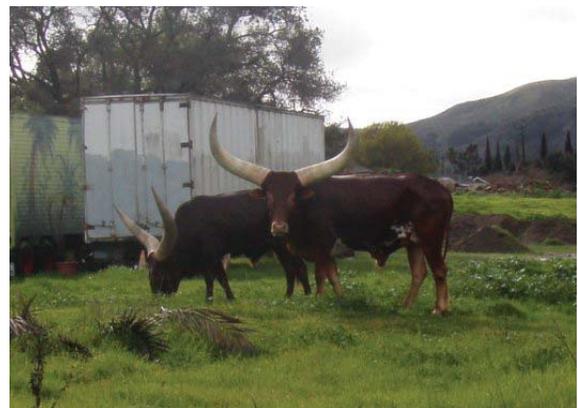
Figure 23: Livestock in Canada Larga valley.

Allowing cattle to graze in streams and along stream banks can cause significant ecological damage. The State and County should adopt strict policies that prohibit livestock from accessing these areas. Existing Federal Confined Animal Feeding Operation (CAFO) requirements do not apply to smaller livestock enclosures or to pasture lands. Other states have adopted policies to protect surface waters from these land uses. Kentucky and Wisconsin are both states that have broadened their water quality protection policies to apply to not only livestock enclosures but also to pasture lands (Dexter, 2010). In both states, livestock in pasture lands are prohibited from contacting surface waters. Erosion and water quality problems would be further improved in the Ventura River watershed by expanding exclusions to accommodate stream banks and buffer areas.
