SAN ANTONIO CREEK
SOUTHERN STEELHEAD HABITAT
CHARACTERIZATION
VENTURA COUNTY, CALIFORNIA

Prepared for:
VENTURA COUNTY FLOOD CONTROL DISTRICT

February 1996

Project Number 96-61-0301

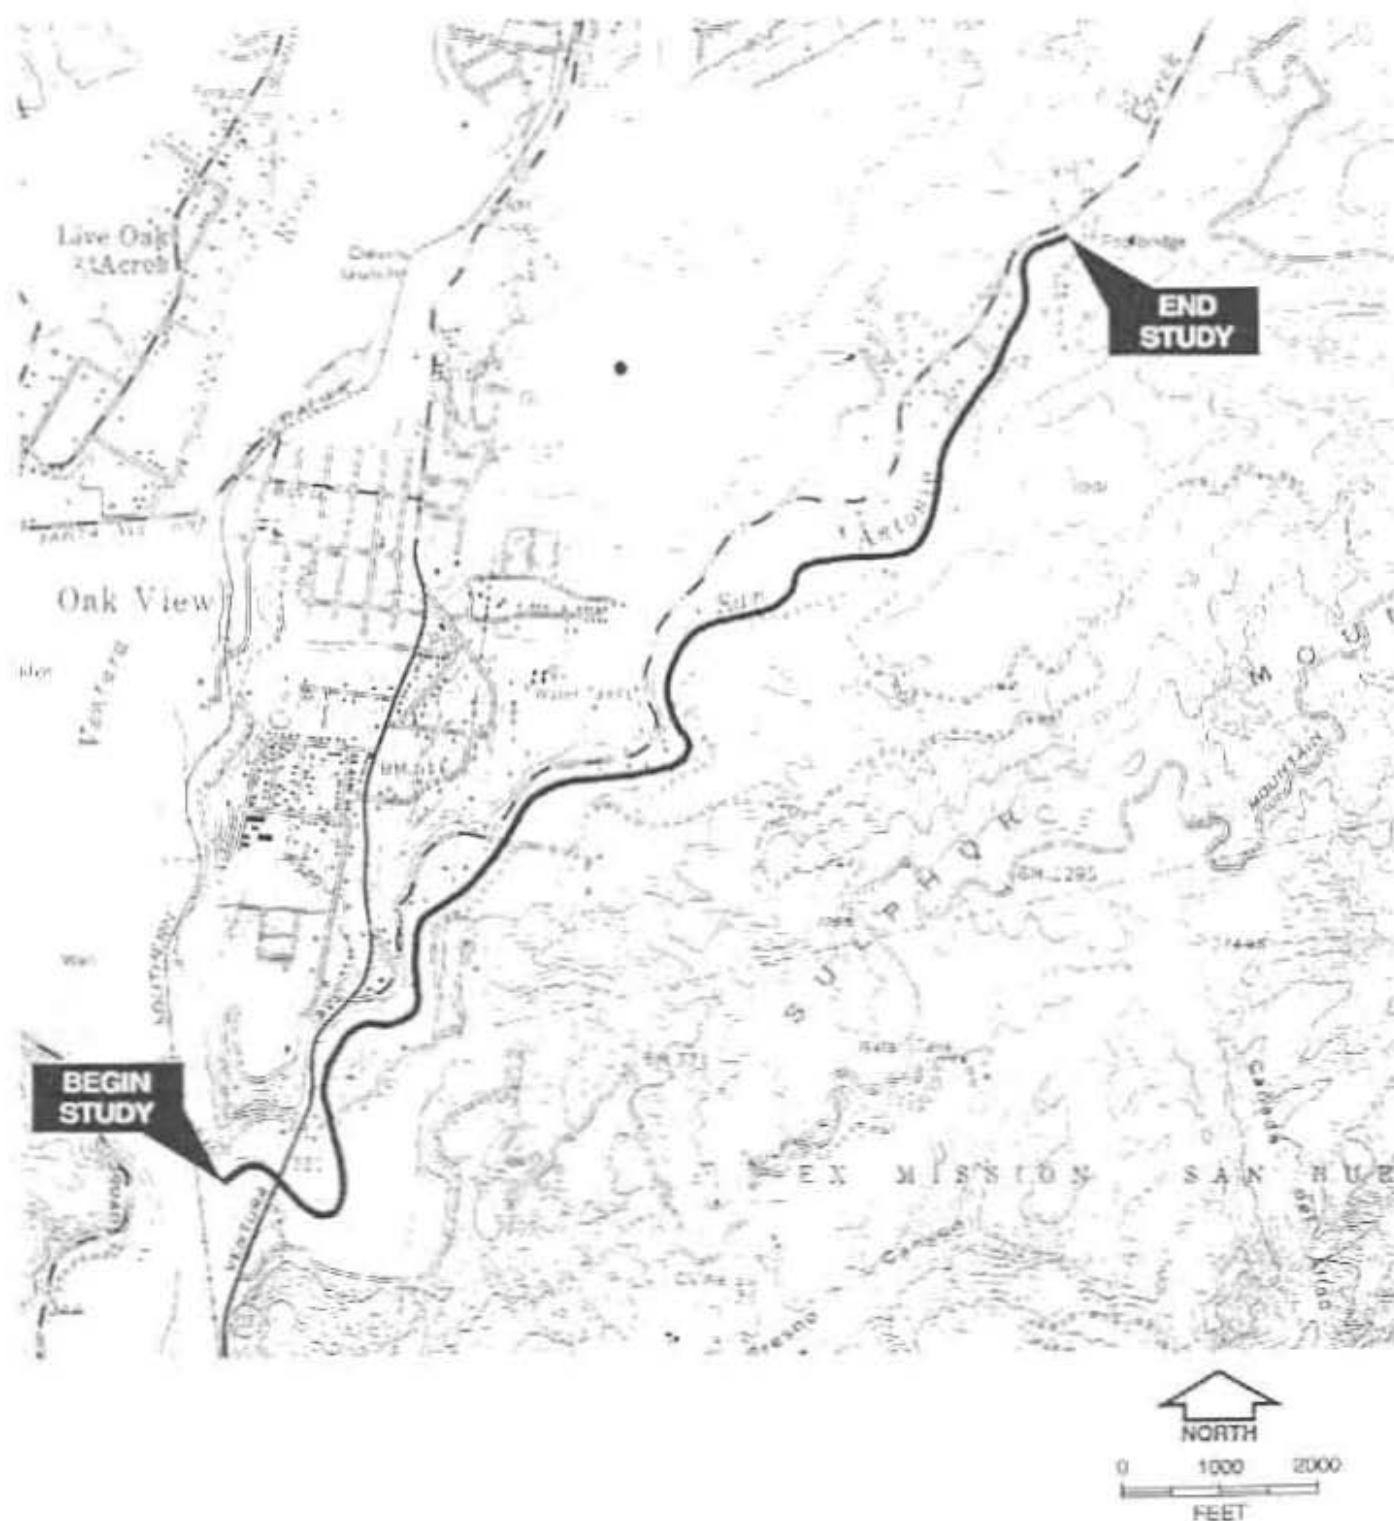
FIGURE 1

SAN ANTONIO CREEK HABITAT STUDY AREA

San Antonio Creek is a major tributary to the Ventura River, along with Matilija Creek, the North Fork of Matilija Creek, and Coyote Creek. The location of San Antonio Creek, in relation to the Ventura River, is illustrated in Figure 1, San Antonio Creek Study Area. San Antonio Creek originates on the southern slopes of the Topa Topa Mountains and Nordhoff Ridge in the northeastern portion of the Ventura River Basin. It flows approximately 18.4 kilometers (11.5 miles) from Senior Canyon, in a southwesterly direction, to the stream's confluence with the Ventura River. The confluence of San Antonio Creek and the Ventura River is located in the Casitas Springs area, approximately 13 kilometers (8.1 miles) upstream from the mouth of the Ventura River. The total drainage area for the San Antonio Creek watershed is 135 square kilometers (83.9 square miles) (Moore, 1980).

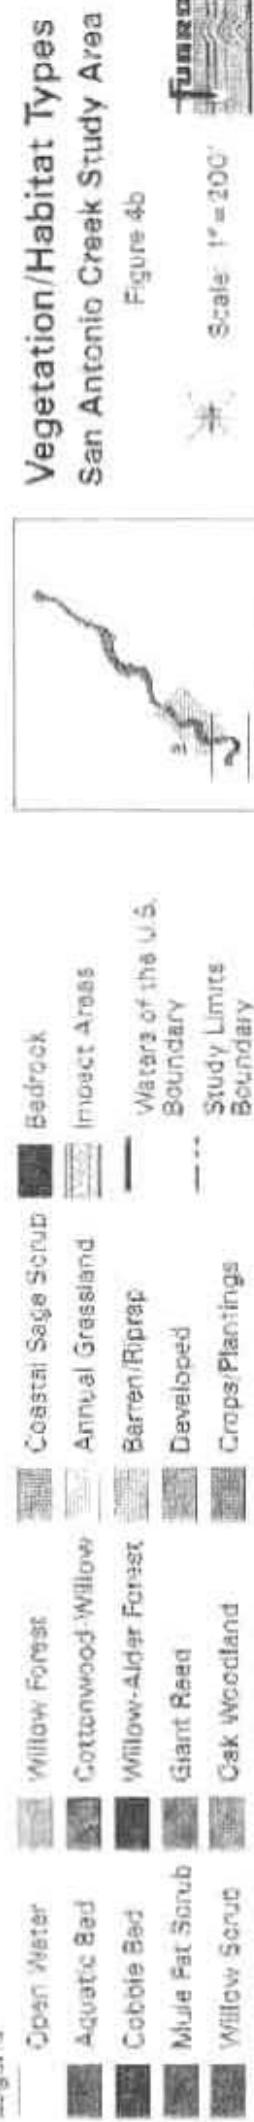
Figure 4c

Vegetation/Habitat Types
San Antonio Creek Study Area

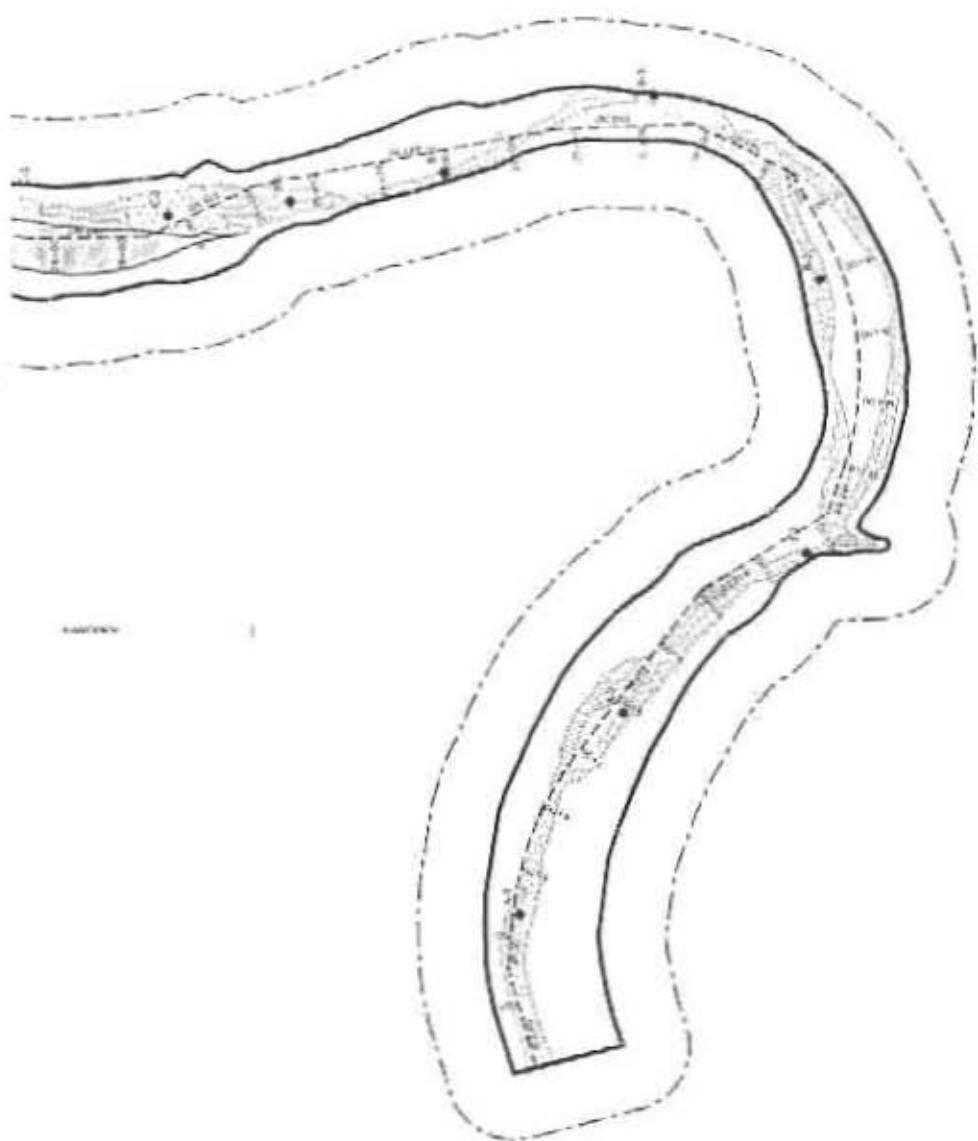
Figure 5b

Instream Morphology
San Antonio Creek Study Area

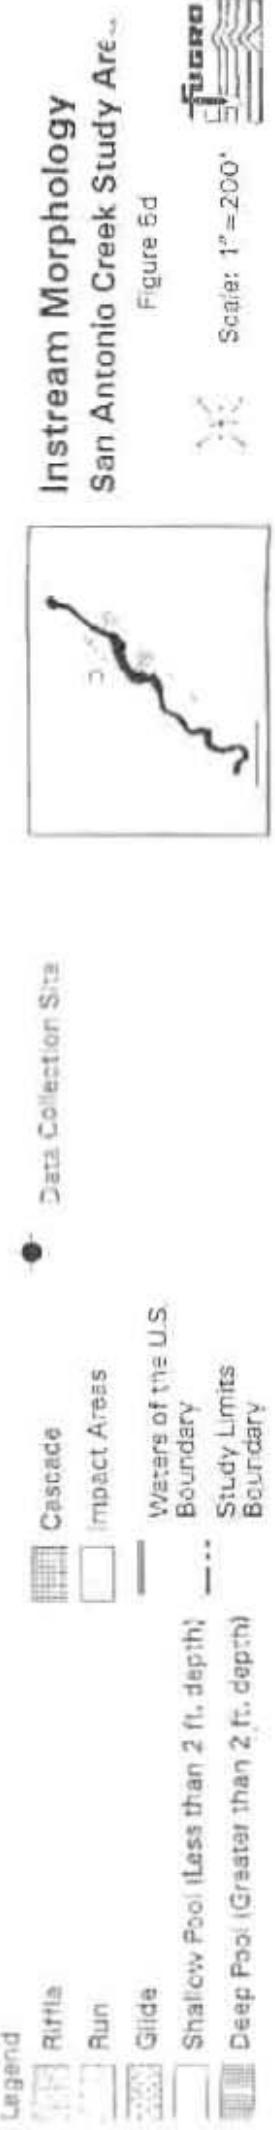
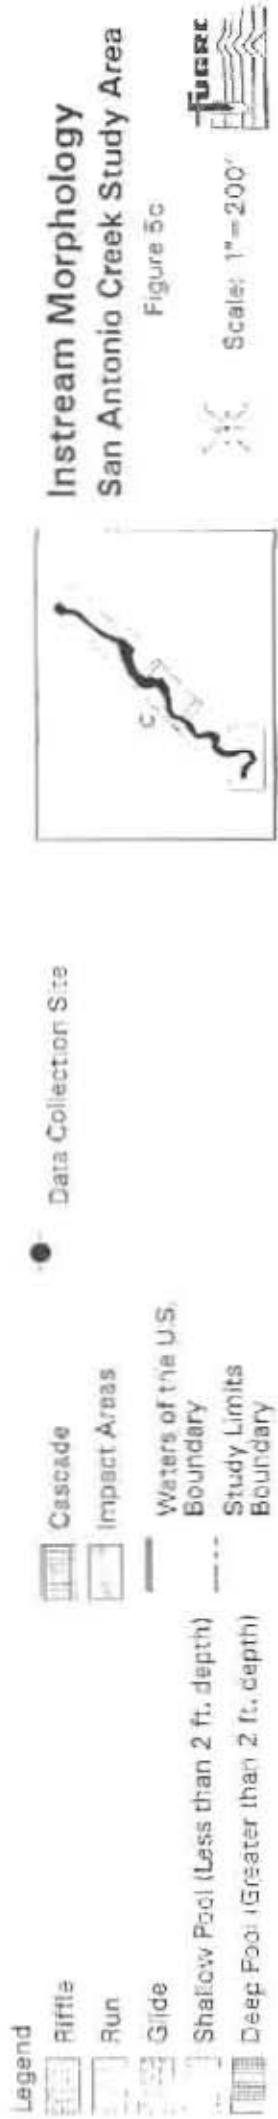
Figure 5B

Instream Morphology
San Antonio Creek Study Area

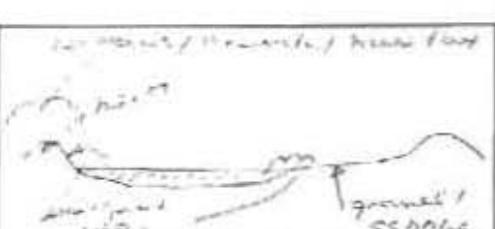
<p>Channel Cross Section</p>

Substrate Composition:	Bottom 10' - gravel covered w/ algae) in silt (abundant)				
Particle Size Range:	0.5" to 5"				
Depth/rank:	rank = 4				
Approximate Area:					
Potential Spawning:	<input type="checkbox"/>	Potential Rearing:	<input checked="" type="checkbox"/>		
Other Observations:	General 1' cable submerged in water sand, 5' - 10' off river bank. Stick in bank and bottom is gravel water is present

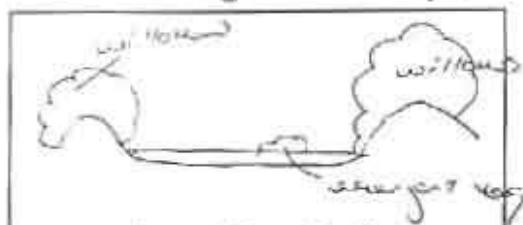
Channel Cross Section

Substrate Composition: gravel
embeddability = 4, hard compact
3-4" (SCS)

Particle Size Range: 1.5 to 1.8"
approx. size: 10-12"

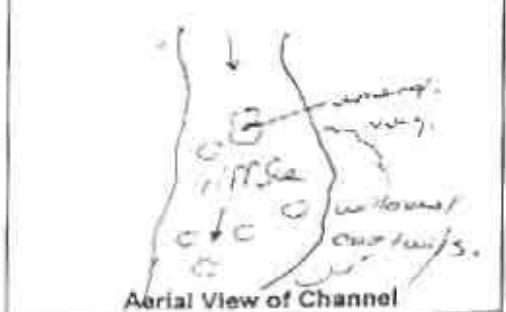
Aerial View of Channel

Not a lot of in channel
cover. A few fish were
seen. Larvae present in
areas w/ higher velocity

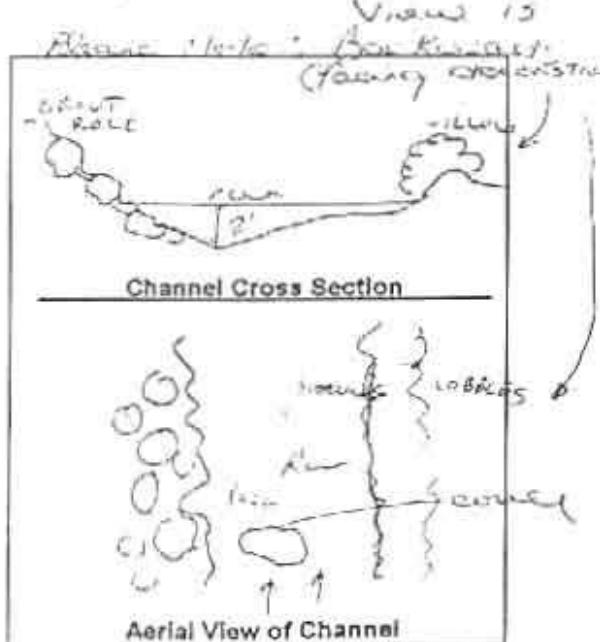
SAN ANTONIO CREEK HABITAT CHARACTERIZATION

Date: 1/24/96 Site I.D. No. C-13
Observer: CGT Photo No. 140415
Time: 1:42 Station Transect No. G-2 T000

Location: Stream to upstream section of
stream near City Rd 901

General Flow Conditions: slow flow channel
From: E 72 To: E 7-62 surface runoff dominant

Channel Morphology:
(Include Stream Banks)
steep on the side of stream
with some undercutting at
bottom of side bank

Nearby Anya Club
21st floor is not
expected to occur
Very exposed (S. side
bank) channel

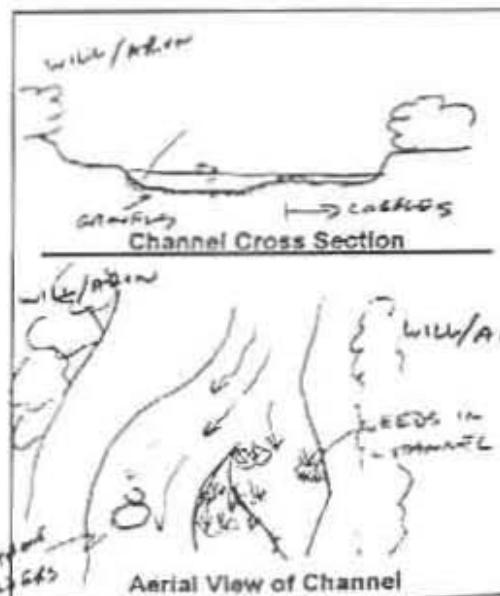
SAN ANTONIO CREEK HABITAT CHARACTERIZATION

Date: 1/29/96 Site I.D. No. C-15
Observer: A Photo No. 20 + 21
Time: 2:40 Station Transect No. 74 + 00
Location: SAN ANTONIO CREEK

General Flow Conditions: Shallow relatively stable banks

Other Observations a bit shallow for
spawning

May provide - tank
spawning w/ inundated to
allow prolonged periods
throughout rainy season.

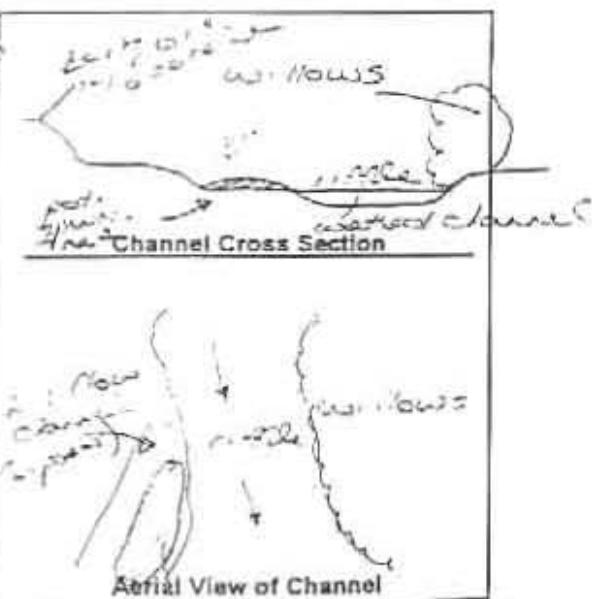
Aerial View of Channel

Minimally cover near pot - open area

This is pot inundated channel

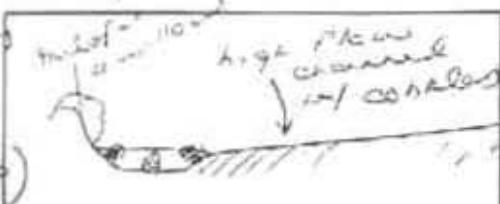
Channel Cross Section

General Flow Conditions: base flow conditions
Flow = 3.72 cfs
T 62 C. 135 15 sec sec channel
Channel Morphology: Wide, deep channel, no cut
70% undercut on the left side of flowing
channel, cutbank on right side
in front of bridge
with some
