**ASSESSMENT OF STEELHEAD HABITAT
IN UPPER MATILIJA CREEK BASIN**

Stage One: Qualitative Stream Survey

Public Works Agency
Ventura County Flood Control District
800 South Victoria Avenue
Ventura, California 93009-1610

Thomas R. Payne & Associates
890 L Street
Arcata, California 95521
707-822-8478

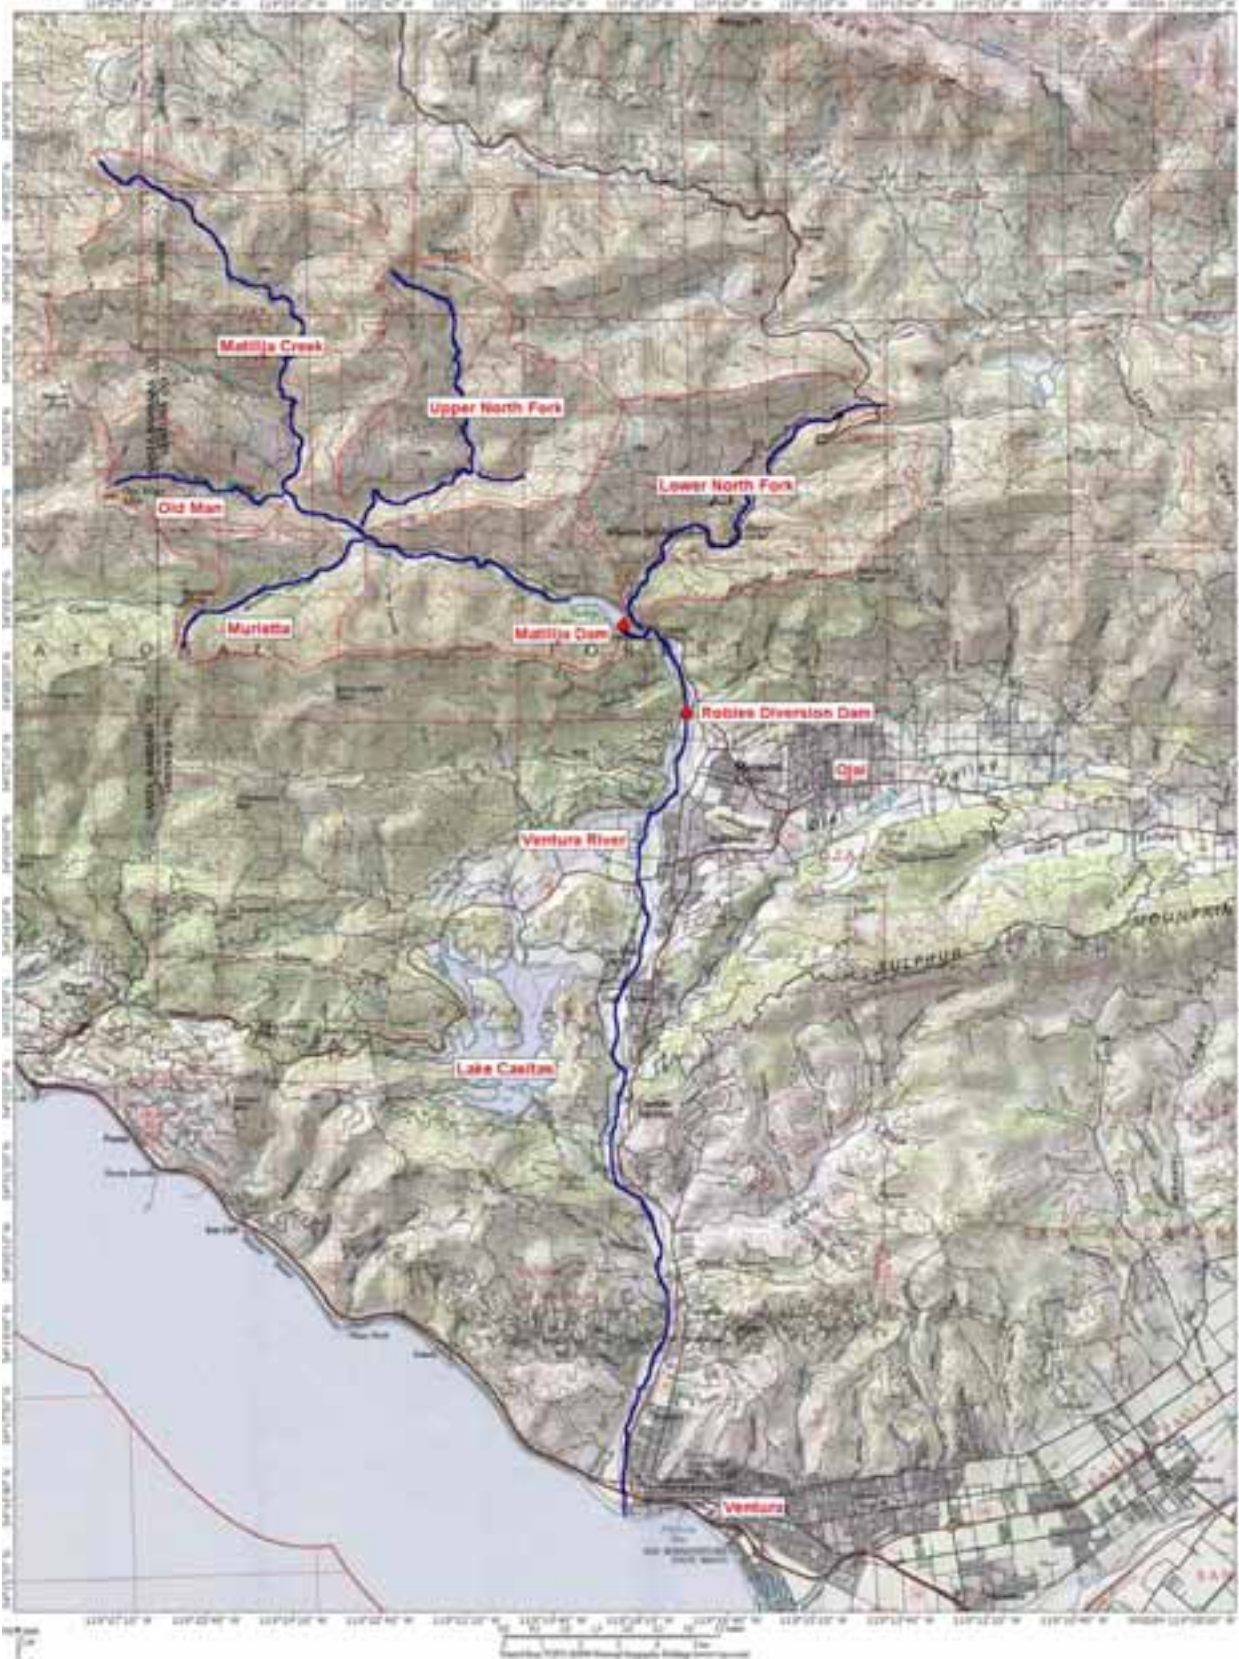
Figure 1. Map of upper Matilija Basin showing sub-watersheds and significant geographical features.

Older topographic maps (i.e., Figure 1) and personal communications with Water Department personnel have indicated that much of this reach is within the historical lake level (Table 1). Consequently, channel characteristics in this section could change considerably following removal of the dam. The flood plain was wide with some split channels. The riparian vegetation was dominated by *Arundo*, mule fat, and willow (Figure 5). There were several good holding pools in this reach. Substrate was cobble dominated, and no spawning gravel was observed in this section. Mineral deposits were beginning to be more evident in this section. The surfaces of gravel, cobbles, and boulders were physically gritty due to the deposits, which effectively “cemented” the particles together. These deposits appeared to significantly reduce substrate quality for spawning, and benthic invertebrate production appeared to be very low. However, it is unknown to what degree these depositions are removed or if gravels are significantly loosened during winter and spring high-flow events. Several gravel deposits were revisited in April following the March 15th storm event, but such deposits showed little evidence of becoming significantly loosened following that event. This mineral cementation is seen throughout most of the basin. There were about 10 non-game fry observed in this section, but no trout were observed. No potential barriers were encountered. Despite the mineral effects and paucity of fish, the overall physical appearance of this reach was fair to good.

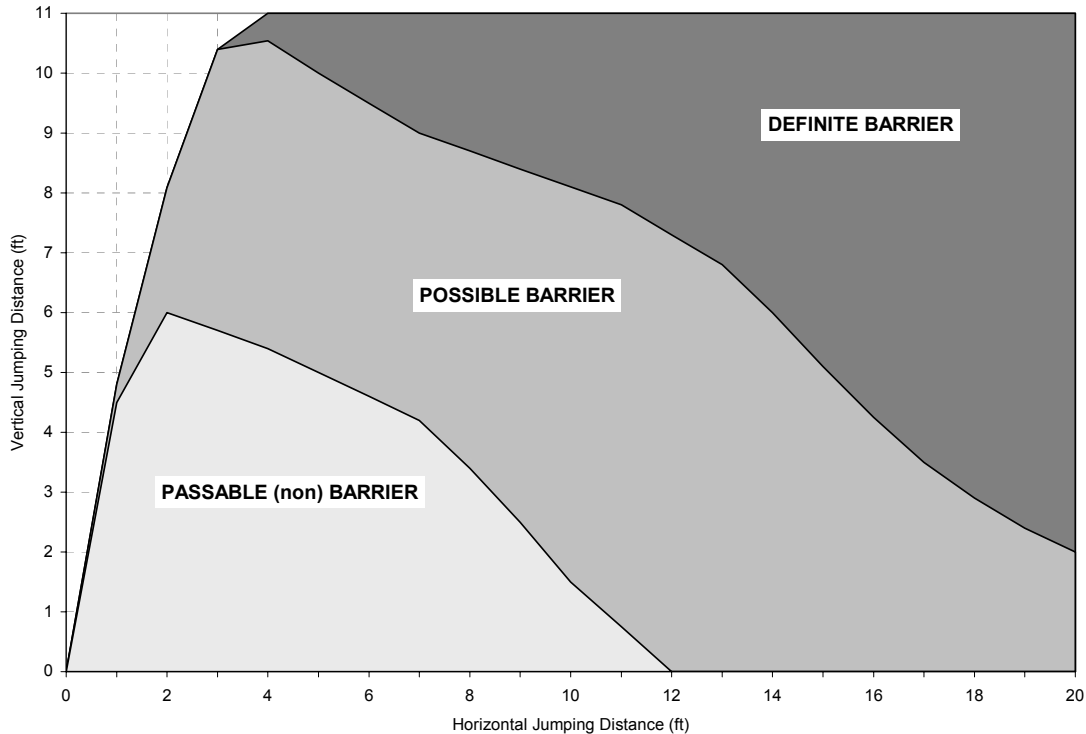
To assist the evaluation of each potential barrier, the biologists referred to a figure quantifying the relationship between jump height and jump distance for adult steelhead (Figure 2). The figure was a composite of data representing the jumping ability of steelhead in “bright” condition and in “good” condition (Orsborn 1985). It was further assumed that the maximum jumping height of a steelhead was no greater than the depth of the jumping location (for pools less than eight feet deep, Reiser and Peacock 1985). This 1:1 ratio is a liberal estimate compared to the traditional estimate of 0.8:1 from Stuart 1964. We then used the jumping charts for the “good” condition fish to distinguish between passable barriers and possible barriers. The jumping charts for bright steelhead were used to distinguish between possible barriers and definite barriers. Possible barriers were sometimes classified as “probable” barriers if additional factors, such as characteristics of the jumping or landing areas, appeared to reduce the efficiency of a jump.

Figure 2. Barrier jumping chart used to assess degree of passage for upstream migrating adult steelhead. Based on data from Orsborn (1985).

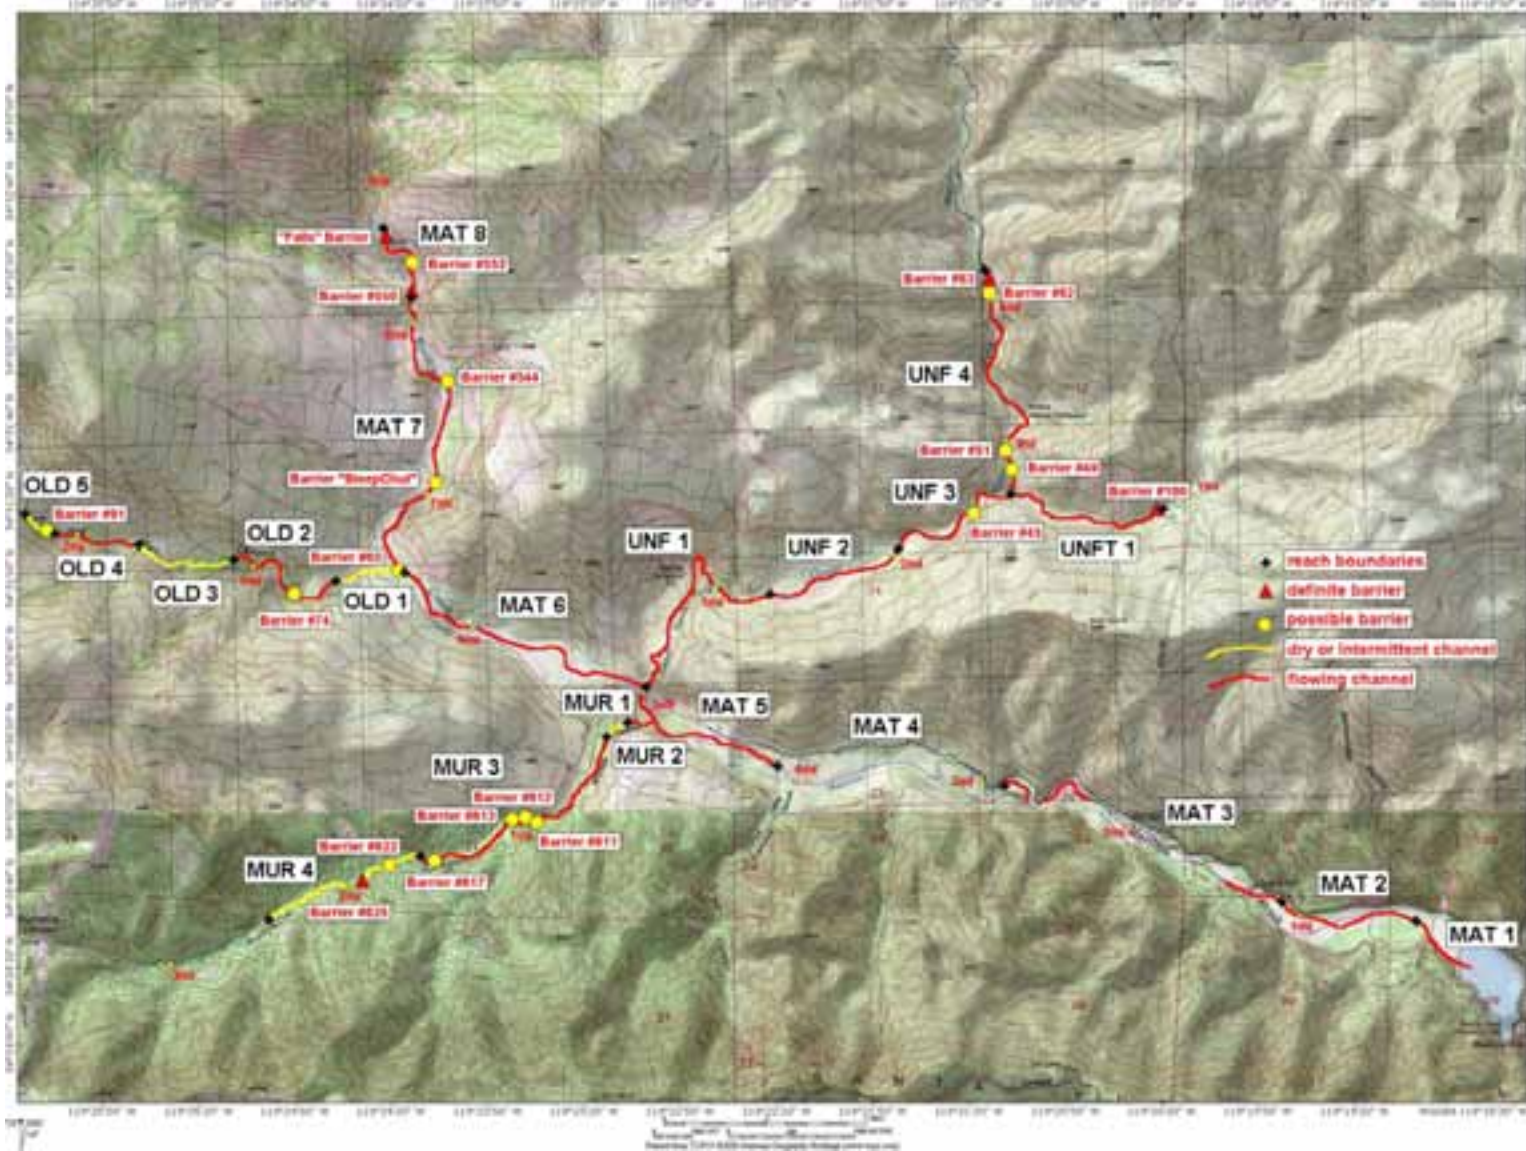
Figure 3. Map of the upper Matilija Basin showing reach boundaries, dominant streamflow characteristics (colored lines), and barrier locations. Channels not outlined were not mapped.

This reach is believed to be inaccessible to steelhead because of barrier #550, which is an 18 ft bedrock falls at the downstream boundary (Table 2, Figure 3). In this steep, confined reach the weathered bedrock walls contributed lots of gravel-sized rock that were noticeably sharper and more angular than the downstream gravels. Riparian forest dominated this B and A channel reach (Table 1, Figures 4 and 5). In addition to a significant 10 ft falls halfway up this reach (barrier #552), the reach was terminated by a spectacular 50 ft waterfall (Table 2, Appendix C). This waterfall is a frequent destination for local hikers, which has a highly distinctive appearance due to the bedrock geology and heavy mineral deposition.

throughout this reach, the cementing of some gravel was still evident. Access was good with one possible barrier (barrier #46, Table 2, Figure 3, Appendix C). One unidentified fish was observed in this reach. Overall, the habitat rating for this reach was good.

This reach begins immediately above the confluence with the unnamed tributary (Figure 3). Here, the stream channel became narrower and steeper, and transitioned from a B channel to an A channel (Figure 4). In this reach several potential barriers were encountered (barriers #49, #51, #62, and #63). Barrier #63 was judged as a definite barrier to upstream migrant steelhead, but barrier #49 also appeared formidable (Table 2, Appendix C). The substrate was dominated by boulders and bedrock, with fine silt in deep pools. Overhead, the channel was enclosed by thick riparian forest (Figure 5). There were 12 positive rainbow trout observations in this reach. The overall habitat quality appeared good, but access may be restricted to a short length below barrier #49.

The lower 900 ft of Murietta Creek contained flowing water to its confluence with Matilija Creek (Table 1, Figure 3). On March 7th this flow was measured at 1.2 cfs. No barriers or spawning gravels were observed in this reach, and boulders dominated the substrate. Riparian scrub dominated the vegetation but riparian forest species (alder and oak) were present on upper flood terraces and they provided some woody debris in the stream channel (Figure 5). One rainbow trout was observed. The rearing habitat in this reach appeared good, but the stability of surface flow during summer months is unknown.

Most of this reach was completely dry making access to the rest of the stream impossible at the current flow (Table 1). Access at higher flows would probably be difficult, due to some steep cascades and falls (barrier #65, Table 2, Figure 3, Appendix C). Less than 300 ft of this reach contained intermittent flow (<0.5 cfs), and no fish observed in this portion of the stream. No spawning gravel was observed in this reach, and the overall habitat rating for this reach was poor.

This reach was relatively steep, open, and dry (Table 1, Figures 4 and 5). The survey ended at a potential barrier (barrier #91, Figure 3, Table 2, Appendix C), but the channel continued dry for at least another 500 ft. The habitat quality in this reach was judged as poor.

be provided, with an additional two to three miles of habitat if the definite barrier at the Wheeler Campground was removed. Of the 21.6 miles, 6.7 miles occur above “possible” barriers to upstream migration (Table 2), and thus such areas may not be accessible to steelhead. Also, 1.5 miles of the potentially accessible habitat were either dry or intermittent during the March survey, and thus such areas would be unlikely to provide summer rearing habitat except during wetter years (Table 1, Figure 3).

“complete” that are relatively close to the barriers we classified as “definite” in the upper mainstem Matilija and the Upper North Fork (Figure 3, Table 2). However, the Chubb Report also shows complete barriers in the Lower North Fork that we did not encounter (or, that we judged differently). Also, we identified a number of “possible” barriers in Old Man Creek and in Murietta Creek that were not identified in the Chubb Report. Given the lack of detail in how barriers were assessed for the Chubb Report, it is difficult to give a cause for these differences. Even with the semi-quantitative methodology that we employed, a significant amount of “professional opinion” is ultimately involved in most evaluations, and the streamflow conditions that exist during the survey can also have a large effect on the final assessment. Despite the ambiguities inherent to barrier assessment, the results can clearly have significant effects on the overall estimation of potential steelhead habitat. As previously discussed, a thorough barrier analysis is best performed under flow conditions typical during upstream migration and, ideally, in the presence of migratory steelhead. Neither option was feasible during this short-term study.

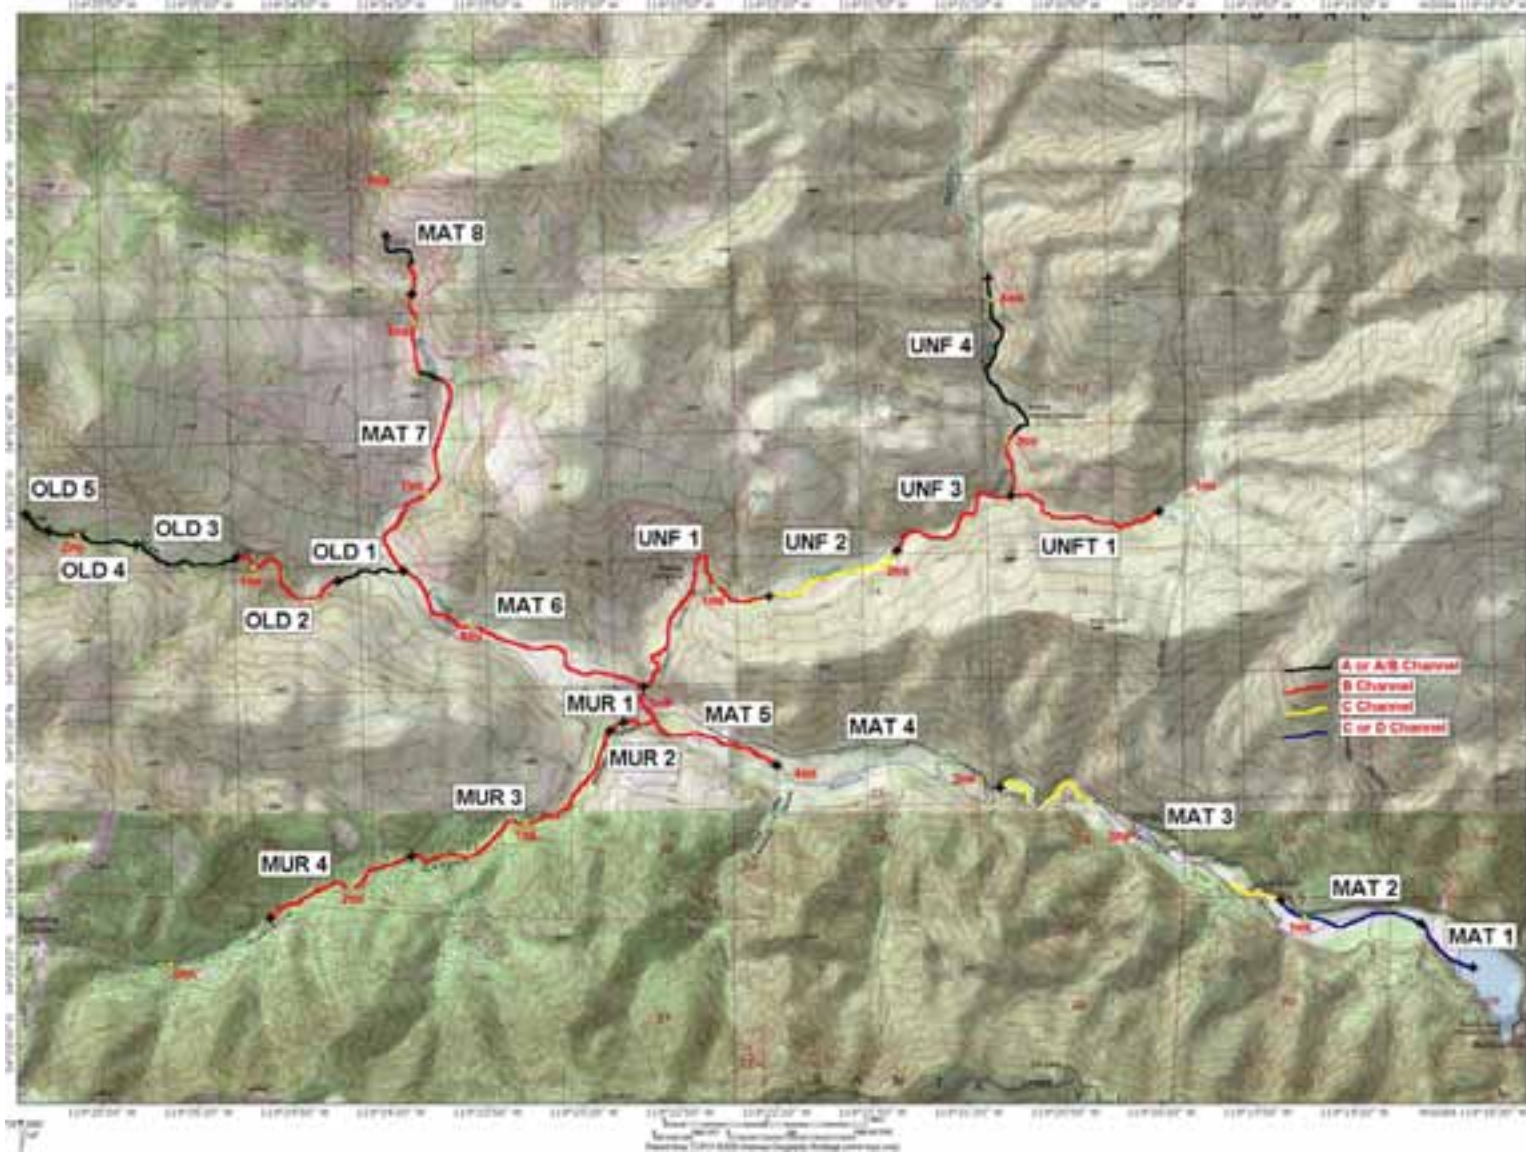
Figure 4. Map of the upper Matilija Basin showing reach boundaries and dominant channel types (colored lines). Channels not outlined were not mapped.

The first portion of this reach was visually characterized as a C channel type, however after 800 ft the creek transitioned into a more confined B channel and remained that way throughout the remainder of the reach (Table 1, Figure 4). Riparian forest species dominate the banks, although short areas of riparian scrub and alluvial scrub also occurred (Figure 5). There were few holding pools in this reach, and streambanks appeared highly unstable in some locations. No barriers were observed, although the road crossing would prevent passage during periods of low flow. At the time of this survey, Murietta Creek, which enters the mainstem in the upper portion of this reach, and the Upper North Fork, which enters at the upper reach boundary, contributed a significant portion of the streamflow within this reach. There were also numerous sulfur springs contributing flow to this reach approximately 500-1,000 ft below Murietta Creek, and the few spawning gravels available were highly cemented. There were no trout observations in this reach. The overall rating for rearing habitat in this reach is fair.

This reach abruptly opened up into a C channel with a much wider flood plain, some split channels, and a relatively low slope (Table 1, Figure 4). Very little canopy cover was present in this reach, the dominant vegetation was sparse mule fat and willow (Figure 5). Despite the lower gradient, there was virtually no spawning gravel, but more silt in this reach than in UNF 1. Cobble substrates were highly cemented. There were some good holding pools in this reach, however only one rainbow trout was observed. No barriers were observed in this reach. Overall the habitat rating for rearing was judged as fair to good, with little spawning habitat.

In this reach the flood plain narrowed and the riparian forest returned (Table 1, Figures 4 and 5). The substrate was dominated by boulders and bedrock, but slack water areas frequently contained fine silt. Although there was some good spawning gravel

This reach consisted of approximately 500 ft of dry B channel (Table 1, Figure 4). Stream channel was less confined than downstream and contained a large split channel. Riparian forest species dominated banks on the upper flood terrace but riparian scrub dominated the channel margins (Figure 5). Because of the dry channel it is doubtful that this reach provides much rearing habitat, except during intermittent periods of higher flow. No barriers were observed, although assessment of barriers is difficult in the absence of surface flow.

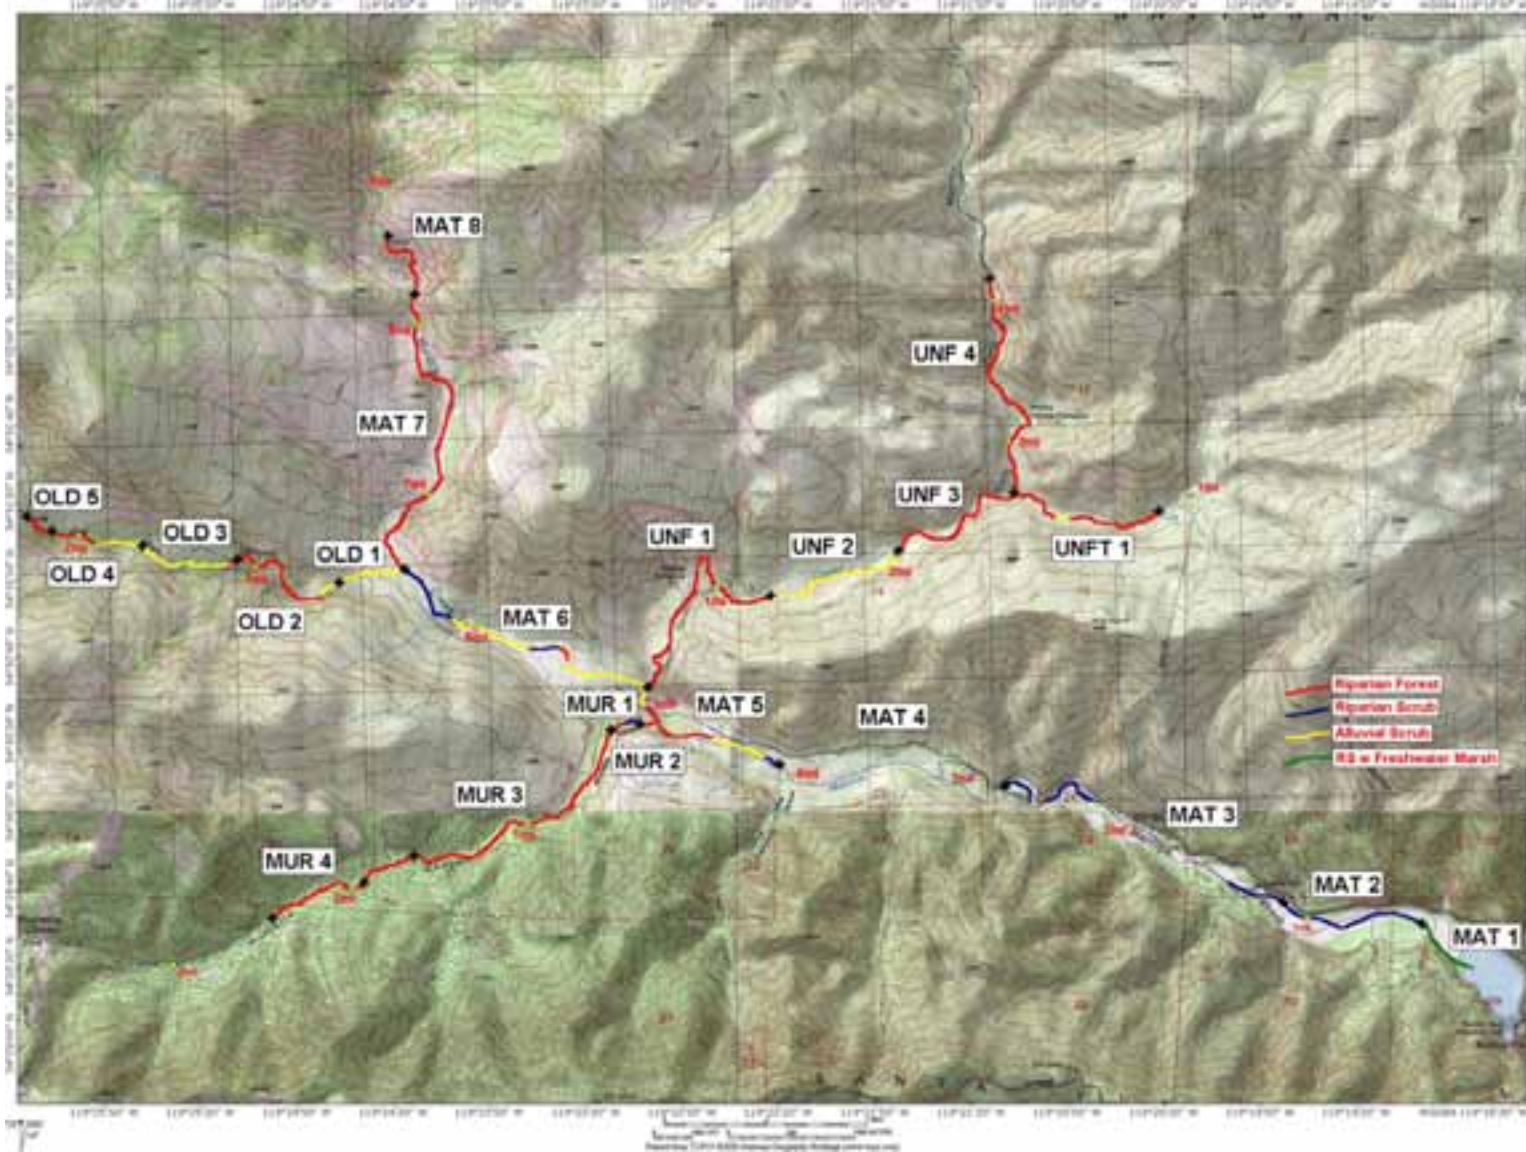
Figure 5. Map of the upper Matilija Basin showing reach boundaries and dominant riparian types (colored lines). Channels not outlined were not mapped.

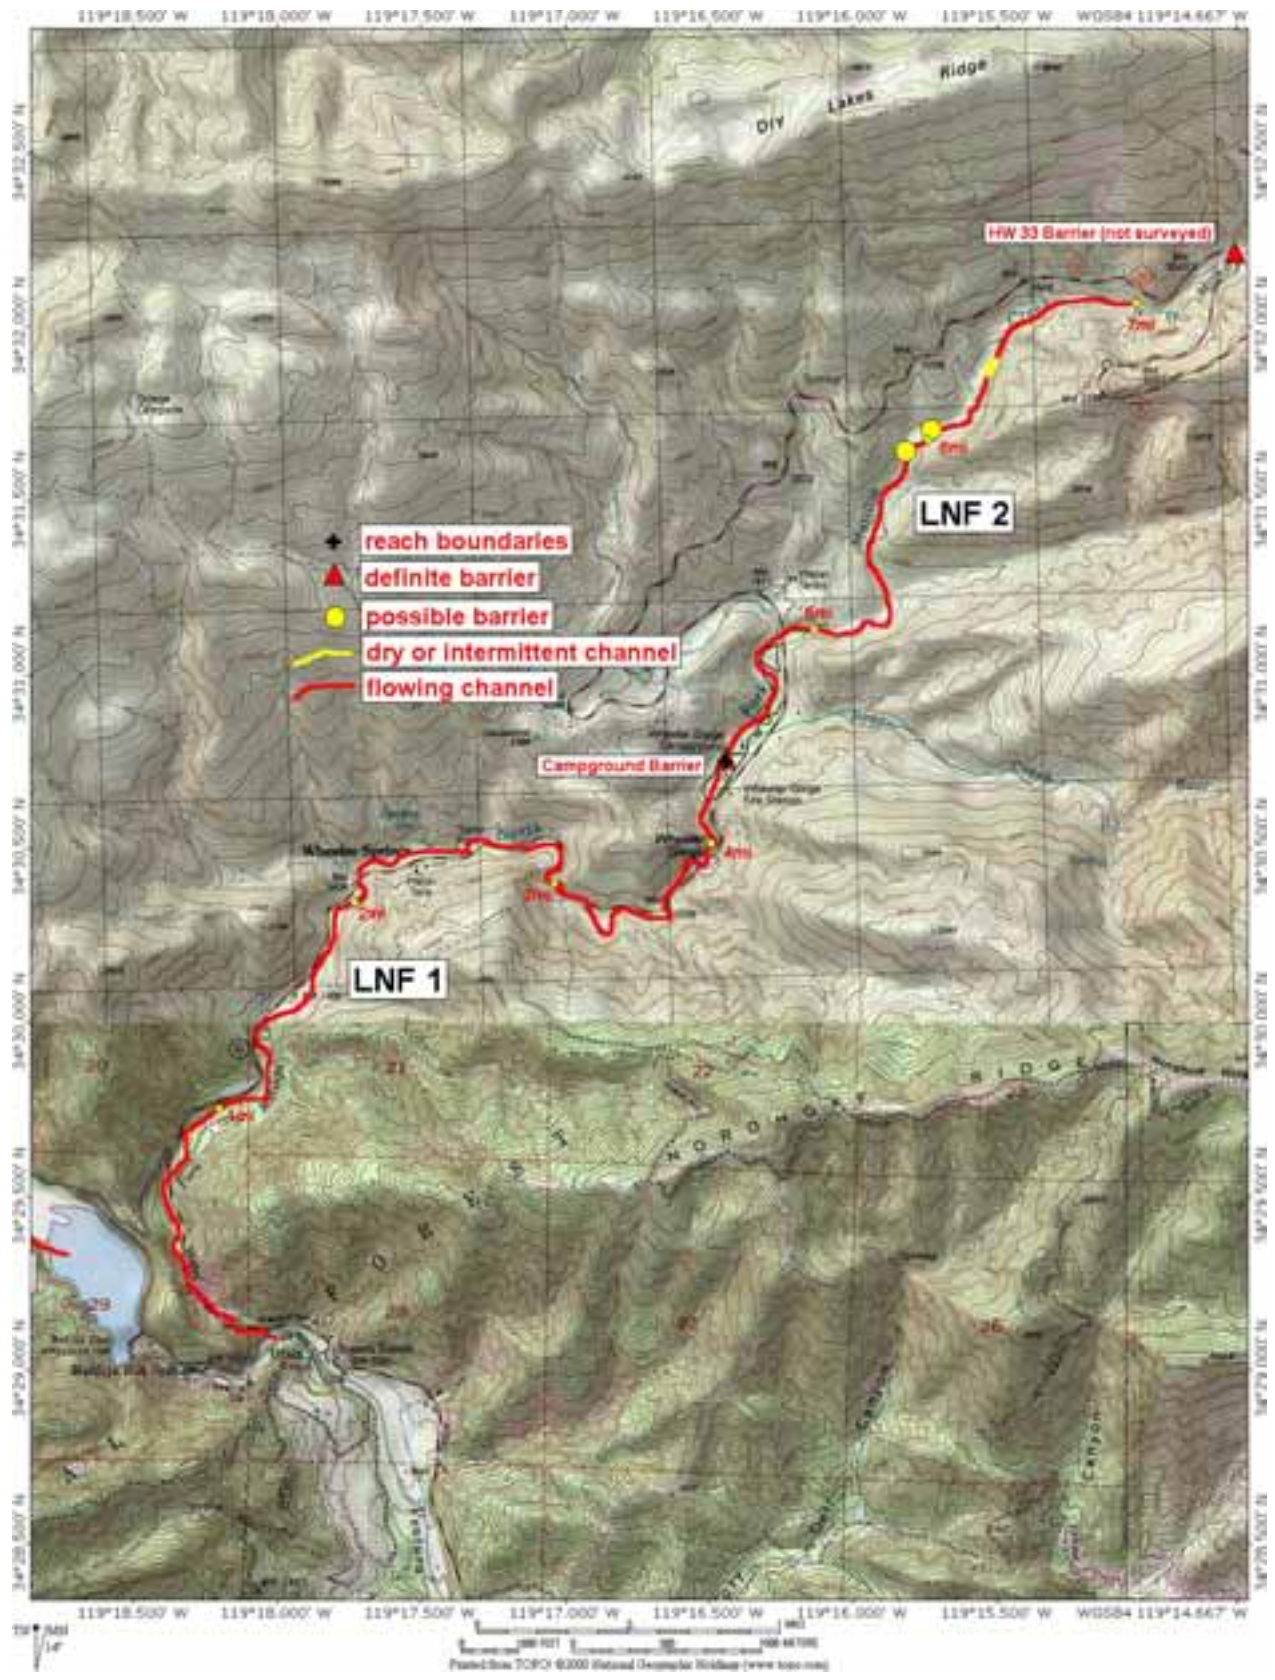
Figure 6. Map of Lower North Fork Matilija Creek showing reach boundaries and barrier locations. Most of the channel was B-type with surface flow and riparian forest. Channels not outlined were not mapped.

The Lower North Fork of the Matilija appeared to contain some of the best habitat for steelhead spawning and rearing within the upper basin. The majority of the channel was type B and was enclosed by riparian forest or, in Wheeler Gorge, by canyon walls (Table 1, Figure 6). Spawning gravels were very abundant and in good condition, although there was some mineral cementation in areas. Rainbow trout were frequently observed, and several redds and spawning adults were also seen during the March survey. Potential access for steelhead was good throughout most of this reach, despite some steep cascades and falls in the lower end that were expected to be passable at higher flows. There was, however, a definite man-made barrier at a road crossing in the Wheeler Gorge Campground (barrier #710, Table 2, Figure 6, Appendix C).
