STATE OF THE WATERSHED – Report on Surface Water Quality
The Ventura River Watershed

California Regional Water Quality Control Board – Los Angeles Region
May 2002

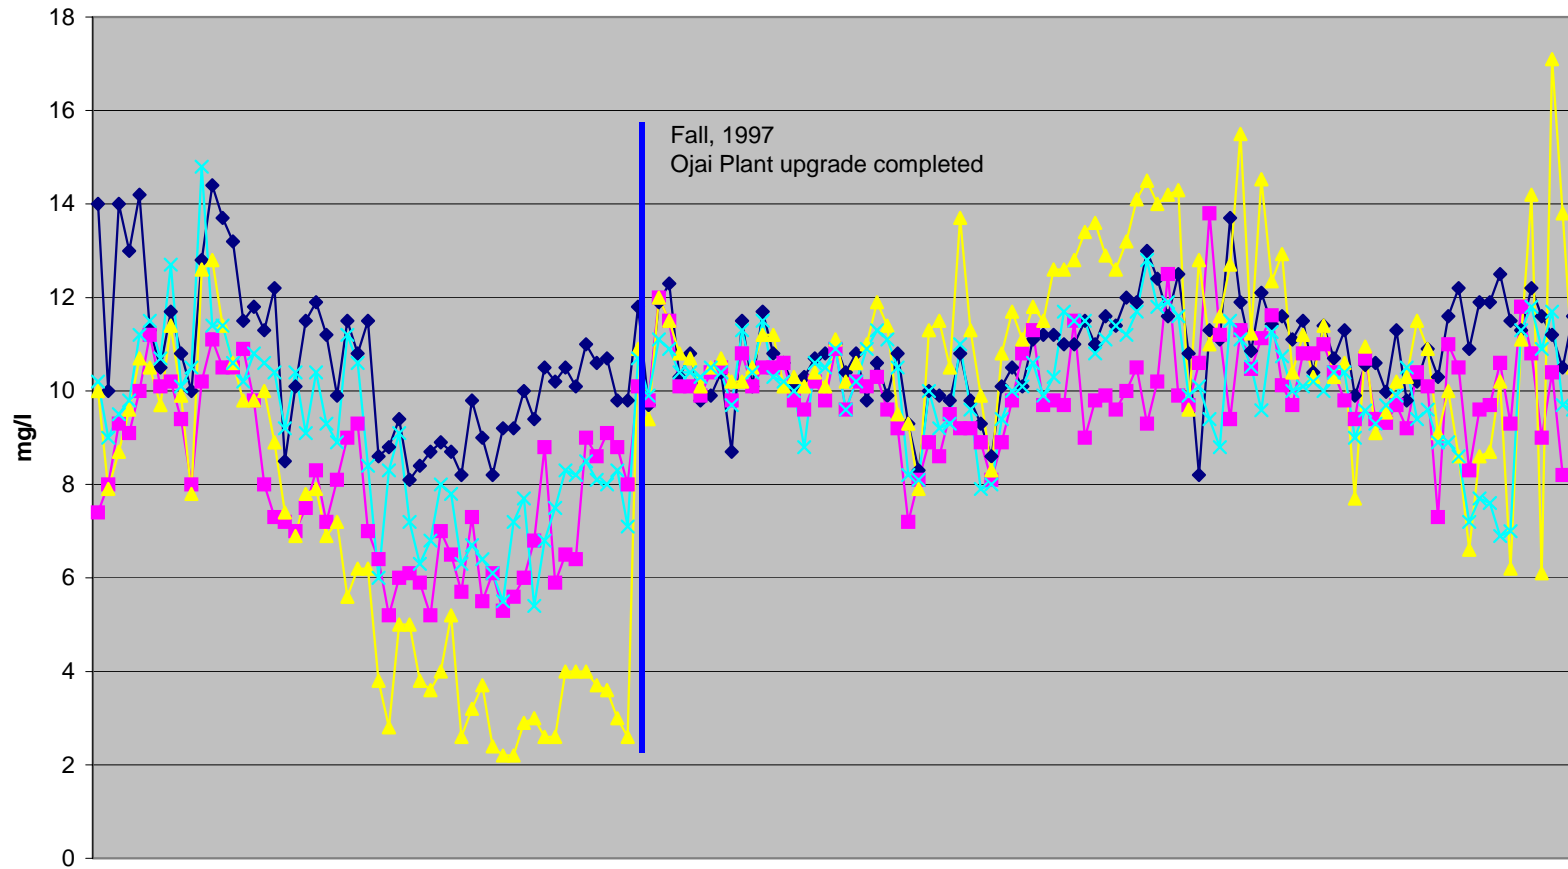
Figure 14

Dissolved Oxygen in the Lower Ventura River

From 1994, 1998-2000 Ojai POTW Monitoring

—◆— R3 (u/s of Ojai Plant) —■— R4 (50' d/s of Ojai Plant) —▲— R5 (3000' d/s of Ojai Plant) —×— R6 (at Shell Rd)
