STATE OF THE WATERSHED – Report on Surface Water Quality
The Ventura River Watershed

California Regional Water Quality Control Board – Los Angeles Region
May 2002

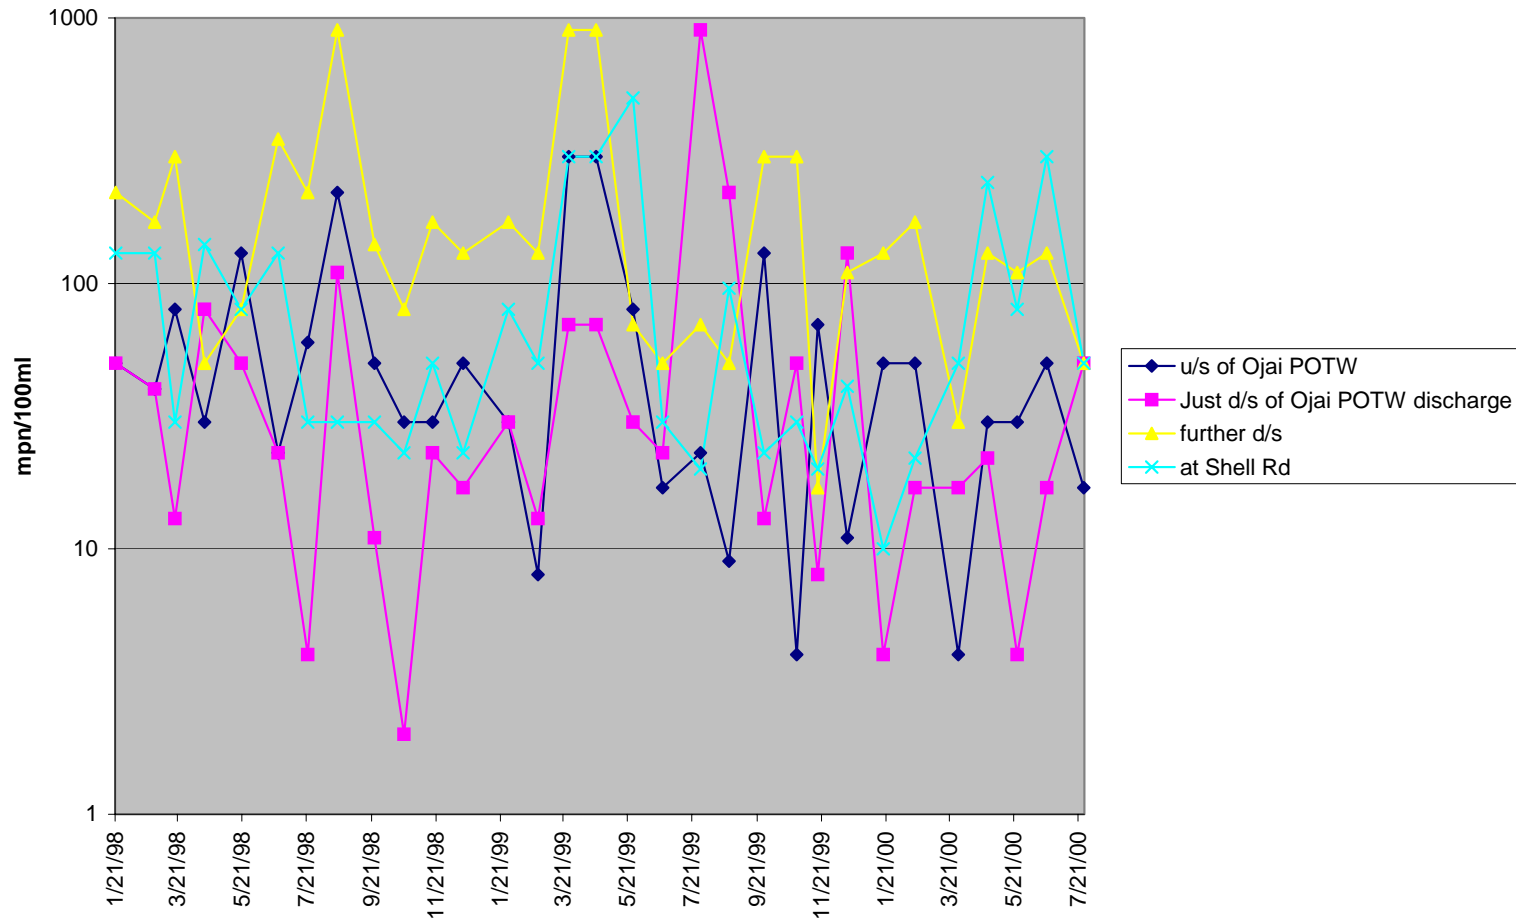
Figure 17

Fecal Coliform in the Lower Ventura River Watershed

Fecal coliform has been generally below the proposed single sample Basin Plan objective of 400 mpn/100 ml except for in the estuary where more frequent exceedances are seen. The majority of bacterial indicator data is for total coliform which does not have a Basin Plan objective; however, concentrations have generally been over 1000 mpn/100 ml with a median of 1600 mpn/100 ml at several locations (Figures 16, 17). *E. coli* and enterococcus sampling has only recently begun with too few samples to draw conclusions. The 2000 Sanitary Survey Update also noted that coliform levels at the Foster Park Diversion were at times quite high. The cause has not yet been identified. Limited sampling for Giardia and Cryptosporidium cysts have occurred at the surface water diversion with only minor presence of cysts being found (San Buenaventura, 2001).
